# EVAPORATION MEASUREMENT FOR THE PRESERVATION OF HISTORICAL BUDDHIST MONASTERY AJINA TEPA, TAJIKISTAN

**Key Words:** Ajina Tepasite, evaporation, new evaporation meter, accuracy check, salt crystallization

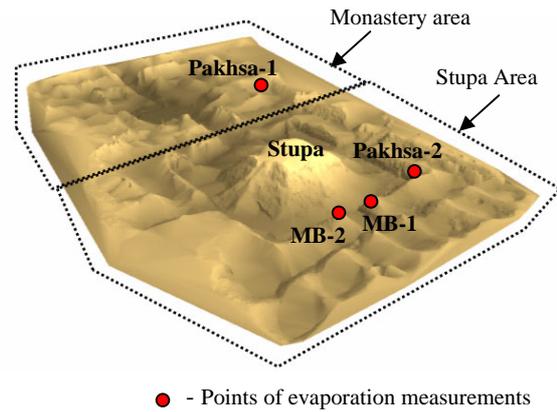
● - Points of evaporation measurements  
Fig.2 3-D graphic for Ajina Tapa

Fig. 2 is the 3-D graphics made by the authors during 2006-2007 by using the technique of photogrammetry<sup>6)</sup>. The Ajina Tapa site is divided into two parts, the stupa area and the monastery area. Fig. 3 shows the damaged historical walls in the monastery area. The historical walls were constructed with mud bricks and Pakhsa (local name of the rammed earth) and have been much decayed after the archeological excavation conducted during 1960-1975<sup>7)</sup>. Fig. 4 shows an example of the support and the surface cover newly constructed for the stabilization of an unstable wall by using new mud bricks.

Walls in the site are covered with soil debris. Some of these walls in the site were cleaned with removing debris before the preservation work. Intense salt crystallization on the wall immediately occurred after the cleaning. Fig. 5 displays the salt crystallization on a mud brick wall after the cleaning performed in the end of April, 2007. Major salts are halite, gypsum and calcite. The evaporation on the two mud brick walls (MB-1 and MB-2) and two Pakhsa walls (Pakhsa-1 and Pakhsa-2) were measured for basically evaluating salt crystallization at four points as illustrated in Fig. 2.

Evaporation measurements were performed 5 times ((1) 20 May, 9:00~10:30, (2) 20 May, 12:00~13:30, (3) 21 May, 14:30~15:00, (4) 22 May, 9:00~10:30, (5) 25 May, 9:00~9:30) at 4 points (MB-1, MB-2, Pakhsa-1 and Pakhsa-2) in **Fig. 2**. **Fig. 13** displays those selected 4 walls (MB-1, MB-2, Pakhsa-1 and Pakhsa-2). **Fig. 14** schematically illustrates the possible two ways of moisture movement due to the evaporation in the historical wall; one is the rain water origin and another one is the ground water origin. One objective of this measurement was focused to study the major moisture movement in the historical walls. If the evaporation rate is very big at the foot of the wall and

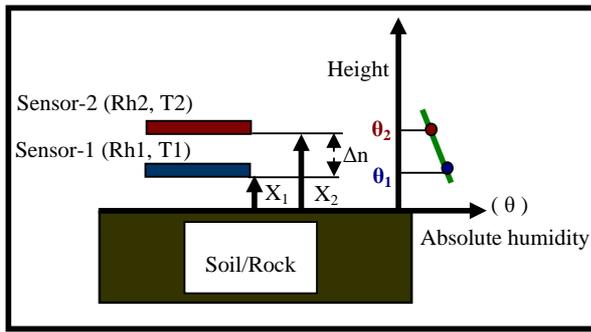
Fig.6 Schematic diagram of evaporation measurement

gradient method (Watanabe, K.<sup>1</sup>). It can be assumed that the vapor flux supplied by evaporation from the surface is upwardly transported by the molecular diffusion in the thin laminar layer formed just above the surface. A vapor flux or evaporation rate could be calculated by Eq.1 (See in Fig. 6).

$$Ev = D \frac{\Delta \theta}{\Delta n} = D \frac{(Rh_1 \cdot Sr_1) - (Rh_2 \cdot Sr_2)}{\Delta n} \quad (1)$$

where D is the diffusion coefficient of water vapor (m<sup>2</sup>/s),  $\Delta \theta$  is the absolute humidity difference between two sensors in ( $\theta_2 - \theta_1$ ) (g/m<sup>3</sup>),  $\Delta n$  is the distance between two sensors in the normal direction to the surface ( $X_2 - X_1$ ) (m),  $Rh_1$  and  $Rh_2$  are relative humidity obtained from sensor 1 and sensor 2,  $Sr_1$  and  $Sr_2$  are vapor saturation at sensor 1 and sensor 2. The relative humidity (Rh) and temperature (T) are measured by two sensors (sensor1 and sensor2) at different vertical distance from the surface of soil as schematically illustrated in Fig. 6.

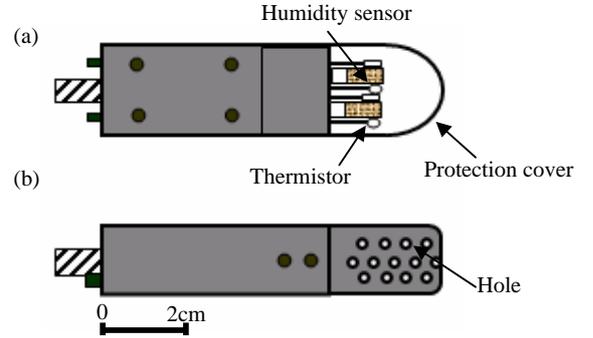
Fig.7 Schematic diagram of sensor part of evaporation meter  
(a) plan view and (b) side view

(Tokyo Keisoku ETH 6101) is composed of two pairs of humidity sensor and thermistor. The shape and the size of the sensor part of the measurement equipment are illustrated in Fig. 7.

The humidity sensor has a plate shape with the size of about 5mm x 3mm. Thermistor is spherical in shape with 2mm diameter. The shape of plastic protection cover surrounding these two sensors is semicircular and its size is about 2.5cm x 2cm and the height is about 1.5 cm. The distance  $\Delta n$  between two pairs of the humidity sensor and thermistor is fixed as 7mm. The other parts of this evaporation meter are an anemometer and a data logger including a small computer. The schematic diagram of the evaporation measurement is illustrated in Fig. 8. All data (i.e. temperature and relative humidity from two sensors and wind velocity from anemometer) are sent to the data logger and the evaporation rate is calculated from the absolute humidity difference ( $\theta_2 - \theta_1$ ) between two sensors. Evaporation rate and wind velocity value are displayed on the monitor of data logger. The response time of sensor is about 60 seconds and average evaporation values were recorded in the data logger.

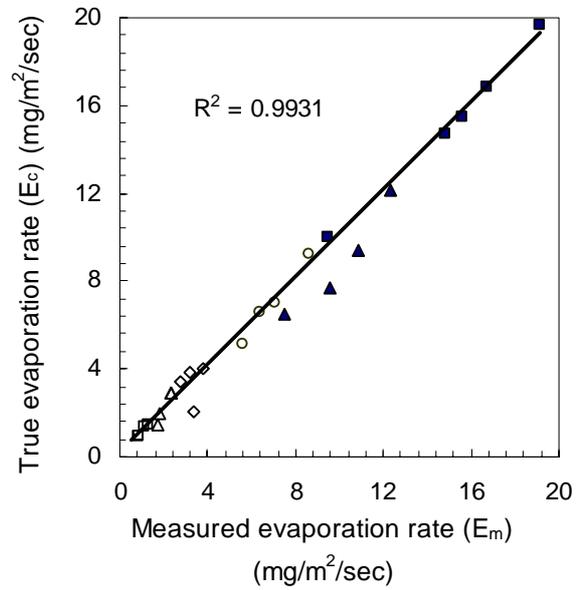
Fig.10 Comparison between true and measured evaporation rate

Six disk type specimens of mud stone (S-1 to S-6) were used for the accuracy check under no-wind condition. Disk shape specimens at which diameters are 7cm and thickness of 1~2cm were used. Both the side wall and the bottom of these specimens were completely sealed with sealant. Therefore, evaporation was allowed from the surface of specimens only. The weight of the specimen decreased if the water from the specimen evaporated and the weight increased when the specimen sucks the vapor in air. Thus, the true evaporation rate could be estimated from the weight changes of these specimens. The schematic diagram of the accuracy check test was illustrated in Fig. 9. The accuracy tests were carried out for a period of 2 hours under no-wind condition. The comparisons between 2 evaporation rates (i.e., measured evaporation rate and true evaporation rate) were shown in Fig. 10. From this figure it was found that, the evaporation rate ( $E_m$ ) measured from the evaporation meter gave the good agreement with true evaporation rate ( $E_c$ ) calculated from the weight change. Difference of evaporation rate is mainly due to the difference of saturation conditions of specimens used in the test. The region of saturation was 50%~100%.

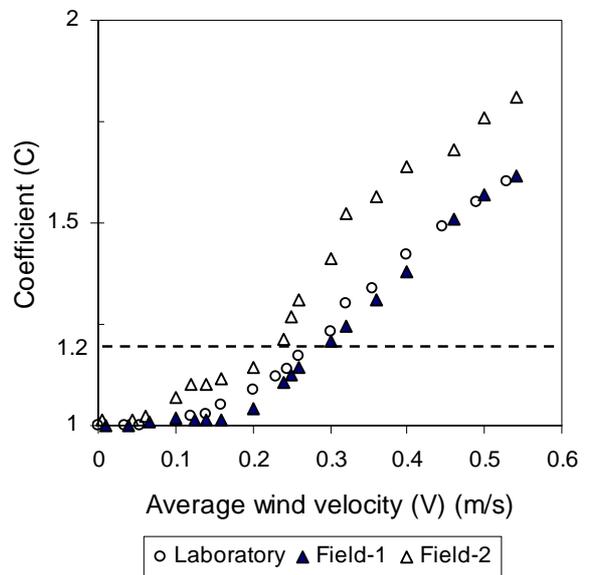
Fig.11 Three examples of accuracy tests results. The relations between coefficient (C) and the average wind velocity (V) are presented. Actual evaporation rate is 0~20 mg/m<sup>2</sup>/sec.

Fig. 11 shows the results of three tests and the relations between the coefficient (C) in Eq.4 and the average wind velocity (V) measured at 5mm above

the surface of specimen are presented. The coefficient (C) values increasing with the increase of the average wind velocity (V). It looks difficult to formulate the relation between C and V, because the effect of wind can not be estimated from only the average velocity fluctuation of wind velocity is also important. However, under the condition that the average wind velocity is less than 0.2 m/s, the coefficient (C) were less than 1.2. This result implies that when the measurement could be performed under the average wind velocity less than 0.2 m/s, the maximum measurement error is lower than 20%.

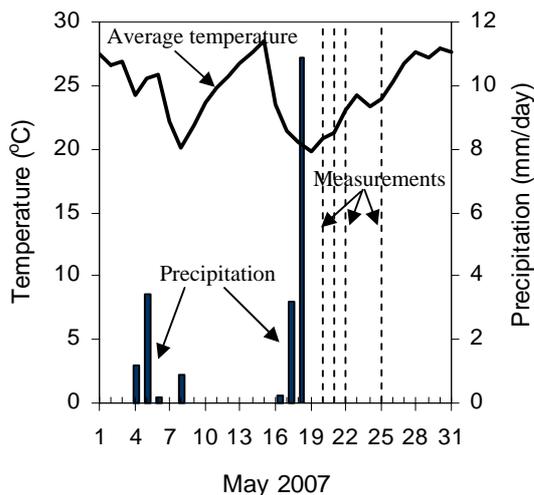
**Fig.12** Daily precipitation and average temperature measured at Kurgan-Tube

**Fig. 12** shows the meteorological data in May, 2007, that was provided from the meteorological station located at Kurgan-Tube. Only the data of daily average temperature and daily precipitation were provided. Four broken lines in this figure illustrate the days of evaporation measurements.

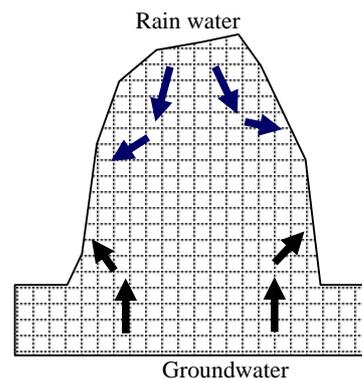
**Fig.14** Two possible ways of the moisture movement due to the evaporation in the historical wall

decreasing with the increase of the wall height, it can be thought that the moisture supplied from the ground is more dominant than the rain water origin. If so, the foot part of the historical wall should be properly coated with thick mud bricks layers to protect the historical wall from the salt crystallization as illustrated in Fig. 15. The top part of the historical wall should be also covered with the plaster to avoid the rain infiltration and the decay of wall due to the repetition of drying and wetting processes.

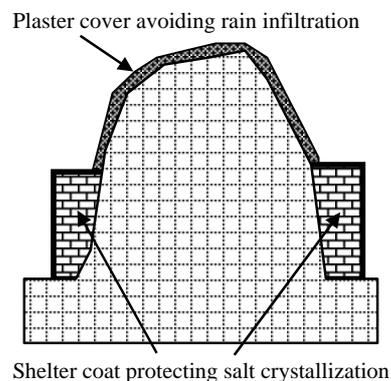
**Fig.15** The protection covers of historical wall due to salt crystallization and weathering processes

1.0~1.2m. Because evaporation rate is big at the foot of wall, the intensity of salt crystallization is thought to be also intense just above the ground surface. So that, wall tends to be destructed from its foot part. It can be concluded that the shelter coat of which height is, at least, larger than 1.0m is needed to reduce the decay of historical wall due to the intense salt crystallization for this site (see in Fig. 15).

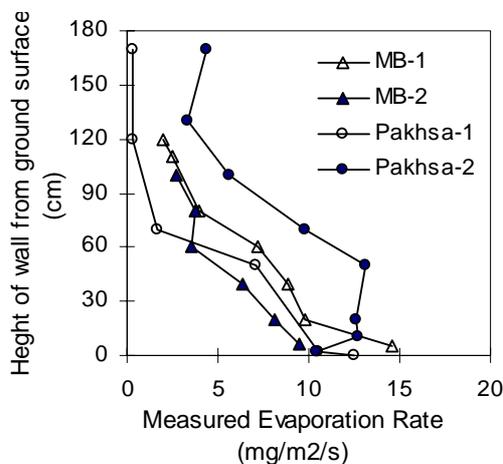
Fig.16 Average evaporation on the mud brick walls (MB-1 and MB-2) and Pakhsa walls (Pakhsa-1 and Pakhsa-2)

All of these measurements were carried out when the average wind velocities measured at 5 mm above the wall surfaces were less than 0.2 m/s with considering the accuracy of measurement. Because the evaporation rates are influenced by the moisture condition in walls, contact condition of sensor on wall, air humidity, air temperature, and so forth, the measured values are fluctuated and not the same for all measurements. For this reason, average values of 5 measurements for each location were considered. The average values may be enough to consider the general tendency of the moisture flow and protection works. Fig. 16 displays the vertical profiles of the evaporation rate on these walls (MB-1, MB-2, Pakhsa-1 and Pakhsa-2). Vertical and horizontal axes of the figure are the height from the ground surface and measured evaporation rate (mg/m<sup>2</sup>/s), respectively.

It is clearly found from this figure that the evaporation rates are big near the ground surface and gradually decrease with the height. This feature implies that the moisture is essentially supplied from the ground, then, it is going up in the wall by capillary suction and evaporates from the wall surface. As the general tendency, the evaporation rate becomes small when the height of wall is larger than
