TURBIDITY RESPONSE TO DISCHARGE IN THE UPSTREAM REGION OF THE HITOTSUSE RIVER WATERSHED

Donny HARISUSENO¹, Satoru SUGIO², Jun NAKAMURA³, Chikashi DEGUCHI⁴,
and Mitsuhiro SEZAKI⁴

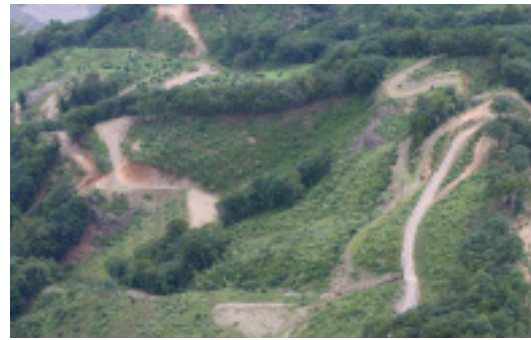
Fig.3 Forestry working passage (bad management forestry).

Forestry working passages are a primary sediment source in forested watersheds⁶⁾. Most of forestry working passages in the study area correlate with collapsed area occurrence, and become the main source of turbid water in the study area. **Fig.3** shows forest working passages in the study area.

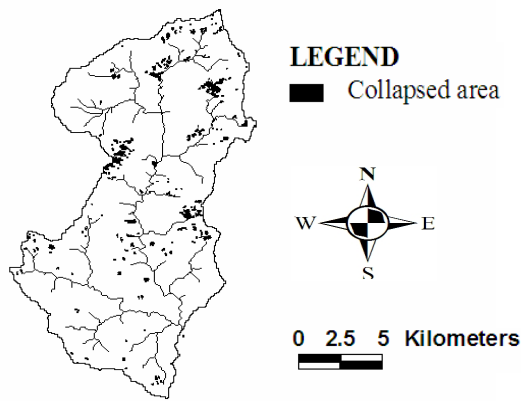
Analyses of the collapsed areas in this study were conducted by extracting land cover characteristic from satellite remote sensing. The land cover was classified by using SPOT images having the ground resolution of 10 by 10m. The observation dates of the SPOT images are taken on October 13, 2004 and February 3, 2006. Land cover was classified using the Maximum Likelihood Method. **Fig.4** shows the distribution of collapsed area in the study area. The change of the collapsed area in the study area is displayed in **Table 1**. In the period 2004 to 2006, there was a significant increase of about 14% in total collapsed area.

Fig.4 Distribution of collapsed areas in the study area.

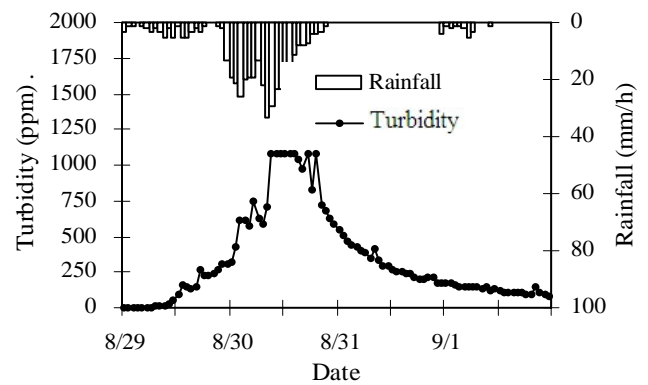
Fig.5 Turbidity-rainfall event in 2004.

Fig.5 shows the response of turbidity peak to the heavy rainfall occurrence. During this time, there was a possibility that a considerable amount of collapsed soil, which contained a high percentage of fine particles (silt and clay), were eroded and routed down from the mountainside to the river channel. **Fig.6** shows the soil size distribution of collapsed soil which was obtained

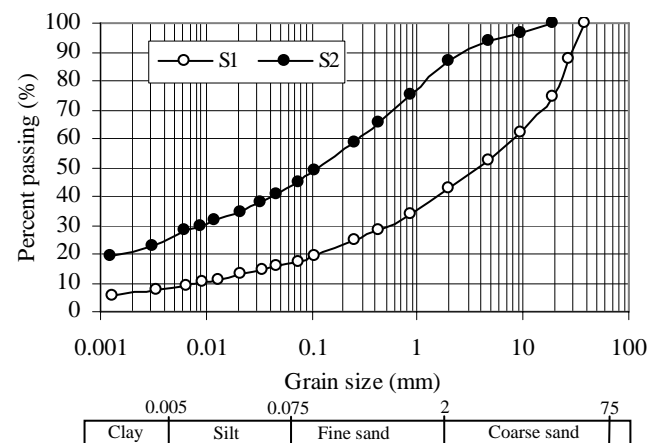
Fig.6 Soil size distribution of collapsed soil.

from field investigation on July 27, 2007, at Itayagawa region (**Fig.1**). The top line (S-2) shows the soil distribution graphic for collapsed soil which contains a high percentage of silt and clay. The bottom line (S-1) contains of low percentage of silt and clay. The existence of the collapsed areas in the study area as shown in **Fig.4** was evidence of the generation of turbid water in the river of the Type 1. **Fig.7** shows collapsed area of mountainside.

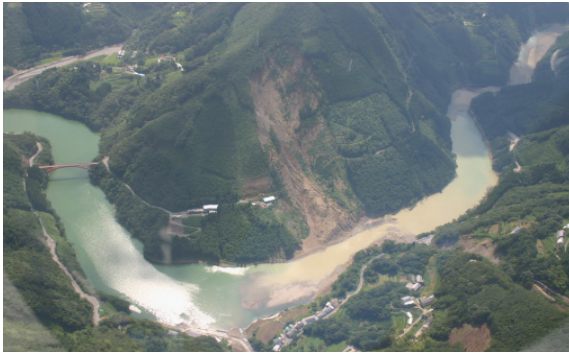
Type 1 expresses to the generation of turbid water due to the collapsed of mountainside. In certain circumstances where the collapsed soils from mountainside fall down into river channel, it will be transported by stream flow.

Fig.7 Collapsed area of mountainside (Type 1).

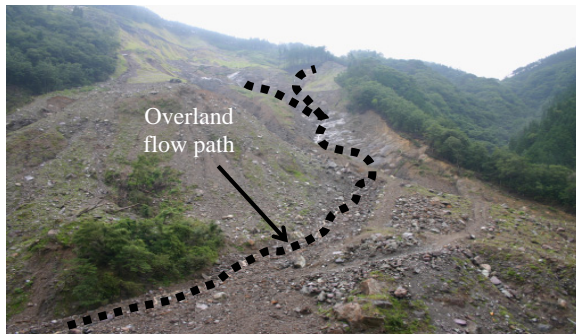
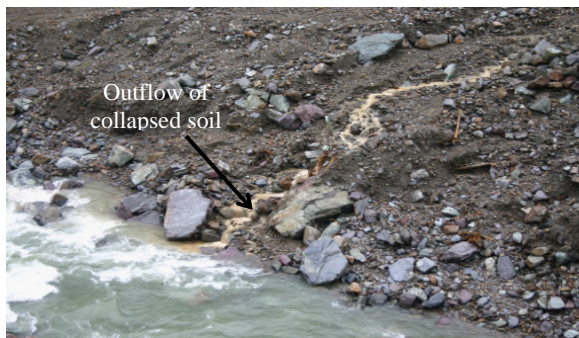
(a) Hillslope middle.

(b) Hillslope toe.

Fig.8 Source of turbid water from outflow of collapsed soil (Type 2).

due to the outflow of collapsed soil. The primary causal factor of source of turbid water in Type 2 is overland flow. In the case of numerous amounts of collapsed soil from the mountainside, some parts of the collapsed soil will be deposited somewhere on hillslope toe on their way before entering the river stream. These deposited of collapsed soil will become a potential source of turbid water in the high rainfall event, where overland flow which come from the surface of collapsed areas will run across the deposited soils and transport fine particles to the river stream. The rill and gully channel resulting from erosion process on the mountain hillslope will give a route for overland flow. The high rainfall which occurred after the slope failure events will cause turbid water of Type 2 and take place over a longer period of time. Therefore, Type 2 turbid water source generation plays an important role in the problem of turbid water prolongation in the river. The source of turbid water from Type 2 in the study area can be seen in **Fig.8**.

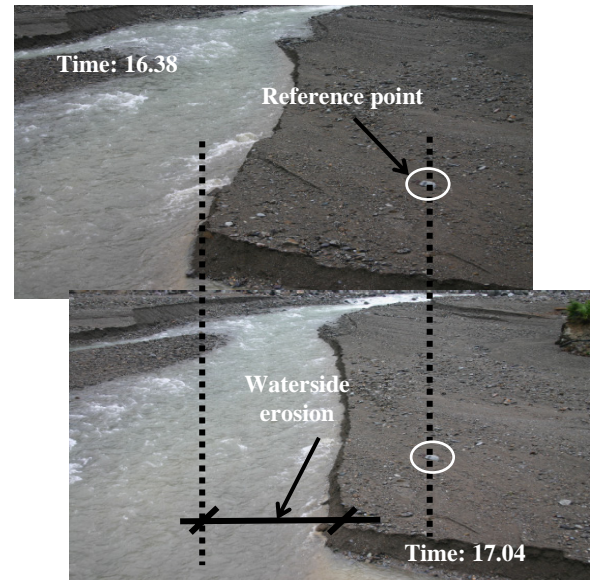
Fig.9 Source of turbid water from waterside erosion (Type 3).

Type 3 expresses the generation of turbid water due to waterside erosion. In this Type, stream flow becomes the driving factor of turbid water generation in the river. Normally, the duration of Type 3 will take place over a long period of time, as long as there is a flow in stream, and this process will continue all the time (continual), either there is rainfall event or not. In Type 1, the collapsed soil transported by stream flow will be accumulated in somewhere in the

downstream part. These accumulated soils, subsequently, will be transported again by stream flow to other parts in the downstream. These transportation and accumulation processes of fine particles in the river stream will take place continually. Type 3 is also the primary causal factor of the problem of turbid water prolongation in the river stream. Fig.9 shows the source of turbid water from Type 3.

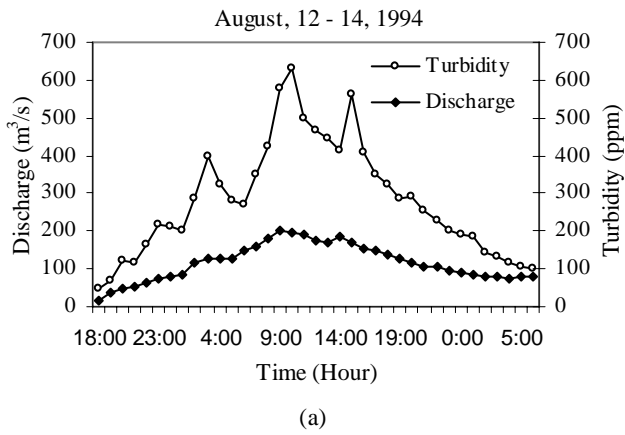
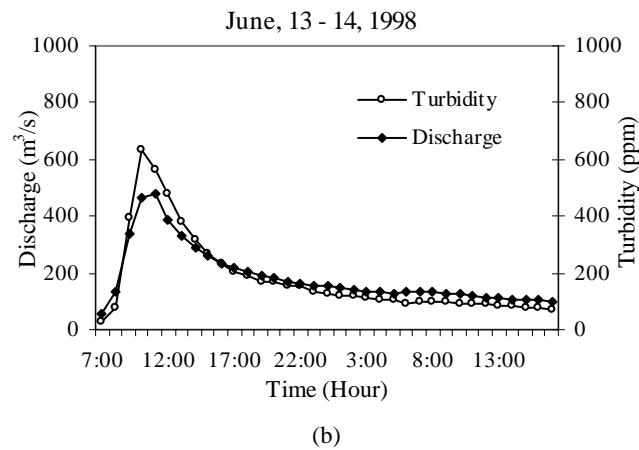
Fig.10 Turbidity-discharge events for selected periods.

Fig. 10 shows two turbidity-discharge events in different period used in this study. Fig.10 (a) was characterized by a higher of turbidity value than discharge on August 12 - 14, 1994, while Fig.10 (b) shows a similar value of turbidity and discharge on June 13 - 14, 1998. Those figures indicate an occurrence of the different response between turbidity and discharge. In order to express these different response phenomena, the Turbidity Discharge Ratio was proposed and defined as the ratio between the total amount of turbidity and total

amount of discharge in a specific period of observation. The total amount of turbidity and discharge, in this case, represent the area of turbidity hydrograph and discharge hydrograph respectively, as shown in Fig.10. Fig.10 (a) shows a value of more than 1 of the Turbidity Discharge Ratio, while in Fig.10 (b) the value is nearly 1. This description clearly shows the change of turbidity in response to hydrological events.

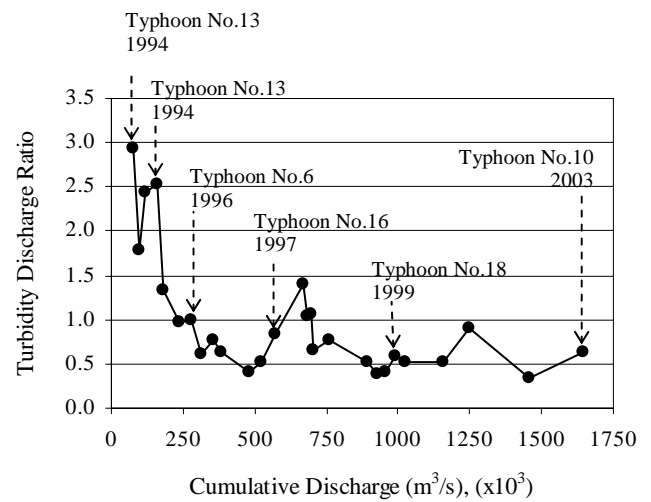
Fig.11 Result of Turbidity Discharge Ratio 1994 - 2003.

The result of the Turbidity Discharge Ratio in the study area over the period 1994 - 2003 as shown in Fig.11, depict the fluctuation of Turbidity Discharge Ratios from year to year, ranging from 2.93 to 0.33. Fig.11 shows that in the early period of observation (within April 4 -

13, 1994), the Turbidity Discharge Ratio was very high (2.93). The height of the Turbidity Discharge Ratio during this period was due to a high percentage of silt and clay in the collapsed soil. The period of relatively high of Turbidity Discharge Ratios were occurred until $180 \times 10^3 \text{ m}^3/\text{s}$ of cumulative discharge (June, 1995).

Within the period of cumulative discharge $230 \times 10^3 \text{ m}^3/\text{s}$ to $1640 \times 10^3 \text{ m}^3/\text{s}$ (July, 1995 to August, 2003), the fluctuation of Turbidity Discharge Ratio values are relatively stable, averaging 0.70. Noted that, during this period, there were several large storms triggered by typhoon hazard which struck a part of Miyazaki, however, those typhoons didn't strike the study area. Therefore, a large amount of collapsed areas almost didn't occur in this period. Hence, within this period there are no significant contribution of high turbid water from Type 1. Therefore, a cumulative discharge about $200 \times 10^3 \text{ m}^3/\text{s}$ is required to reduce the Turbidity Discharge Ratio below 1. The Type 2 and Type 3 play an important role in the fluctuation of turbidity in river stream in this period. Within this period, it can be said that there were no significant problems regarding with the generation of high turbid water in the river stream in the study area.
