Identification of Damaged Areas Due to the 1999 Kocaeli Earthquake Using Satellite Remote Sensing

Institute of Industrial Science, The University of Tokyo
Earthquake Disaster Mitigation Research Center, RIKEN
Institute of Industrial Science, The University of Tokyo

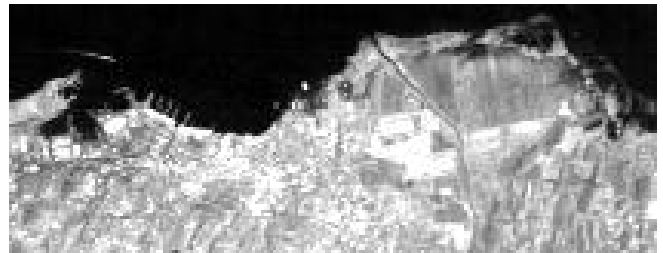
Fig. 5: Image after the earthquake enhanced by NDVI.

$$NDVI = \frac{IR - R}{IR + R}$$
 Since our data comes from Landsat/TM optical image the IR and R bands correspond to Band 4 and Band 3, respectively. As a result of the arithmetic operations between images, we obtain two enhanced or improved images that correspond to image before and after the earthquake. These images contain NDVI, shown in **Fig. 4** and **Fig 5**.

It can be observed in the upper-right part of these images there is a big difference. This difference is due to ground settlement. In the vicinity of east of Gölcük, the vertical offset was about 2m. The ground in the north of the fault settled down. This ground settlement and lateral ground flows in soft soils caused extensive and permanent flooding of large areas along the coast. The inundated area in the post-event image can be recognized because the reflectance in this region of the spectrum is very low and it differs from the one in the pre-event image. Also it can be distinguished in the centre of the post-event image a bright area that highly differs from the one in the pre-event image. This area contains damaged buildings at different levels, from total collapse to slightly damaged. The ratio of the average of the NDVI corresponding to different levels of damaged gives a quantitative analysis of these regions. This rationing, shown in **Fig. 6**, shows a trend from higher values to lower ones, it means from high to lower reflectance, except for the sunken zones, where the trend is reverse. The brightness in these areas is due to the spread of concrete debris after the building collapse. These results agree with the survey reconnaissance made by Architecture Institute of Japan, shown in the **Fig. 7**.
