"Effect of Plain Bars on Hysteresis Behavior of R/C Members"

University of Boali-Sina

Reza Alaghebandian, Ph.D., PE

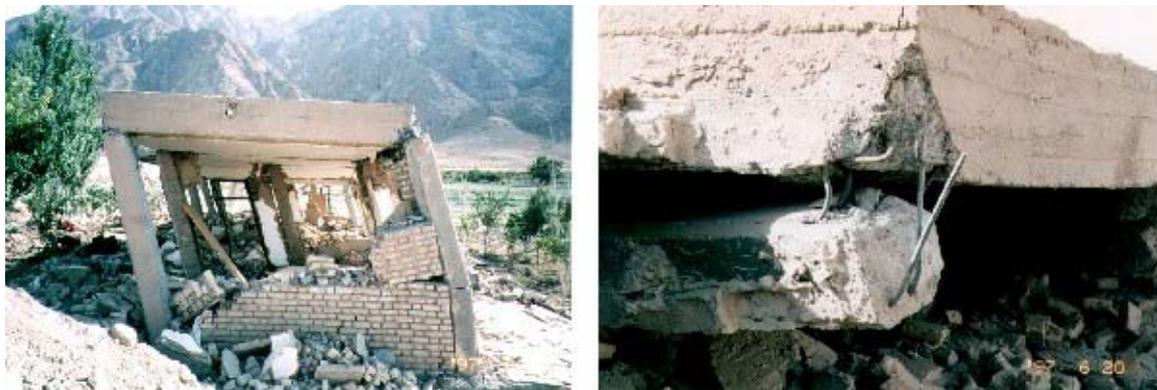
Fig. 1 A typical R/C building (Ardakul) suffered by joint failure and slip out of plain bars

Although, the use of plain bars was prohibited by recently developed Iranian building codes [1], Iranian engineers used to design structures with plain bars till 1980. During the past earthquakes, the bad performance of plain bars was one of the most causes of damages to R/C buildings. Figure 1 shows a typical one story one span R/C building which suffered heavy damages during Iran-Qayen (Ardakul) earthquake of may 10, 1997 [2]. Due to recently killer earthquakes in Iran, the Government pushes for strengthening of existing buildings. In order to strengthening and retrofiting of existing R/C buildings with plain bars, a proper member hysteresis model is of essential. Unfortunately there is a lack in such proper member hysteresis model that implies the effects of bonding and pinching of plain bars. This can be due to lack in experimental results. Two identical R/C structural members one with plain bars and another with deformed bars were designed and constructed in almost same conditions. The members were subjected to cyclic load to obtain and compare their hysteresis diagrams. The test procedures, observations and results are explained in the following sections.

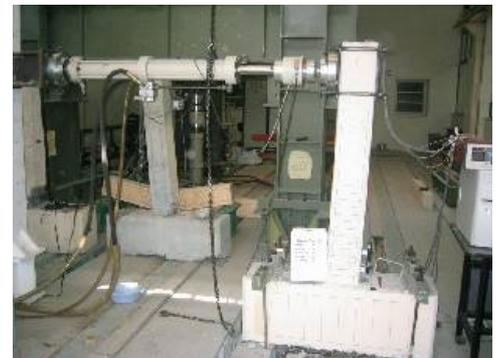
A cantilever member was used to simulate the seismic behavior of a member with moment contra-flexural point at mid-span during earthquake motion (Fig. 2). A 100KN servo hydraulic jack, manufactured by Instron Company, was used to apply cyclic concentrated loads history at a point with a distance of 126cm from top of the stub level. The loading system was controlled by servo hydraulic dynamic actuator systems at the structural laboratory of Tehran University. Data acquisition systems consisted of a static data logger, transducers, and strain gauges, which were obtained from Tokyo Sokki Company. Two half scaled R/C members one with plain bars and another with deformed bars were designed to meet setup capacity of the laboratory. The members were prototypes of a big Hospital in Tehran, which is target for a strengthening project. Lateral steels ratio was adequately large to prevent shear failure. In order to compare the results of the test, the

Fig. 2 Test set-up of prototype member

dimensions of specimens, lateral and longitudinal steel ratios, reinforcement detailing, steel types, concrete mixture, and curing conditions were identical for both specimens. Totally 6 strain gauges were used for each specimens, 3 at each sides. The 3 strain gages were mounted on longitudinal bars at a distance of 2, 10 and 18cm from top of the stub. Strain gages on each side were mounted at the same level. Strain gages were calibrated using simply supported steel plates at the laboratory. The information of calibrated strain gages were monitored and registered at each loading step to find out the mechanical behavior of steel at each step. Mechanical properties of longitudinal steel bars are shown in Table 1. Four 15*15 cubic specimens of concrete were casted and subjected to uniaxial compressive test at the date of member test. The average of compression strengths of concrete for specimens with plain and deformed bars were 32.25 and 321 MPa, respectively. Moment-curvature diagram for plain bar member and deformed bar member was drawn and compared in figure 3. Tensile strength of concrete was assumed to be 10 percent of compressive strength. Initial elasticity Young's
