Investigation of Sediment Disasters caused by Heavy Rainfall on November–December 2004 in Quezon Province, Philippines

Rolando P. Orense Yamaguchi University
 Samuel E. Sapuay Infra-tech Consultants
 Elmer B. Billedo DENR Mines and Geosciences Bureau

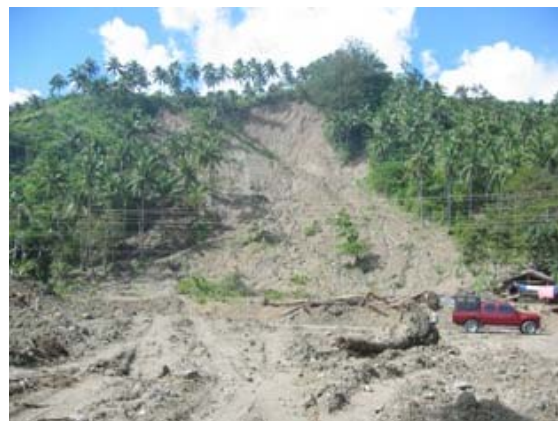
Fig. 2: View of landslide in Real town where more than 100 people were killed.

Madre, even in areas which are heavily forested. Trees were uprooted from these mountains and slid down the slopes together with great masses of soils. Most of the landslides involved only surficial soils and were not deep-seated. Rockslides and rockfalls were also observed near mountain streams. In one of the worst hit areas, about 100 persons were trapped when a three-storey building being used as an evacuation site collapsed under the impact of one landslide. The site is shown in **Fig. 2**. Moreover, five road bridges were destroyed by the sediment- and debris-laden flood waters, and logs and debris blocked major portions of the national highway, rendering Real and adjacent towns inaccessible to traffic for several weeks. One of the washed-out bridges is depicted in **Fig. 3**.

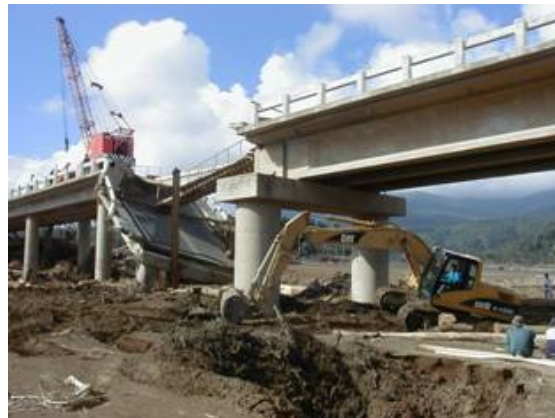
Fig. 3. One of the bridges washed-out by debris-loaded floodwater.

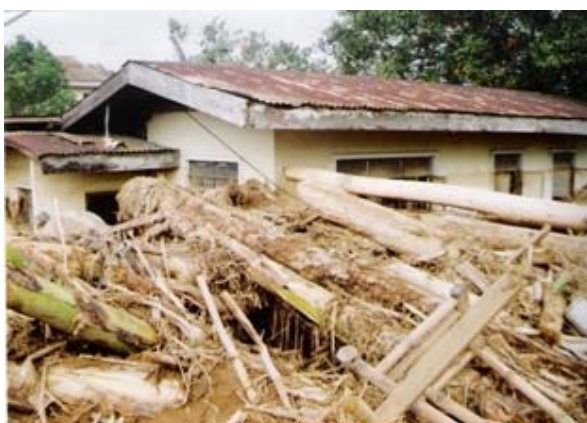
Fig. 5: A house buried by logs and mud in Infanta.
