## Autogenous healing ability of bond cracks along reinforcing bar

### 1. Introduction

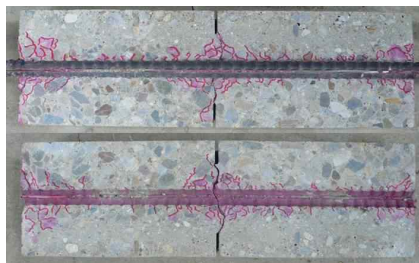
Fig.5 Cracks deformation of a normal concrete

Cracks investigation can provide the recuring effect more visually. Figs 5 and 6 show the dyed cracks pattern of each concrete. Cracks along reinforcing bar were shown after loading by dying, but a few cracks were found at specimens with recuring in water condition. On the other hand, specimens with recuring in air condition had almost same cracks with those of just after the loading.

- 1) Air permeability coefficients increased by the cracks around reinforcing bar due to tensile loading. By recuring in water condition, air permeability coefficients were decreased.
- 2) Through the observation of dyed cracks, cracks along reinforcing bar could be investigated. Most cracks of specimens with recuring in water condition were closed. But cracks of specimens with recuring in air condition were almost same with those just after the loading.
