CREVICE CORROSION STATE OF GUSSET PLATE CONNECTIONS ON STEEL TRUSS BRIDGE

Tokyo Metropolitan University
Waseda University
Public Works Research Institute

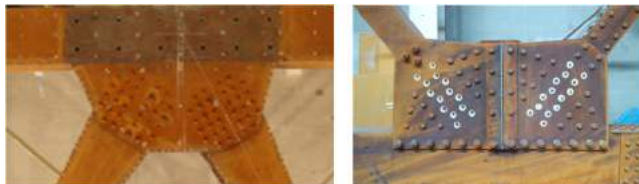
(a) P25d (b) P72u
Photo 1: Gusset plate connections

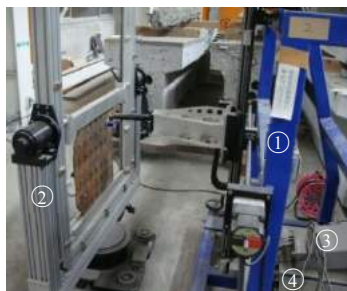
Photo 2: Laser measurement equipment

In order to measure the corrosion shape of the surfaces on the specimen, the specimen was set vertically parallel using the grabbed tool device. The laser measurement equipment was set up as shown in Photo 2. The laser measurement equipment is composed of ①surface roughness measuring device, ②grab tool device, ③A-D converter and ④measurement - control equipment. Table 1 shows the specifications of equipment. Measurement interval of the laser measurement equipment of the specimen was selected as 1mm in order to understand its mechanical performance. The based-plane was set by hands at the visually healthy place and must be sure that corrosion has not occurred on the specimen surface.
