An Acoustic Emission Method for Detecting Aggregated Regions in RC Decks: A Fundamental Experimental Verification

Kyoto University
West Nippon Expressway Co. Ltd.
Hanshin Expressway Co. Ltd.

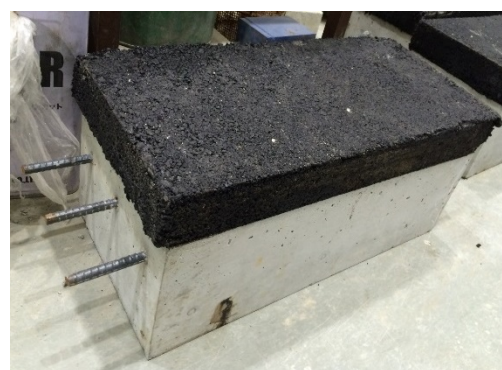
Photo 1. A specimen with asphalt pavement.

A reinforced-concrete specimen (see Photo 1) of 30×70×20 cm in size, paved with asphalt of 8 cm in depth, was designed to model a portion of deck. Before pavement, a cavity of 20 cm in both width and length and 4.5 cm in depth was filled with gravels of 2 cm in maximum size to model the aggregated region (see Photo 2).

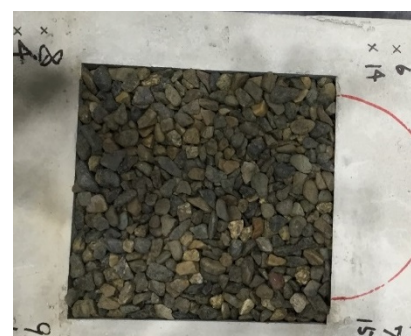
Photo 2. Modeled aggregation
