EFFECT EVALUATION OF REPAIRING METHOD USING CFRP SHEET FOR STEEL GIRDER END

Nagaoka University of Technology Student Member David Galicia Garcia
 Nagaoka University of Technology Student Member ○Jonathan Gonzalez Rodriguez
 Nagaoka University of Technology Regular Member Takeshi Miyashita
 Central Nippon Expressway Company Kouji Kuroki

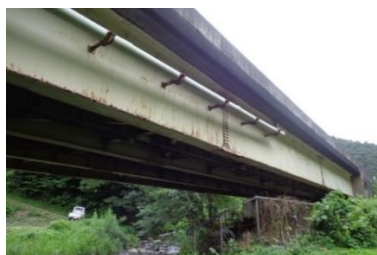
Figure 1. Bridge of Study.

The above mentioned bridge is a steel bridge with 4 I-shaped girders and a RC deck. It is a 72.0 m long-bridge, and it possesses two spans of 36.0 m. It was completed and opened to traffic in 1973 (See Figure 1).
