# Bond Strength Degradation due to Corrosion Cracking in Concrete Specimens without Stirrups

筑波大学 学生会員 ○ Syll Amadou Sakhir  
筑波大学 正会員 金久保 利之

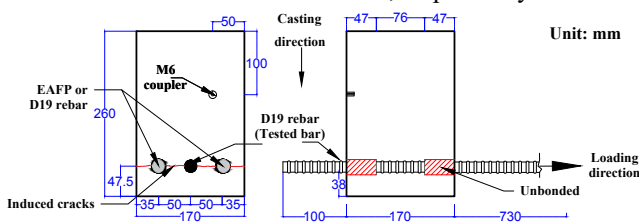
Fig. 1 Specimen detail

The pull-out specimen is designed as shown in Fig.1. The dimensions of the specimen are 260×170×170 mm, and the D19 rebar is embedded at 47.5 mm from the specimen cover side. A short bond length of 4 times the diameter of the rebar equal to 76 mm is chosen to focus on the local bond behavior. Two rebars or EAFPs are set to 50 mm from the main tested rebar to simulate the cracking of surrounding concrete. In addition, an unbonded part was set to avoid cone failure of concrete. The compressive and splitting strengths of the concrete were 22.4 MPa and 2.2 MPa, respectively.

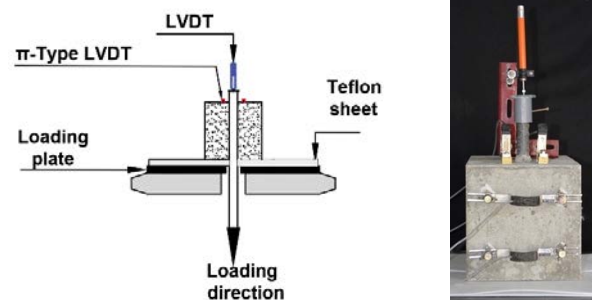
Fig. 2 Loading and measurement of pull-out test

Fig. 2 shows the test set-ups for the pull-out test. The

specimen was set on the Teflon sheet and the loading plate on which the hole with the same diameter corresponding to concrete cover to not restrict the lateral deformation of concrete. The D19 rebar is subjected to monotonic pull-out loading at 0.5mm/min.

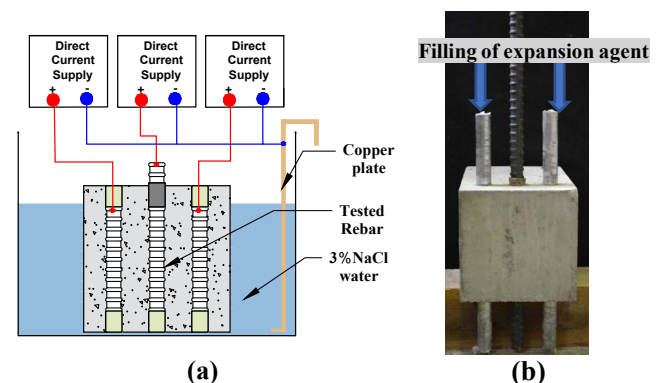
Fig. 3 Crack simulation: (a) electrical corrosion; (b) EAFP

Fig.3 (a) shows the setup for electrical corrosion. The specimen was immersed in a 3% NaCl solution and a direct current was separately impressed in the three rebars using three different current supplies. An intensity of 0.3 A was applied to simulate cracking in a reasonable time.

Fig.3 (b) shows the setup for crack simulation by EAFP. It consists of inserting an aluminum pipe into the concrete and then filling it with an expansion agent to simulate the volumetric expansion of the bar due to corrosion. More details can be found in a previous paper [1].

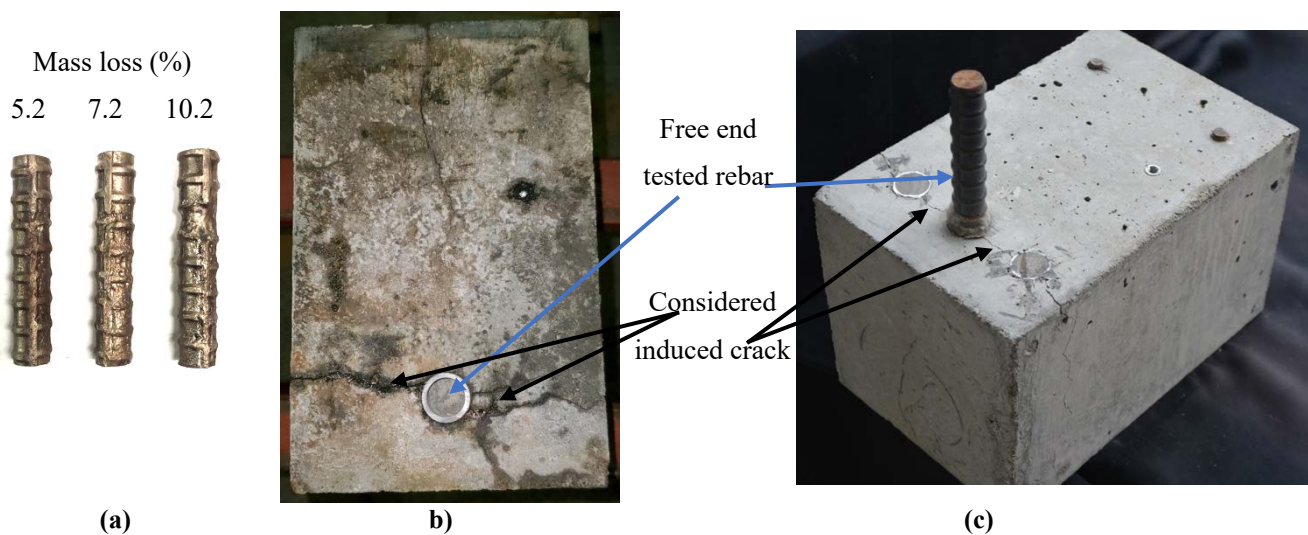
Fig. 4 Crack simulation : (a) Rebar after corrosion (b) Electrical corrosion; (c) EAFP

Fig. 4 (b) and (c) shows an example of crack patterns by electrical corrosion and EAFP, respectively. The side split type cracks took place in all specimens. The considered crack width ranged from 0.15 to 1.10 mm in specimens cracked by EAFP and from 0.15 to 0.65 mm in specimens cracked by electrical corrosion. After loading, the mass loss due to corrosion was calculated for electrically corroded specimens. An example of the change in the rebar surface can be seen in Fig.4(a). Moreover, Fig.5 shows that the relationship between the mass loss and induced crack width is unclear.

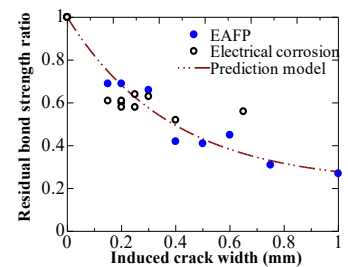
Fig. 6 Residual bond strength ratio versus crack width

The residual bond strength ratio associated with the induced crack width is obtained by normalizing the bond strength of the cracked specimens to that of the uncracked reference specimen. Fig. 6 shows the relationship between the residual bond strength ratio and the induced crack width. With increasing induced crack width, residual bond decreases in most specimens. Also, the residual bond strength ratio can be correctly estimated by considering the single effect of cracking, ignoring the rebar profile change. This demonstrates that the bond mechanism through interlocking ribs is predominant with respect to frictional influence after cracking. Furthermore, it is confirmed that a direct relationship between interlock reduction and crack width can ignore ambiguity related to the accumulation of corrosion products. The result also suggests that a crack-based approach can lead to more accurate results because corrosion-induced surface cracks represent the net amount of corrosion. In addition, it is practical to have a direct and visible damage

indicator that can be measured on the outer concrete surface. However, more research is necessary to investigate the influence of other involved parameters such as concrete strength, cover/diameter ratio, confinement effect, and so on, to develop a predictive model for general applicability.
