Features of the relationship between artificial coastal topographic changes and coastal plants in Hakata Bay, Fukuoka, Japan

Graduate School of Engineering, Kyushu University, Jinzuo LIU · Yawen SONG · Hideo KINOSHITA · Satoquo SEINO

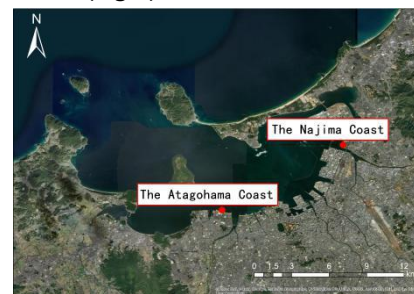
FIG.1 Survey site

The sites of this survey are the Atagohama and Najima coasts of Hakata Bay (FIG. 1), both of which are artificial coasts constructed near landfills. The total length of Atagohama coast is 1.1 km, with offshore dikes built along the coast. Influenced by the rip current formed at the opening, the special coastal shape is formed (FIG. 2). The Najima coast is 0.23 km long and is a semi-open bay facing Hakata Bay with breakwaters at both ends and rocky reef-like terrain at the front. The Najima coast is heavily influenced by tidal currents. A preliminary survey of tidal current directions and coastal

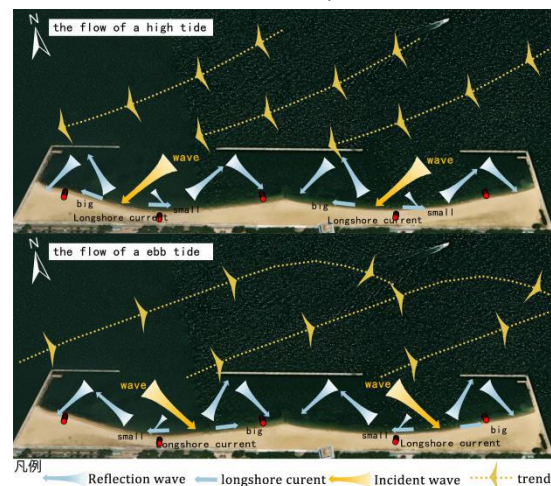
FIG.2 Atagohama offshore flow

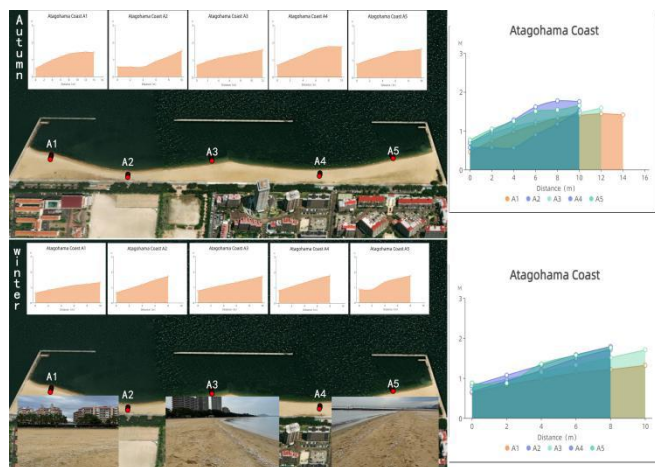
According to the survey data of Atagohama coast, it can be found that there is almost no coastal plant distribution along the coast. Due to the influence of the outer offshore embankment, the inner offshore embankment forms a relatively stable sea area. Overall sand loss of the beach is not obvious. The internal change of the beach is obvious, and the phenomenon of coastal sand transport occurs in the interior of the offshore dike. Sand is easy to accumulate on both sides of the offshore embankment (FIG. 4). The most obvious place affected by waves is at the mouth of the embankment. The two surveys were conducted at high and low tide, when the wave direction changed. The change of slope surface under impact is also very obvious.

FIG.4 The Atagohama Coast topography changes

The survey took two topographic surveys in September and December. Select a representative area and set the measurement area from the timberline to the revetment junction. Observation points are set up every 2 meters to observe the changes of coastal topography and coastal erosion.

It can be seen from the above results that Atagohama can effectively prevent sand from flowing out due to the existence of offshore embankment, but it will also cause partial quicksand phenomenon. After the restoration of the coast, the South Island lost a lot of sand. On the Najima coast, after some time, the height and slope of the beach are almost even. You don't get particularly severe erosion in one area.

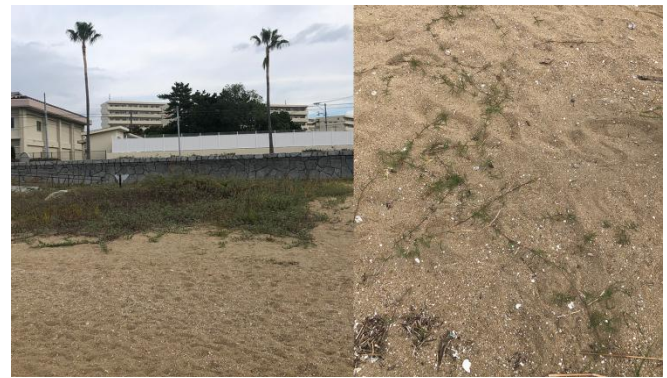
FIG.5 Coastal plants on the Najima Coast

On the back coast of Najima, there are monophylls and a few sea anemones, which have the ability to consolidate sand (FIG. 5). During the Survey in September, the Najima coast had just been repaired, making it easier to observe sand loss. After completing work on the Najima coast. With no coastal protection, sand runs off the coast at a rapid rate. It'll settle down in a few months. There are lots of rocks in front of the shore which are good for waves. The changes caused by wave impact are basically the same in all coastal areas (FIG. 6).

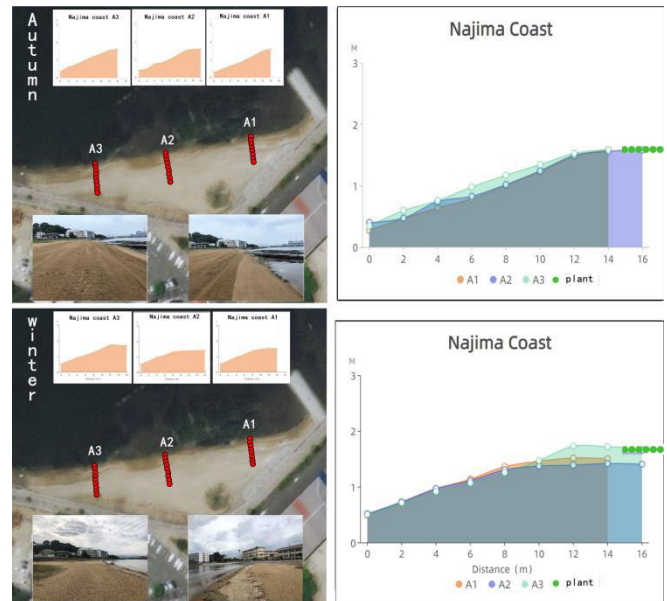
FIG.6 The Najima Coast topography changes
