SEISMIC RISK IN GREECE: WHAT RECENT EARTHQUAKES HAVE TAUGHT US

Vassilis LEKIDIS¹ and Petros DIMITRIU²

¹Dr. Eng., Director, Institute of Engineering Seismology and Earthquake Engineering (ITSAK)
(PO Box 53 Finikas, GR 55102 Thessaloniki, Greece)

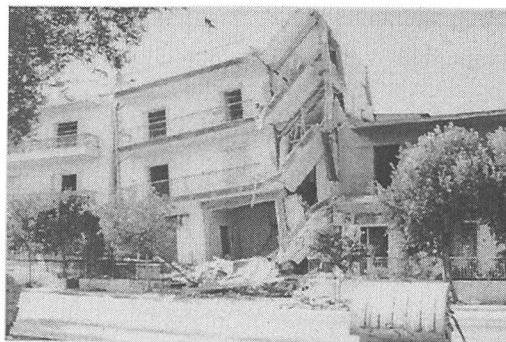
Photo 3 Damage due to pounding, Menidi.

The overall damage picture in the meizoseismal area is very similar to what had been observed in previous earthquakes in Greece. Typical examples include: (1) damaged columns and failures at joints in buildings with “pilotis” (**Photo 1**); (2) damage due to lack of shear walls, particularly around staircases; (3) shear failures of short columns (**Photo 2**); (4) damage due to lack of stirrups in columns. Also, concrete in Ano Liosia was apparently of lower quality than elsewhere. Furthermore, a number of adjacent buildings suffered because of pounding (**Photo 3**). The overall performance of new buildings (1984 and 1995 Codes) was rather satisfactory. A summary of the second-level inspection results for the broader metropolitan area of Athens is presented in **Table 8**, where the buildings were categorized and marked according to their state following the standard “green-yellow-red” classification (see above).

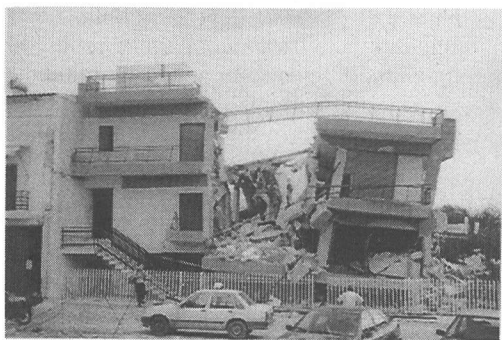
Photo 2 Column failure, due to the short-column effect, in a 5-story building in Ano Liosia.
