STRUCTURAL AND GEOTECHNICAL ASPECTS OF THE 1995 GULF OF AQABA EARTHQUAKE

Mohamed A. H. ABDEL-HALIM¹ and Eid AL-TARAZI²

Key Words : earthquakes, damage, concrete, construction, structures, performance, structural design

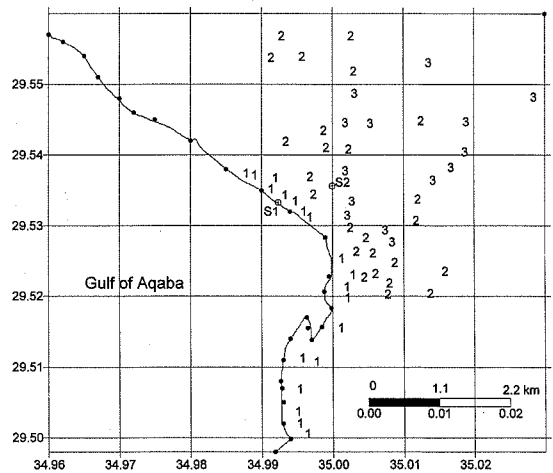
Fig.5 Maximum Observed Intensity distribution in Aqaba city of Nov. 22, 1995 (after Al-Tarazi, 2000). Note: 1 represents intensity VIII, 2 intensity VII, and 3 intensity VI. S1 is the Location of strong motion in the Hotel, while S2 is the second station in the Civil Defense building.

sity (MMI) in Aqaba city, shown in **Fig.5**, also demonstrates the local site effects, where VIII degree on MMI were observed along the shoreline near site S1, while lower intensity VI were observed in the northern part of the city near S2 location.

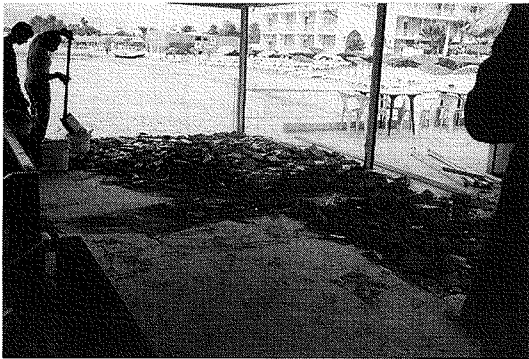
In this Earthquake, in the hotels area on the shoreline, liquefaction possibly caused ground deformations, and crushed most of the jetties and slabs on the ground beside the shore line into pieces, as shown in **Fig.6**, **Fig.7**. Ground subsidence, differential settlement, and fissures were observed in the slabs constructed on the ground in this area. The relative set-

tlement in these slabs vary from 10 to 20 cm and the fissures were as wide as 10 cm, as shown by the previously mentioned figures. Also, it was noticed that more damage occurred in the hotels area than any other area in Aqaba city.

Fig.6 Ground deformation caused crushing of the floor slabs in structures built on the shoreline.

- 6) Some evidence was shown to demonstrate that soil conditions and liquefaction influence the destructiveness by which an earthquake hits various types of structures. The existing hotel area in Aqaba on the shoreline may be riskier

for more flexible buildings during major earthquakes. Inland areas with denser alluviums or rock sites should be considered for constructing highrise buildings and hotels.

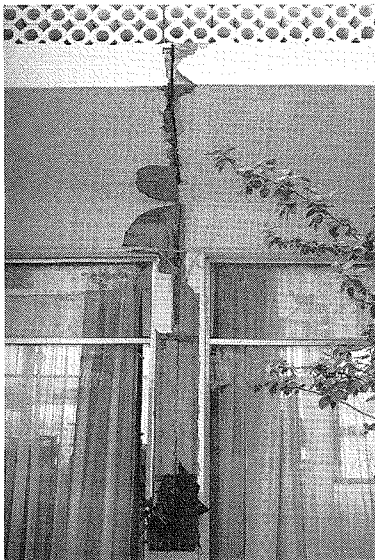
Fig.14 Narrow expansion vertical joints caused pounding between two wings for one of the hotels building.

the effect of narrow expansion vertical joints, which caused pounding between two wings of one of the hotel buildings.

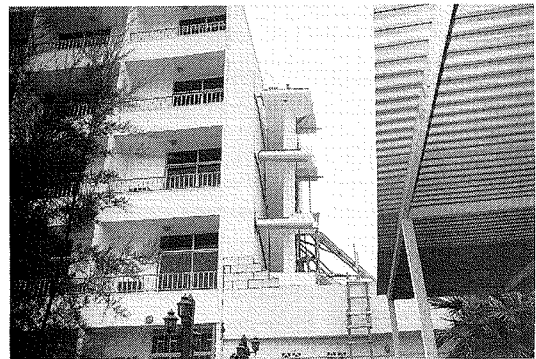
4. Design with stiffer upper parts supported on weakly braced, relatively long columns to provide room for shops, lobbies, and the like. **Fig.15** illustrates this type of design deficiency, which caused the concrete at the top of the columns to be crushed.
5. Separation of secondary members such as emergency exterior stairs which were poorly connected to the building, as shown by **Fig.16**.

Fig.16 Separation of a poorly connected emergency exterior stair.

- 4) The damage served to demonstrate once again the importance of tying different parts of the structure together.
- 5) Hopefully, a useful consequence of the earthquake will be a total revision of Jordan's Code for Loads and Forces, and the addition of "Special Provisions for Seismic Design" to Jordan's Code for Ordinary and Reinforced Concrete. The revision of these codes should be in accordance with modern scientific developments and design concepts.

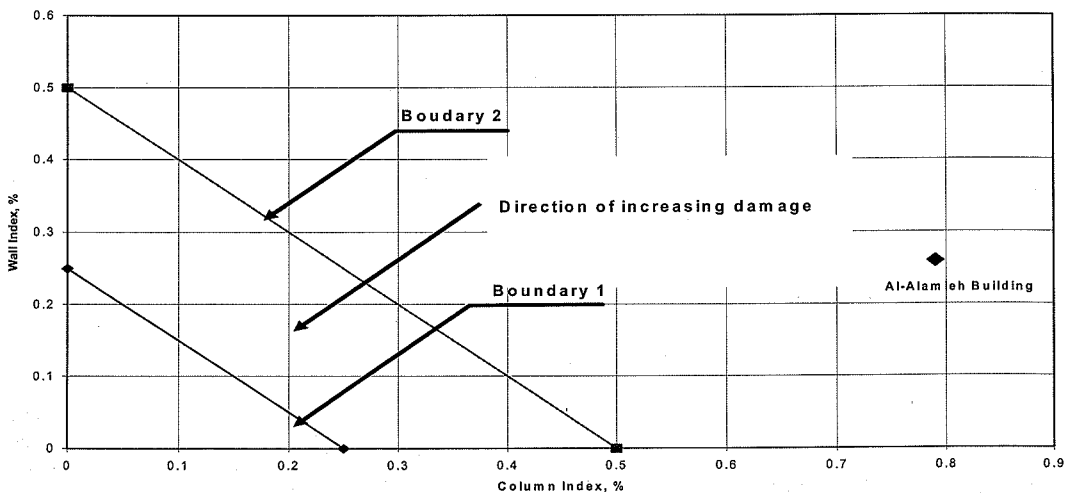
Fig.19 Proposed Evaluation Method¹⁹⁾.

Also, the seismic vulnerability assessment of low-rise buildings in regions with infrequent earthquakes developed by Hassan and Sozen¹⁹⁾ was used. The format developed by Hassan and Sozen is shown in Fig.19. In this figure, each building is represented by a point in a two coordinate representation. The y-axis represents the "wall index," WI, which is defined as the ratio

For the building under consideration, in the short-direction, $WI = 0.26$ and $CI = 0.79$. When the building was represented by a point on the format of Fig.19, its damage state was identified as none.
