FATIGUE STRENGTHS OF BOX SECTION TRUSS CHORD WITH CORNER JOINTS

By Koei TAKENA, Shigeru HIRANO*, Fumio ITOH**
and Chitoshi MIKI****

Keywords: fatigue strength, truss chord, corner joint, defect

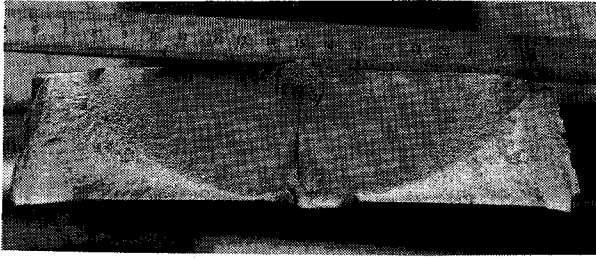
Photo 2 T-8 Specimen¹⁾, blowhole 0.6×0.4 mm Failure Surface with Beach Marks $S=216$ MPa, $N_f=1.708 \times 10^3$.

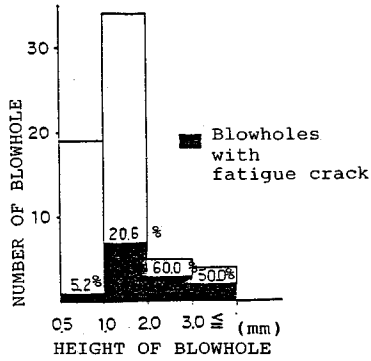
Fig. 6 is the histogram of the occurrence of blowholes larger than 0.5 mm and of fatigue cracks as observed by longitudinal exposing examinations along the weld (Fig. 7). Typical blowholes are shown in photos 8 and 9. As shown in Fig. 6, the larger the size of the blowhole, the higher the occurrence ratio of fatigue cracks. Photo 8 shows a fatigue crack that started from the upper position of the sharp shape of a 1 mm high blowhole, and Photo 9 shows a situation where, in spite of the height of the 4 mm blowhole, no fatigue crack occurred because the shape was smooth. These results indicate that longitudinal exposing

Fig. 6 Occurrence of Blowholes and of Fatigue Cracks.

examinations cannot always identify starting points of fatigue cracks or discover the highest position of blowholes. However, it is assumed that the occurrence of fatigue cracks is influenced not only by the size but by the shape as well. Although BD, BE, and BF were very carefully fabricated, as shown in Table 2, quite a few blowholes still existed. It is difficult to prevent the initiation of blowholes with the current welding techniques.

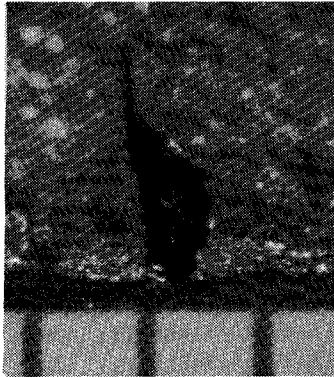
Photo 8 Small Blowholes with Fatigue Cracks (BD-1 Specimen).

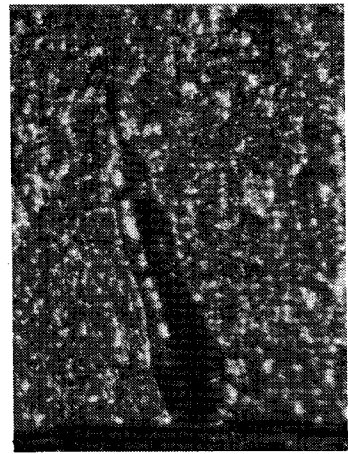
Photo 9 Large Blowhole without Fatigue Crack (BB-1 Specimen).
