REPAIR OF FATIGUE DAMAGE IN CROSS BRACING CONNECTIONS IN STEEL GIRDER BRIDGES

By Chitoshi MIKI, Hiroyuki TAKENOUCHI**, Takeshi MORI***
 and Seiji OHKAWA*****

Keywords: fatigue, repair, steel girder bridge, TIG dressing

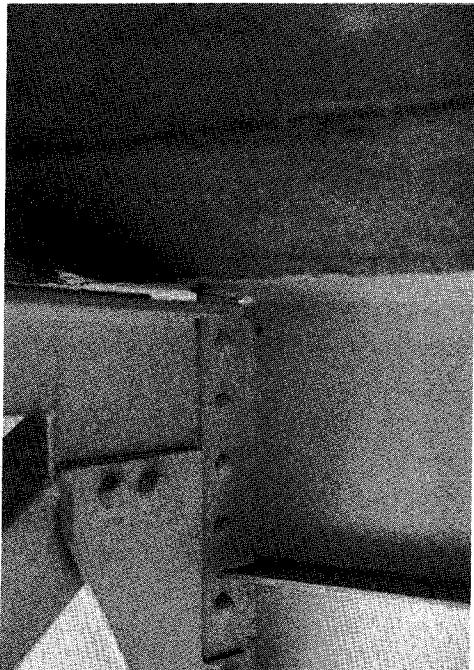
Fig.1 Types and locations of crackings.

In recent years, fatigue cracks have been found at welds between vertical stiffener and the top flange of main girders, where cross bracing or transverse girders are attached in highway plate girder bridges as shown in Fig. 1¹⁾. The occurrence of fatigue cracks at such locations is most typical of fatigue damage to highway bridges in Japan. Such fatigue damage is featured by occurrence of many cracks around the same time at the same kind of details of bridge, in spite of some amount of differences in details and qualities of fabrication.

AB type+D type Crack

Based on the above results of study described so far, it is proposed that the method as applied to TIG-B specimens be the basis for the repair method for actual bridges. According to the results of investigations of actual bridges, most of the fatigue cracks are Type A, as shown in Fig. 1, and their surface length is less than 10 mm at the edge of box welds. For cracks of this kind, gouging is not especially necessary and should be repaired by fillet welding performed on top and toe finishing by TIG dressing. This repair method can be applied similarly to cracks of B and C types also. The crack sizes to which this repair method can be applied would be of a degree that the surface length will not exceed plate thickness of the vertical stiffener.

In case a crack of Type A or B grows further, that part is to be completely removed by gouging and filled by welding, and moreover, additional welding performed overall. In this case also, the toe is to be finished by TIG dressing. When the crack becomes large, gouging is to be done over the entire length of the weld, and full penetration welding is to be performed. However, there is a possibility of adverse effects of large heat input by full penetration welding to the surrounding members and concrete deck plate. Therefore, extending full penetration welding to unnecessary portion must be avoided. There is considerable possibility of a crack initiated from the root having grown substantially at the root even though the length at the surface may be short. Therefore, gouging is to be performed until the crack can be completely

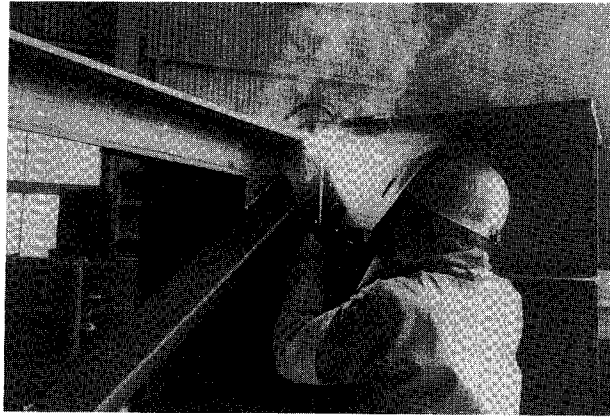
Photo1 Bridge model used for making test specimens.

The TIG-D specimens have details identical to TIG-B, but TIG dressing was done in very adverse conditions assumable to occur in the actual field practice such as raising electric current and shaking the torch. Fabrication of TIG-A, B, C, and D specimens was performed in the model bridge shown in Photo 1 with the aim of reproducing repair work efficiencies at damaged portions of the actual bridge.
