# ANALYSIS OF TYPICAL SEISMIC DAMAGES OF HIGHWAYS IN 2008 SICHUAN EARTHQUAKE

by Shuming FANG \*\* and Hiroshi WAKABAYASHI\*\*\*

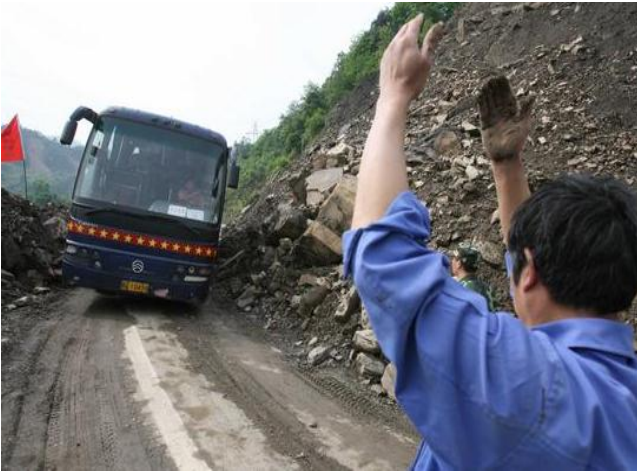
Figure 1: Landslide of the highway G213

1) Landslide: A large number of cubic meters of earth and stone slipped along structural surface of layer of rock because of the powerful seismic forces and a highway was buried or dislocated such as Figure 1.

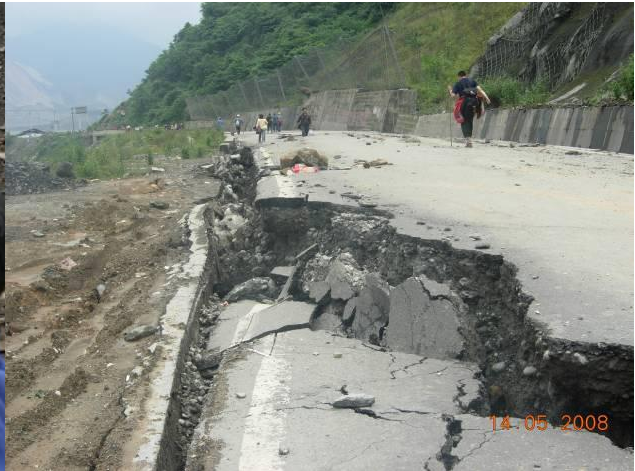
Figure 2: Collapsing of road surface of the highway G213

2) Collapsing of road surface: When the earthquake happened, the roadbeds collapsed easily after the retaining structure of roadbeds was destroyed such as Figure 2.

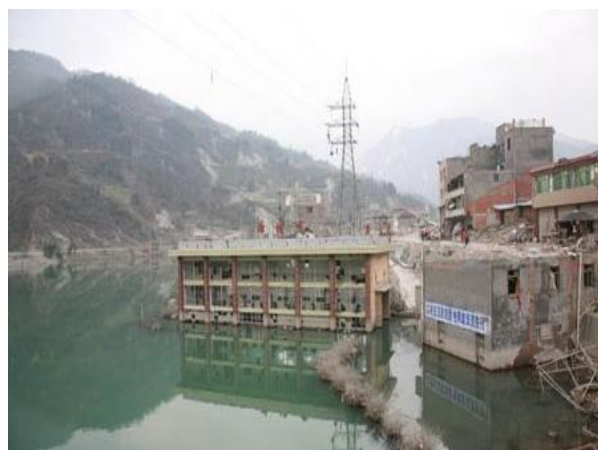
Figure 4: The barrier lake located in Tang jia shan canyon

5) Barrier lake: Barrier Lake is the secondary disasters caused by earthquake. The upstream of rivers formed lakes when the rivers were blocked up by the landslide, deposit of rocks and soils and the mud-rock flow in stream valley zone. The barrier lake located in Tang jia shan canyon in 2008 Sichuan earthquake was very dangerous such as Figure 4.

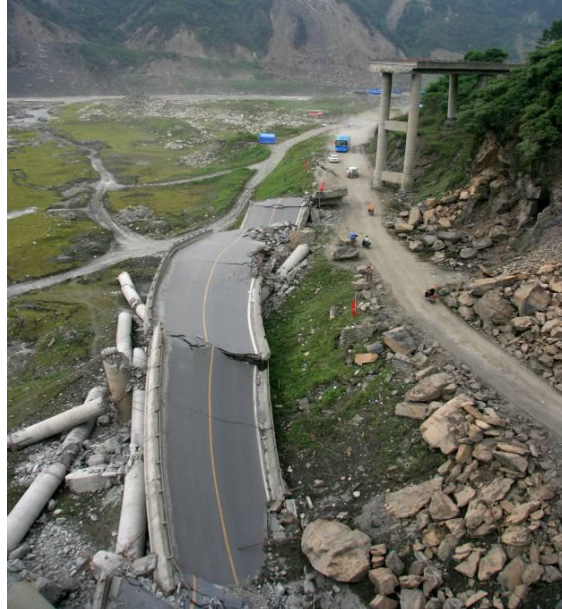
Figure 5: the collapsed Baihua Bridge in the highway G213

7) Bridge collapsing. There were many bridges collapsing in 2008 Sichuan Earthquake. The collapsed Baihua bridge in the G213 Highway was shown as Figure 5.
