## Flood Resistant Bridge Design in Papua New Guinea

### 1. INTRODUCTION

**2. FIELD INVESTIGATION WORKS**

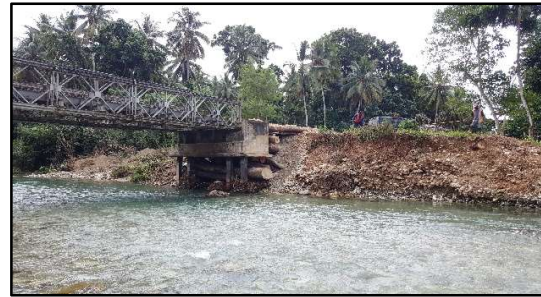
Figure 1 Flood-damaged Himutu Bridge, Boluminski Highway, New Ireland, Province, Papua New Guinea. Photo Credit: Gibson HOLEMBA (2016).

As seen in the signing of the Paris Agreement (COP21) on Climate Change by world leaders to decrease the rate of carbon emission into the atmosphere in September 2016. The effects of climate change causing devastating disasters such as shown in Figures 1 and 2 is now a major focus on global front and as engineers, we are entrusted with more responsibility to provide innovative ideas into engineering and technology that can be sustainable to the lives of people using the infrastructure.

Richard Davies, a News Reporter for Floodlist Asia, published on 16th October 2016, that Papua New Guinea is vulnerable to both inland and coastal flooding. The country has suffered from severe coastal flooding in 2008 as many as 75,000 people were displaced from eight (8) different provinces. In 2016, around 10,000 people were affected by flooding in West New Britain Province with thirty-five (35) houses, bridges, roads and agricultural farms were damaged across both provinces of Gulf and Southern Highlands such as sampled in Figures 1 and 2 respectively.

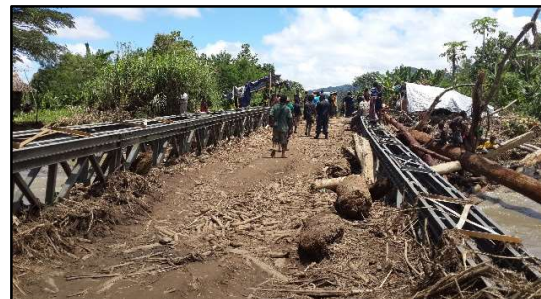
Figure 2 Flood-damaged Asas Bridge, Madang Province, Papua New Guinea. Photo Credit: Solomon Pela (2015)

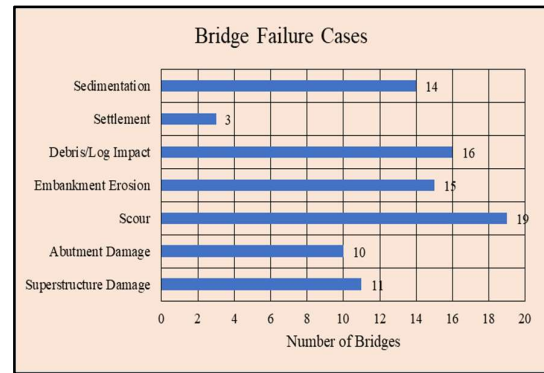
Scouring of bridge abutments and piers, flood debris and log impact and embankment erosions were observed to be the main leading cause of bridge damages as summarised in Figure 3. All rivers have natural banks with no bank revetment or scour protection measures. These bridges were constructed for accessibility convenience; hence no adequate investigation works were undertaken. This was proved with no design record.

Figure 3 Summary of Bridge Failure Cases

forces. Therefore, it is very important to undertake accurate assessments of the hydrodynamic loads during the design stage of the bridge. As presented in Figure 3, debris and log impacts accounted for a lot of bridge superstructure damages and even causing bridge failures. Hence, more research is required to improve the debris and log impact forces on bridges constructed over natural river crossings.

According to Figures 3 and 5, it has proved that scouring is a major cause to bridge failures in Papua New Guinea. Therefore, as a flood-resistant measure against scouring, this research has proposed Eq. (9) for use in bridge design, where  $Z_d$  is the designed bed elevation,  $Z_0$  is the natural bed elevation,  $d_t$  is the total scour depth and 1.0m is the conservative depth as a scour countermeasure.

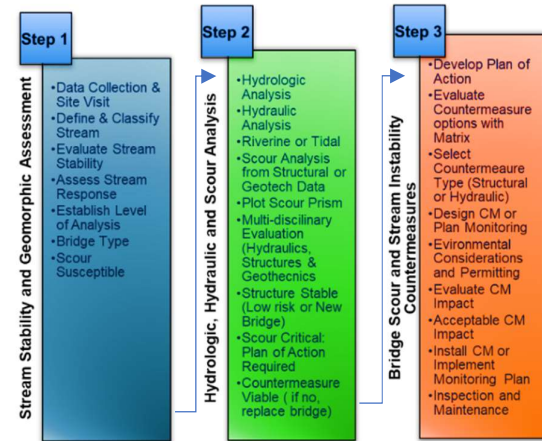
The flowchart given in Figure 7 is for use in the design of a new bridge over a river or stream crossing or in assessing countermeasure for existing bridge. If the structure is stable the design process can proceed to consideration of environmental impacts, cost, constructability, and maintainability, however, if the bridge is unstable then revise the design and repeat the analysis.

For an existing bridge, the finding of structural stability at this stage will result in a low-risk evaluation, with no further action required. However, a plan of action must be developed for an unstable existing bridge where flood-related damage is critical.

Figure 7 Flood-resistant Countermeasure Design Flowchart
