ZEMMOURI, MIYAGIKEN-HOKUBU AND TOKACHI-OKI EARTHQUAKES AND THEIR IMPACT ON HOSPITALS

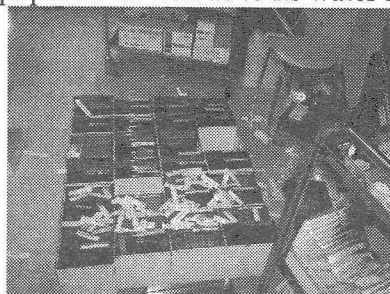
Photo. 4 Equipment damage – Kushiro Clinic

In Japan the situation was much better. However, there were two hospitals, Kashimadai hospital (built in 1968) and Hakuya hospital (built in 1969) that suffered very severe damage to their structures by the Miyagiken-Hokubu earthquake. Both hospitals are reinforced concrete structures. Columns in the second floor of the Hakuya hospital suffered shear failure. In Kashimadai hospital similar damage as the previous hospital was suffered to some of its columns. The Kushiro Urinary Organs Clinic suffered damage to some of its equipment as well as to its water system, as shown in Photos 4, 5 and 6 by the Tokachi-oki earthquake.

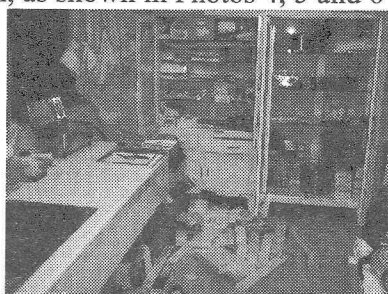
Photo.5 Fallen equipment- Kushiro hospital
