# TORRENTIAL HEAVY RAIN AND FLOOD DISASTER: THE JULY 2008 FLOOD IN THE ASANOOGAWA RIVER BASIN

Kanazawa University, Graduate School of Natural Science & Technology    Student Member    ○Wahid Uddin Ahmed

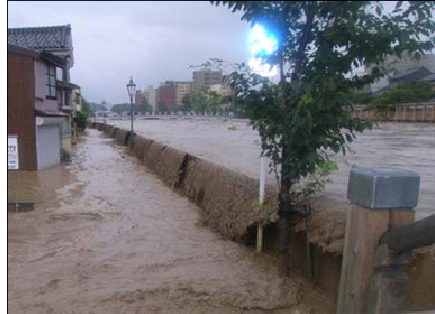
Photographs: Flooding circumstances of Kanazawa city

The muddy flood water flowed into fields and rice paddies, fruit trees were washed down, and the rice was filled up with a large amount of mud. In several areas where the river narrowed, or at bends, flood waters overflowed the dike. Because of delays in closing the floodgate, the river overflowed at opening in the dike called 'kirikaki'. This heavy rainfall caused overtopping from the Asanogawa River running through the downtown of Kanazawa City, inundation water depth over 1 m and large amount of sediment deposition in the city area. This disaster is referred to as the Asanogawa flood of 2008
