第II部門

Effect of Submerged Aquatic Vegetation on Water and Sediment Environment in the Southern Part of Lake Biwa -2023 Field Investigation and Laboratory Experiment-

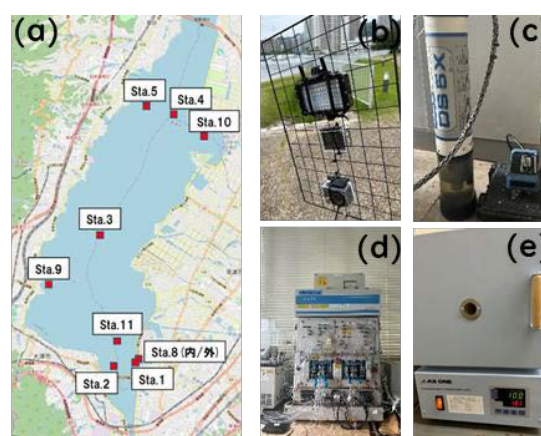
Figure 1 Station information and equipment images. (a) station information, (b) underwater camera setup, (c) water quality profiler, (d) autoanalyzer, (e) electric furnace

The field surveys were conducted by boat on July 12, August 2, September 1, and September 27, 2023. The vertical profiles of water temperature, chlorophyll, and DO were measured by a water quality profiler (Hydrolab, DS5X) at ten stations, as shown in **Fig.1**. Two underwater cameras oriented in different directions with lighting equipment were installed to capture videos of the SAV situation. Surface and bottom water and sediment were also sampled. An autoanalyzer (BLTEC, SWAAT) was used to analyze nitrogen and phosphorus concentrations. Ignition loss (IL) of the sediment samples was assessed by dry ashing processes with an electric furnace at 600°C for 2h.

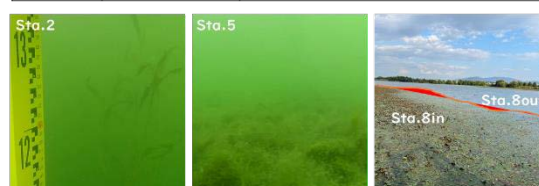
Station	SAV Situation	Remark
Sta.2	Sparse	Situated near the navigation route.
Sta.5	No	Covered with “Lyngbya” in bottom.
Sta.8in	Lush	Behind a reclaimed island, water chestnut covered.
Sta.8out	No	Behind a reclaimed island, without water chestnut.

Table 1 SAV situation at four selected stations.

Table 1 summarizes SAV density at stations 2, 5, 8in, and 8out by video analysis. **Figure 2** shows the vertical profiles of DO, temperature, and chlorophyll at the same stations.
