Disaster and Relevant Management Problems along the Pujon – Ngantang Road in Konto Hulu Watershed, Indonesia

University of Miyazaki, Student Member, ○ IDRUS Miftachul Alam
University of Miyazaki, Regular Member, Cikashi DEGUCHI
Gadjah Mada University, SURYANTO

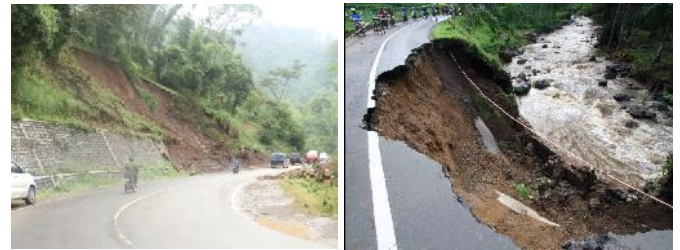
Table 1 shows the number of incidents of landslide and slope erosion along the Pujon-Ngantang Road, especially seven spots of slope erosion and fourteen spots of landslide that occurred on this road during January 29–31, 2014 due to flooding of the Konto Hulu River. The flood also damaged two bridges, several houses, a stall, and farmland and caused the death of three people as shown in **Figure 2** and **Figure 3**. Figure 4 shows the river channel change from 2011 to 2014.

Figure 2. Landslide and slope erosion in the Pujon-Ngantang Road

The Highway Public Works Department of East Java Province has the authority to deal with all problems on the Pujon-Ngantang Road, including disaster countermeasures. When a landslide occurs, emergency treatment is undertaken to clean the landslide material that buried the road to make the road passable by vehicle traffic. For slope erosion, emergency measures are carried out to prevent the slope erosion caused by the river flow from getting bigger and causing more damage to the road. Some slope erosion is severe causing 2/3 of the road damaged and making the roads are impassable for traffic in 2014.

One problem with the countermeasures is the budget in dealing with damaged roads. With regard to disasters, the budget is allocated from the emergency fund of the East Java Province, as considerable time is needed to obtain the budget and to select the company in the procurement process. Consequently, some permanent countermeasures require a long time to be implemented, during which some of the damage gets worse for lack of adequate treatments.

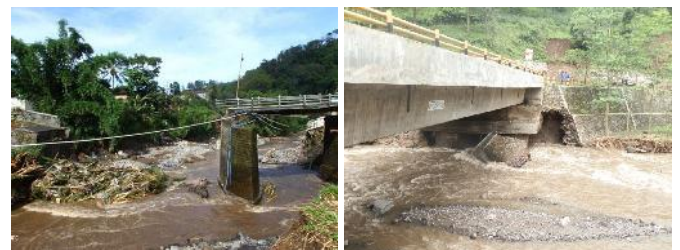
Figure 3. Bridge collapse and damage by flood in the Konto Hulu River

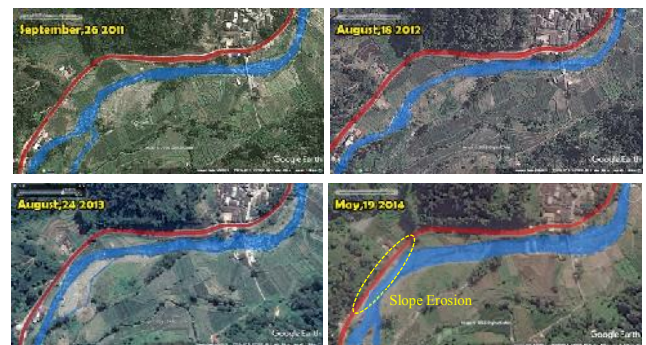
Figure 4. River channel change causes slope erosion on the Pujon-Ngantang Road, KM. P.Jon 8+800

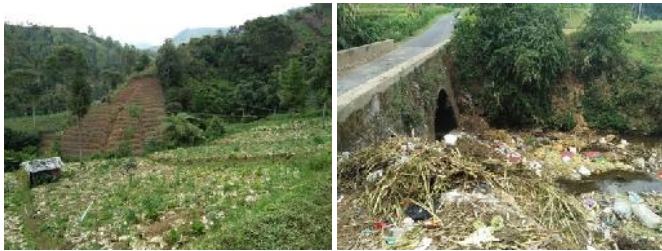
Figure 5 shows the cultivation and garbage thrown by inhabitants into the river. Some cultivation methods in the Konto Hulu Watershed that ignore the conservation principles also contribute to creating critical land. This is caused by a lack of capital, low technology and also lower agricultural yields. In the forest area, some seasonal crops are planted under the forest trees with bad conservation⁴⁾. Moreover, planting seasonal crops on a steep slope results in high runoff and erosion. The inhabitants throw garbage in the river, which damages the environment and contribute to flooding.

**Figure 5.** Cultivation methods and garbage at the river

The change of land use in the watershed may impact the hydrological characteristic that led to a flood and a landslide. Conservation of the watershed is needed to mitigate the conditions along the Pujon-Ngantang Road by cooperation by relevant governments and agencies.
