# FIELD INVESTIGATION ON THE DAMAGE OF ROAD AND INFRASTRUCTURE CAUSED BY THE TSUNAMI IN MEULABOH, ACEH, INDONESIA

The large tsunamis from the 9.0 magnitude earthquake that struck off the west coast of northern Sumatra early on Dec. 26, 2004 caused 300,000 casualties. We carried out damage investigation in the west coast region of Aceh from January 18-22, 2005. In this report we classified damaged and non-damaged areas. There was a significant amount of damaged structures in these areas. The damage to the beach areas from tsunamis erosion and the back arc basin caused by the tectonic movement is described. Ideas for future countermeasures are also discussed.

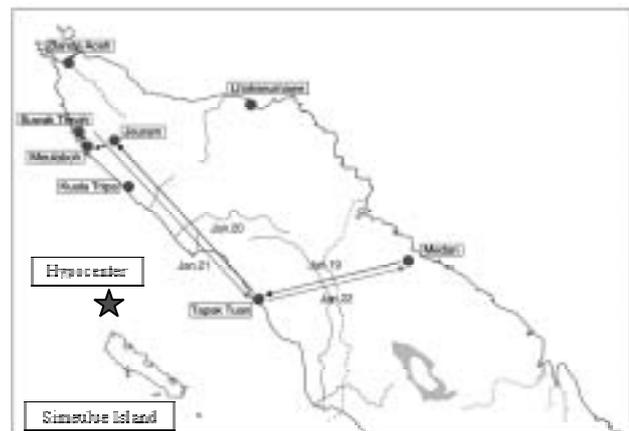
**Figure 1** Survey route

We crossed Sumatra Island from Medan to Tapak Tuan and then on to Meulaboh, Aceh (**Figure 1**). Before this survey was conducted, the tsunamis were thought to have damaged the whole west coast area of Sumatra. However, the damaged area was limited to the area north of Kuala Tuha. One of the

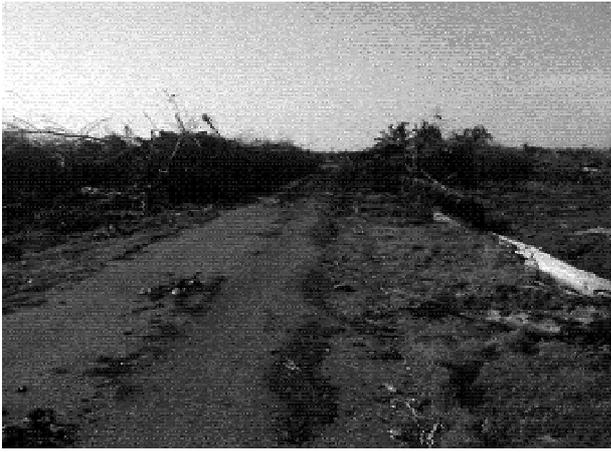
As the roads were damaged by the tsunamis, removal of driftwood from a road poses a big problem. The main roads, rubble and driftwood were removed by the army (**Figure 2, 3**).

**Figure 2** Road Condition from Kuala Tadu to Kuala Tripa (left)

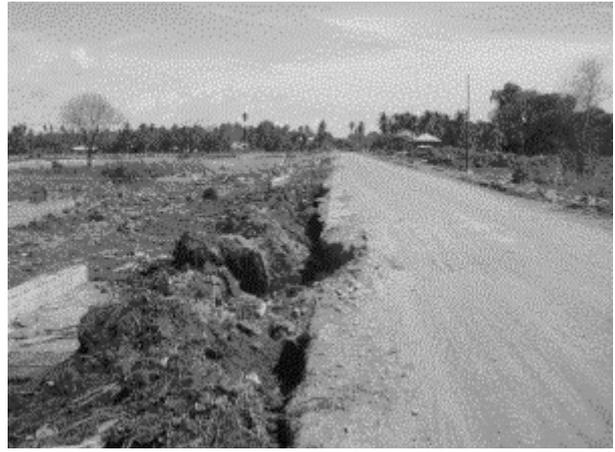
**Figure 3** Road condition near Meulaboh, road shoulder damaged by the tsunamis. (right)

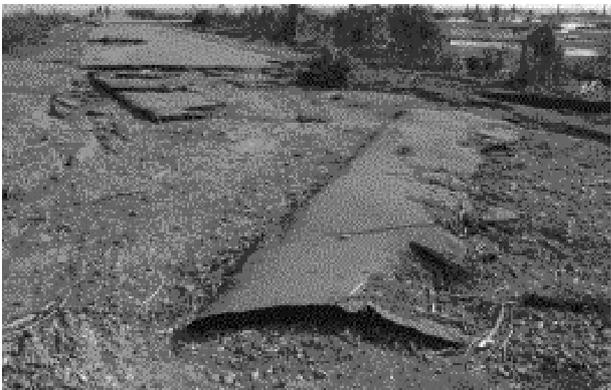
The tsunami runup caused road greatly erosion to the asphalt also exfoliated and the road surface was damaged in the many areas (**Figure 4**).

**Figure 4** Coastal Road from Suwak Timah village to Meulaboh. The asphalt also exfoliated and the road surface was damaged in the many areas (left)

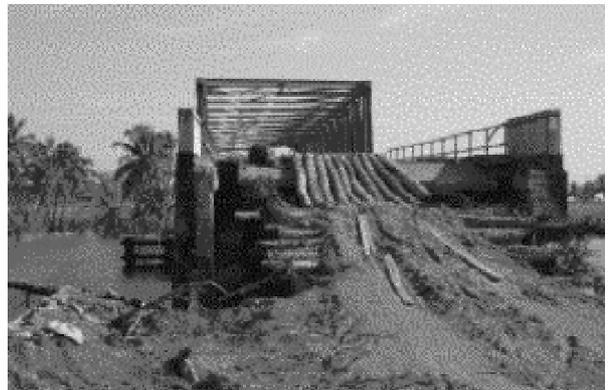
Bridges handrails and superstructure etc. were damaged by the outflow of driftwood at handrails as well as abutment mounts due to severe tsunami erosion. At Kuala tadu river, the down stream side of the abutment was damaged when the tsunami hit. It then passed the bridge and the up-stream side was consequently damaged by the erosion (**Figure 5**).

**Figure 5** Bridge at Kuala Tadu River (right)

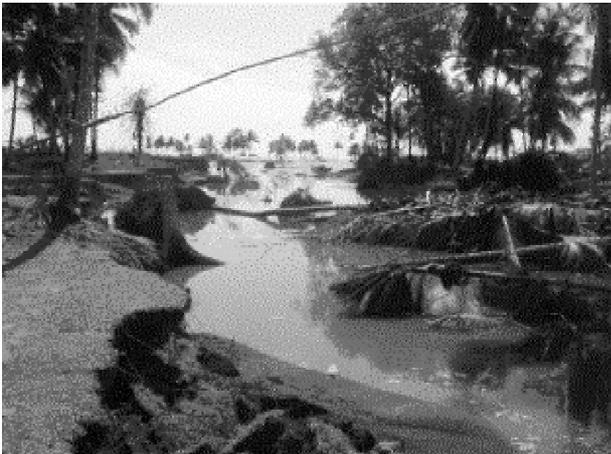
There was damage of the narrow part of the river-mouth where the tsunami struck. The energy of the tsunami concentrates at both sides of the river-mouth banks which causes erosion (**Figure 6**).

**Figure 6** River-mouse near Kuala Tuha

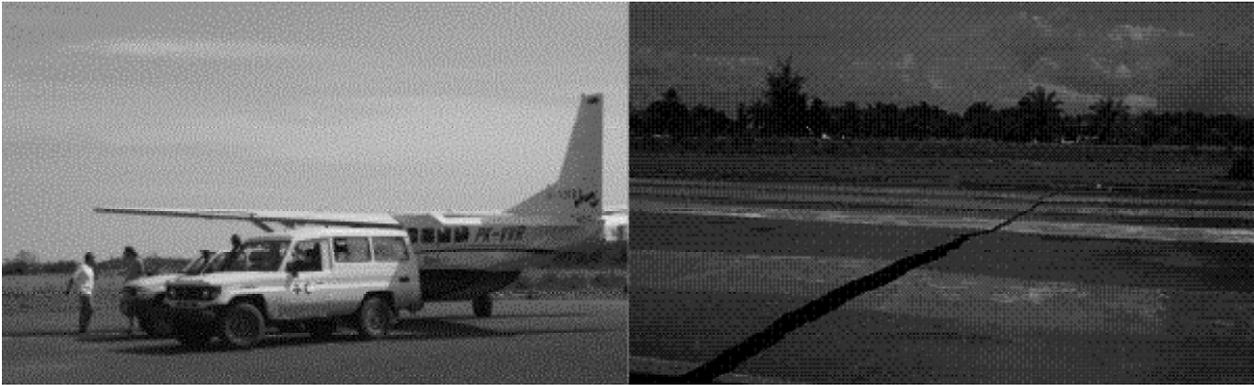
The 1300 m runway at the Meulaboh airport was damaged. Although 200 m of the runway were impossible to use, the runway 1100 m section was restored and made available for use (**Figure 7,8**).

**Figure 7** Meulaboh Airport (left)

**Figure 8** 200 m of the runway were impossible to use, the runway 1100 m section was restored. (right)

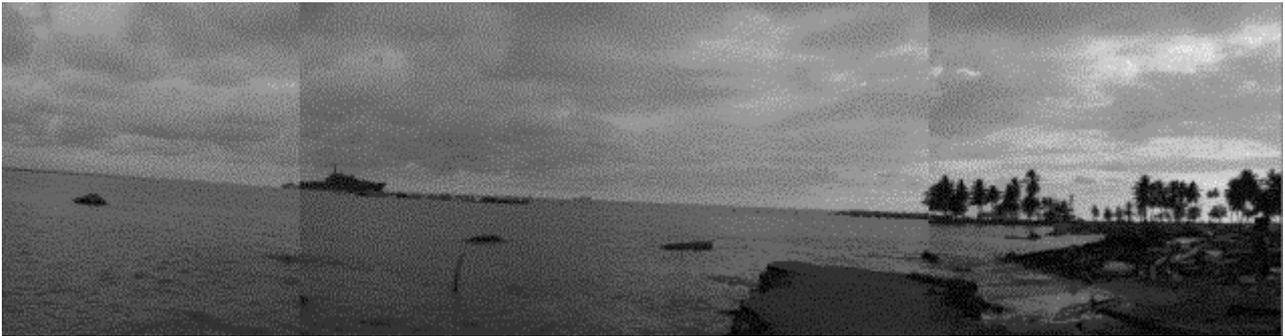
At Ujong Karang harbor which suffered the damage to facilities by the tsunamis, the pier was destroyed and the caisson was also torn off (**Figure 9**). According to the inhabitants, water gushed up from the earth to approximately the height of a person. This might have been caused by liquefaction. Moreover, the coastline advanced inland after the earthquake. This phenomenon was not only caused by tsunami but also by subsidence of the ground due to the earthquake. The damage to the beach areas from tsunami erosion and the back arc basin caused by the tectonic movement is in chapter 5. The mosque, which located approximate 500 m inland, remained standing even though the first floor was completely damaged. The 3.5 m roof was partly damaged, although the glass of the skylight was not (**Figure 10,11**). Therefore, it is thought that the height of tsunami was approximately 5 m.

**Figure 9** Ujounng Karang Port

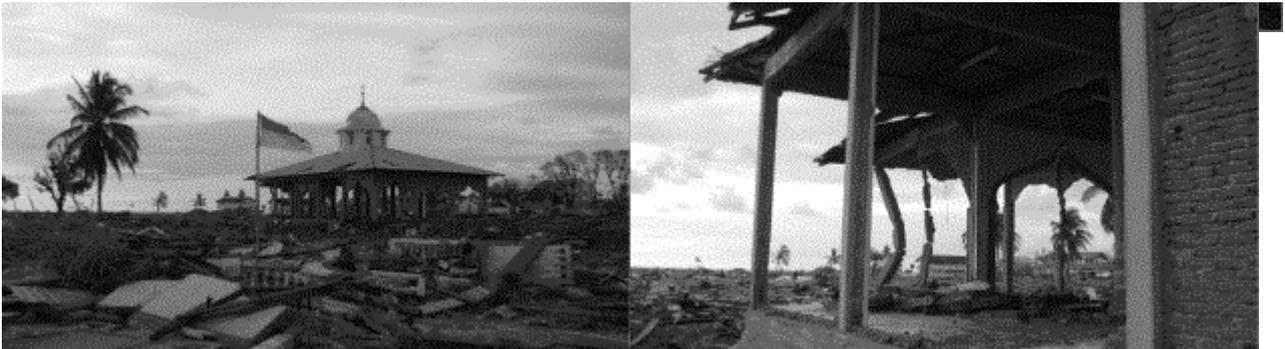
**Figure 10** Mosque near Ujounng Karang Port (left)

**Figure 11** This mosque remained standing even though the first floor was completely damaged (right)

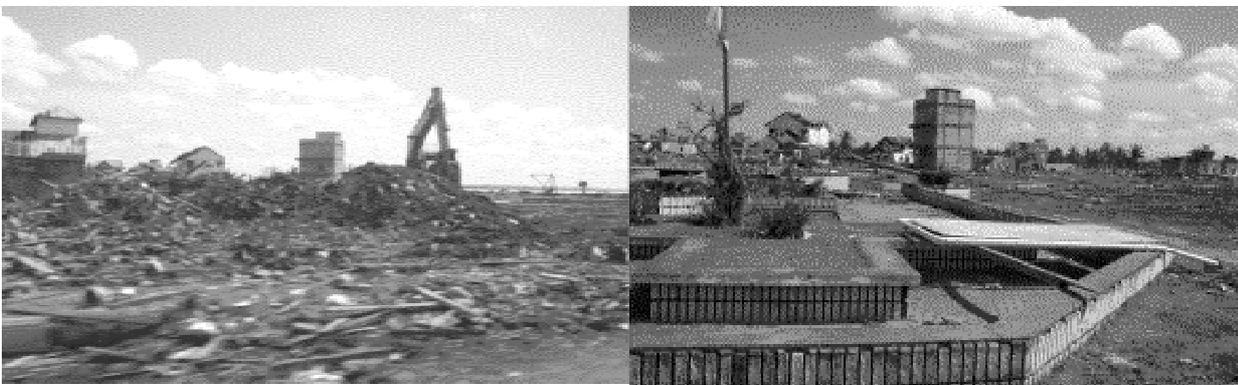
earthquake and tsunamis. The clean up program for the removal of this wreckage is extremely important and of great urgency for the rehabilitation and reconstruction of infrastructure. Only a few masonry structures with RC columns remain standing in the tsunami-stricken areas. Moreover, The structures built continuously, it may be stop in a spread of tsunami damage (**Figure 12, 13, 14, 15**).

**Figure 12** View of Meulaboh City, removal of wreckage (left)

**Figure 13** Center of Meulaboh City, RC frame with masonry structures remained at tsunami damaged area (right)

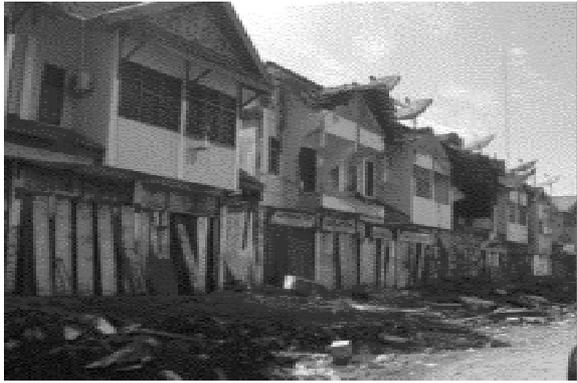
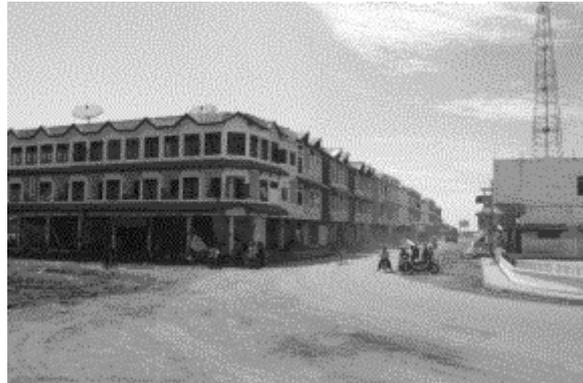
**Figure 14**  
**Figure 15**

View of Meulaboh City. The structures built continuously, it may be stop in a spread of tsunami damage (left).  
View of Meulaboh City. Removed the debris the road in the city. (right).

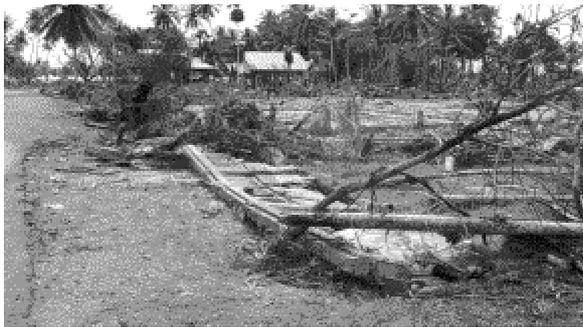
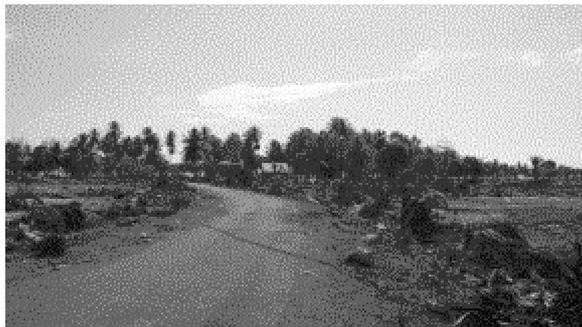
**Figure 16**  
**Figure 17**

According to Suwak Timah Village (located 10km northwest of Meuloboh) inhabitants, only 600 of the 2500 residents survived. Casualties fled to a plantation in the north. Much of the village housing was constructed of wood with tin roofs. The earthquake occurred the coast moved inland 300-500 m. After that, the tsunami hit this area. The residents were divided into two different groups. When many of the structures were destroyed some of the residents went to rescue the injured. However, others, many of them children, went to collect fish on the beach when the sea receded and were swept away by the tsunami. The height of the tsunami, the 2nd wave, reached the top of the coconut trees (about 10m). The coastline is formed like a bay and this is thought to have amplified the force of the tsunami. Geographical features were altered and in some cases even extinguished. The road to Meuloboh from Suwak Timah village was completely destroyed. Thus, we had to use a road through a rubber plantation to get to Meulaboh. The original road now no longer connects to Calang and the only transportation there is by ship (**Figure 16, 17, 18, 19**).

Suwak Timah Village, where located 10km northwest of Meuloboh (left).  
Suwak Timah Village. Many housings of the village were wooden the structure with a tin roof (right).

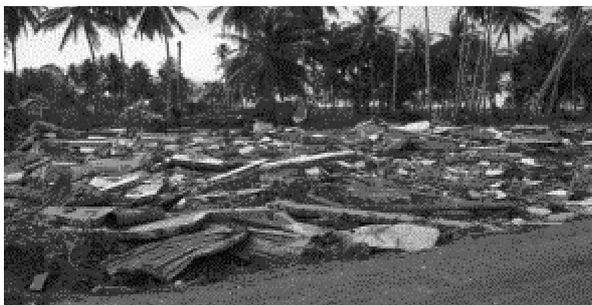
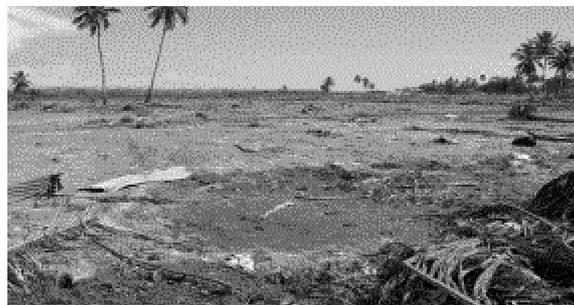
**Figure 18**  
**Figure 19**

Even if masonry structures were completely destroy at Suwak Timah Village (left).  
At Suwak Timah Village, the height of the tsunami, the 2nd wave, reached the top of the coconut trees (about 10m). (right).

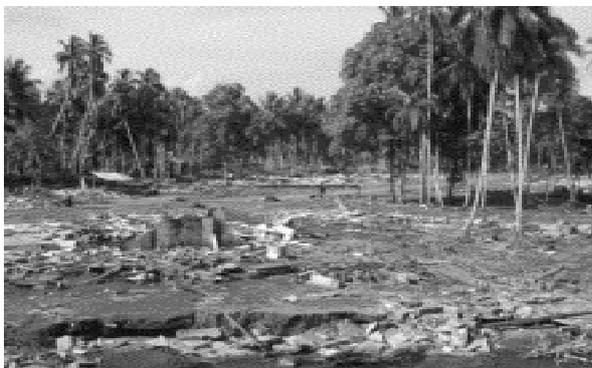
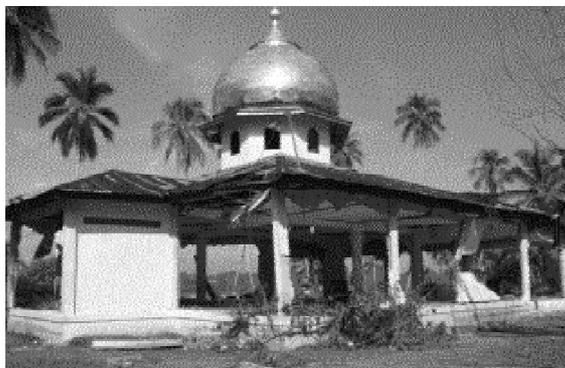
**Figure 20**  
**Figure 21**

245 people of the original 700 inhabitants of Kuala Tudu Village fell victim in the earthquake. Many of the people in this fishing village lost their ships due to the tsunami. All of the survivors have moved to a village 20 km away. The main water supply for the area came from a shallow well (a depth of less than 4m) and according to the inhabitants, the water is now polluted and no longer potable. The mosqu roof was partly damaged (**Figure 20,21**). Therefore, it is thought that the height of tsunami was approximately 4 m.

At Kuala Tudu village, there were 700 people resided, but after the arthquake, 245 persons fell victim (left).  
The mosque roof was partly damaged. It is thought that the height of tsunami was approximately 5 m (right).

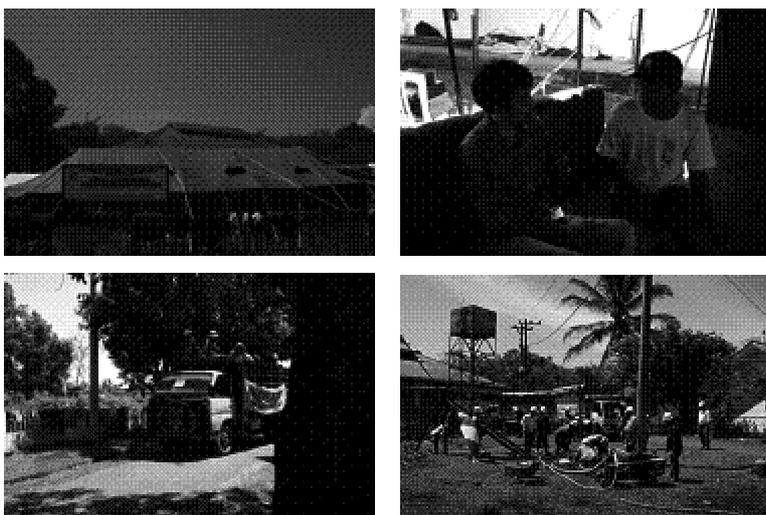
We visited the local urgent correspondence place (POSKO) with KKK was working in cooperation with other local and foreign organizations to share information and give businesslike support. At the POSKO camp they had drilled a well to provide a steady, potable water supply (**Figure 22**).

**Figure 22** Volunteers Activities. POSKO with KKK (KANTOR LATHAN KERJA)

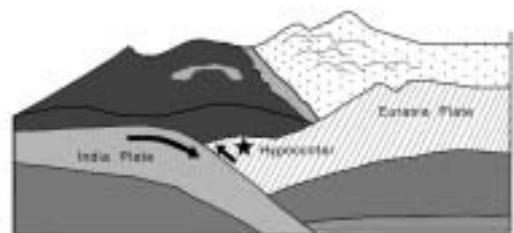
The India plate subduction caused a jump riser in the Eurasia plate (**Figure 23**) and the subsequent earthquake of  $M_w 9.0$ <sup>1)</sup>. This had 1400 times the energy of the Great Hanshin Earthquake. The Eurasia plate jumped and the tsunamis were generated. The sea surface on the Indonesia side rose, and the dilatational wave started off the coast. In the meantime, a compressional wave began off the coast of the Sri Lanka. There was little damage by accretion even though the hypocenter was located close to Aceh. The reason for this is that the Systemic wave contained long-period and destruction rupture from the hypocenter and seemed to propagate to the north. According to the TV news, there were two stages at Banda, Aceh. In the first stage, there was weak ground motion with slow shaking. After 50 seconds, in the second stage, strong ground motion started. This phenomenon corresponds to rupture stage (e.g., Yagi, 2005, personal communication, **Figure 24**)<sup>1)</sup>. In the first stage, the rupture mainly propagated to the northwest of the hypocenter during the initial 50 seconds. The second rupture generated an ultra long period seismic wave. This second slow seismic wave caused the large tsunamis.

**Figure 23** Hypocenter & Tectonic

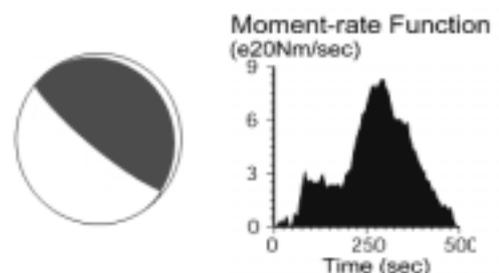
**Figure 24** Focal mechanism (left) ; Total moment-rate function (right) , (Yagi, 2005)  
Moment=1.736 E+23 (Nm).  $M_w=9.4$ .  $D=39.3$  m

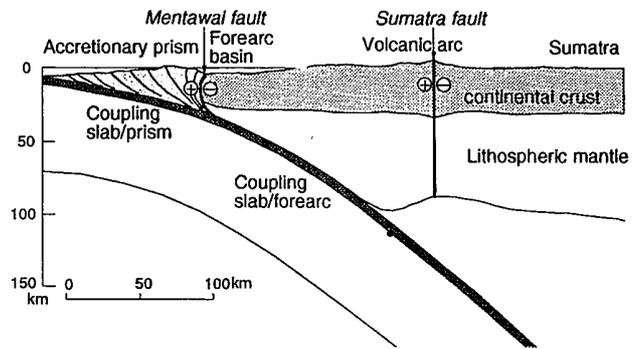
The satellite images of the Tsunami affected areas in the web page were acquired by the Centre for Remote Imaging, Sensing and Processing at the National University of Singapore<sup>3)</sup>. They show the effects of the tsunamis on the affected areas in Indonesia by using IKONOS images. From their work, it is considered that ground sediment moved about 1 m by the earthquake at Aceh (Kimata, 2005)<sup>4)</sup>. This margin is oblique subduction (**Figure 25**: Malod, *et al*, 1996)<sup>5)</sup>.

**Figure 25** Schematic cross-section of the Sumatra subduction system (Malod, , *et al*, 1996)<sup>5)</sup>

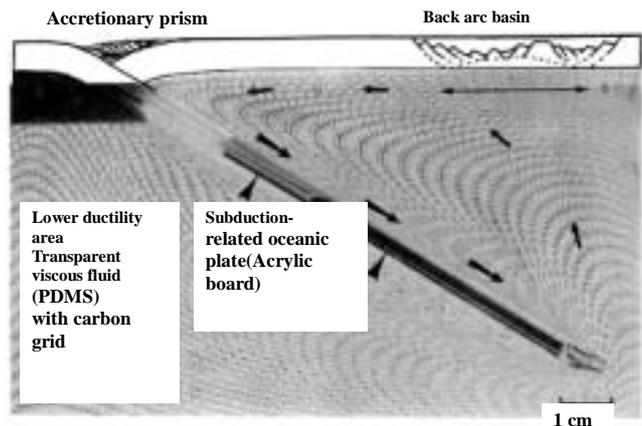
Next we discuss each application and how it relates to the natural examples in some active fault cases in Japan, where many active faults work in the forearc areas. **Figure 26** shows analogue modeling of the subduction-related structure (Anma, 1998)<sup>6)</sup>. In this experiment, a tension zone occurred in the ground surface on the hanging wall side and a shear zone appeared on the foot side. A fracture might be generated that is parallel to the ground surface fault. If the subduction of the plate existed, the stress would create a shear zone near the surface. This tension stress, which causes subsidence, can explain the same mechanism of the pull-apart basins (**Figure 27** Woodcook *et al.*, 1986)<sup>7)</sup>. In this case, the tension stress is thought to contribute to the generation of back arc basin subsidence. This phenomenon can explain the mechanism of the deformation of the typical subduction (Ohsumi and Ogawa, 2004)<sup>8)</sup>.

**Figure 26** Analogue modeling of the subduction-related structure (Anma, 1998)<sup>6)</sup>.

4) The analogue experiment can explain how a fracture parallel to the ground surface fault might be generated. If the seduction of the plate existed, the stress would create a shear zone near the surface. This tension stress, which causes subsidence, can explain the same mechanism of pull-apart basins.

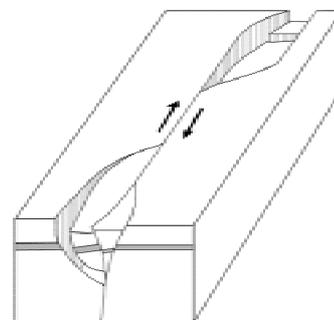
**Figure 27** Those both ends part caused pull-apart basin by tension zoon (Woodcook *et al*, 1986)<sup>7)</sup>.

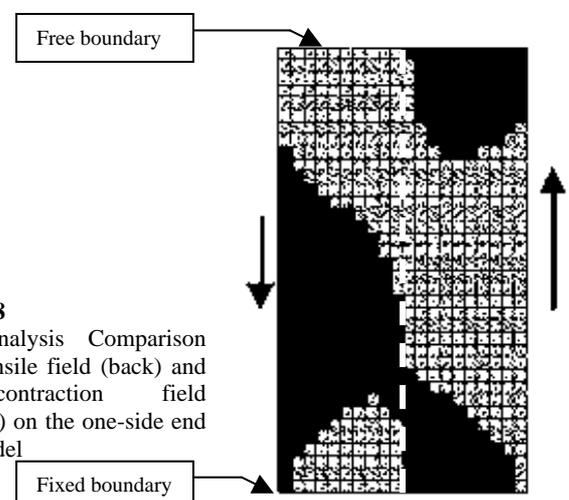
And next, the digital experiment reproduced fracture patterns in the dynamic and nonlinear FEM analysis for a simple shear field. TDAP III package is used for the 2-D model of the dynamic FEM analysis for three varieties of boundary conditions. These fault models are characterized by one free side and one fixed side. This mimics the deformation of a subduction. The top being free in the open it's surface. The shear fractures and tension fractures are shown in **Figure 28**. The tension zone occurred in the ground surface on the hanging wall side and a shear zone appeared on the foot side. A fracture might be generated that is parallel to the ground surface fault. If the subduction of the plate existed, the stress would create a shear zone near the surface. This result also explains the mechanism of the deformation of typical subduction and ground subsidence.

**Figure 28** FEM Analysis Comparison of the tensile field (back) and the contraction field (hatching) on the one-side end fixed model

5) The digital experiment can explain the tension zone which occurs in the ground surface on the hanging wall side and the shear zone which appears on the foot side. A fracture might be generated that is parallel to the ground surface fault.
