# LONG LASTING GEOTECHNICAL PROBLEMS TRIGGERED BY THE 2015 GORKHA EARTHQUAKE

The Gorkha earthquake has caused many damages, including the detachment of soil mass in Dhunche and Ramche area. This damage could have a big impact on the Pasang Lhamu highway crossing this area, and also the hydro power plants nearby. The author conducted an GPS measurement and UAV flights over some period of time to measure the creeping deformation. This paper describes the findings from measurement by GPS and UAV.

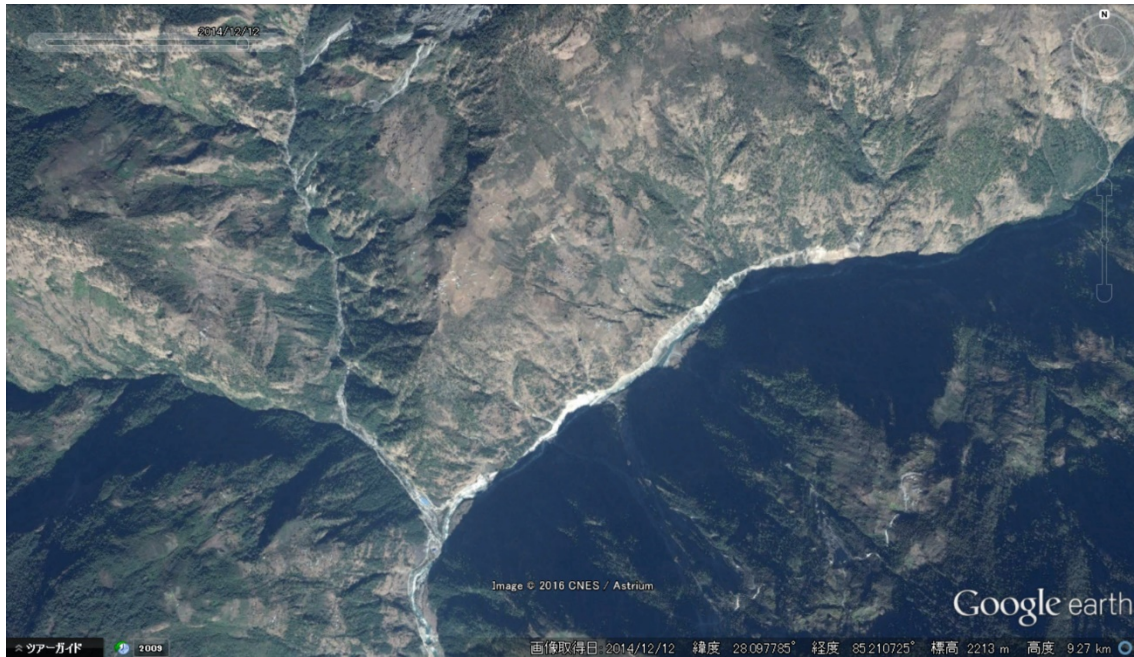
**Fig. 1** Landslide zone (Photos from Google Earth)

(a) Satellite image of landslide one on December 12<sup>th</sup>, 2016

(b) Orthophoto of landslide one on August 10<sup>th</sup>, 2016

**Fig. 1** compares the top view image of Dhunche area obtained before and after the earthquake. The upper one shows the satellite image taken on December 12th, 2014(photo from Google Earth). The image below shows an orthophoto extracted from UAV photos. This UAV flight was done on August 10th, 2016.

These two images show that many collapses occurred by the earthquake. The soil mass that fell into the Trishuli river will surely have a long term influence on the hydropower stations.

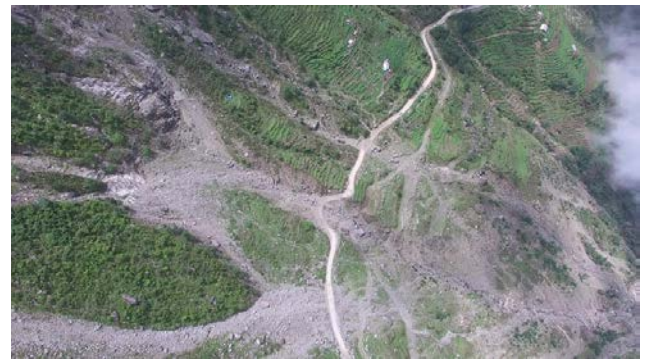
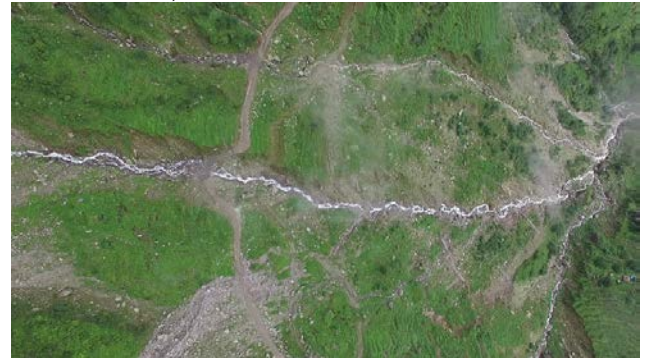
**Fig. 6** Top view of survey areas in a dry season and monsoonal season

On the fourth follow-up survey in the middle of this monsoonal season, it was seen that waters from small gullies were splashing down onto the road, turning this creeping section of the highway into rivers. (**Fig. 6**)

(a) Top view of survey area in dry season (photo taken on June 10th, 2016)

(b) Top view of survey area in monsoonal season (photo taken on August 11th, 2016)
