CONCRETE STRUCTURES IN COLD REGIONS

(Translation from Proceedings of JSCE, No. 402/V-10, Feb. 1989)

Masamichi HAYASHI

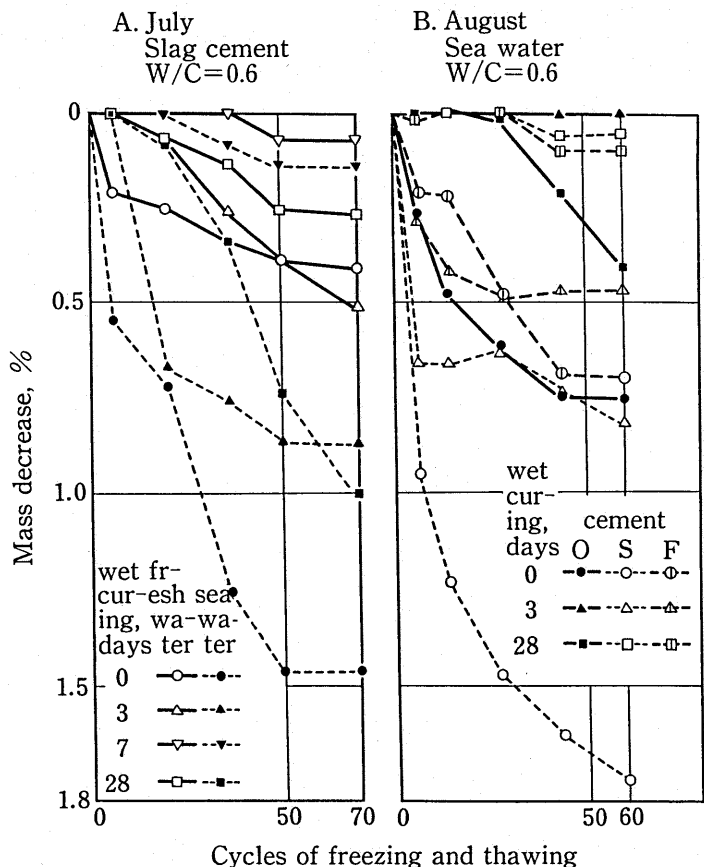
Fig. 5 Result of accelerated scaling test (O: ordinary portland cement S: slag cement B type F: fly ash cement B type)

Maekawa and Imai obtained the graphs in Fig. 5 [7] from the accelerated scaling tests of two cycles of freezing and thawing a day at  $-10$ – $+10$  °C, which started at the age of 28 days, through covering the specimen surface with approximately 5 mm of fresh or sea water. The specimens were made of air-entrained concrete with a W/C of 0.60 in July and August, and after the specified wet curing they were placed outdoors (excluding rainfall) in the city of Sapporo. The result was that the extent of scaling in sea water was 2–4 times severer than in fresh water. The results also showed that scaling occurs more easily in blended cement concrete than in ordinary portland cement, and similar results were also obtained from the exposure test of large test blocks on the coast of the Sea of Okhotsk [27]. The author and Ayuta measured the scaled area on one side after 30 cycles of one direction freezing and thawing, at the rate of one cycle a day, at  $-6$ – $+12$  °C from the age of 28 days. The specimen concrete has three values of W/C and four curing conditions; these are shown in Fig. 6 [28]. Drying was carried out at 33 °C 25 % RH, wetting at 20 °C 90 % RH, and standard curing at 20 °C in water. From these tests, it seemed that the remarkably harmful effects due to drying were based on the coarsening of the pores, described below, in addition to the defects of the interface between aggregate and paste. Also, it was found that drying after the initial adequate curing was effective. This has already been pointed out in the freeze-thaw durability [29–31 etc.], and there is also a paper stating that the effectiveness differs owing to the degree of drying [32]. The author and Ayuta experimented with the effects of fresh water and sea water on surface scaling. Namely,

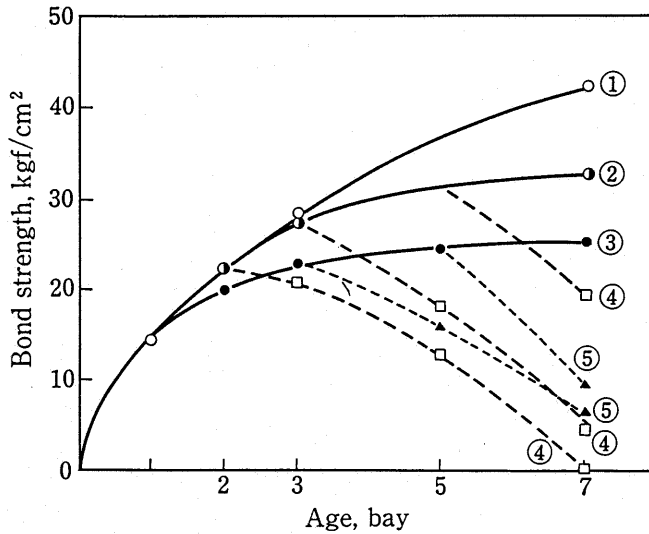
Fig. 9 Bond strength

The studies on the bond strength between cement paste and aggregate, the mechanism of combination in the interface, and so on, have been performed for some years [34–39 etc.]. Iwasaki and Tomiyama reported that as the bond layer is formed early after placing, the bond strength does not easily recover when the bond layer dries at early age, even if wet curing is applied after that. They also stated that as the interface is not a direct combination and it combines through a thin layer consisting of crystalline hydrate, the bond strength is influenced by the strength of the aggregate, the hardened paste and the bond layer itself, the combined force between the aggregate and the bond layer, and between the bond layer and the hardened paste. They also reported the thickness of the bond layer [36, 37]. The author and others performed tests on the bond strength by flexure (Fig. 8) between stone and mortar with W/C of 0.55, in five curing conditions, and as shown in Fig. 9 [40]. Mortar was covered by a wet cloth after molding, and kept at 20 °C 95 % RH. After 20–24 hrs the specimens were remolded and the specified temperature and humidity conditions were fixed. In the case of ① 20 °C water curing, the bond strength increases with age. In the case of ② curing at 20 °C after sealing by lap film, the strength increase with age but is lower than ①. In the case of ③, repeated temperature change from 50 °C for 8 hrs to 20 °C for 16 hrs during sealed curing, the strength is lower than ② (about 80 % of ② after 7 days). Namely, in the cases of ① to ③, the bond strength increases with age more or less. However, in the cases of ④, in which specimens are dried at 30 °C 25 % RH after the removal of the lap film following 20 °C sealed curing for specified periods, the bond strength drops with the increase of the drying periods, while in the case of ⑤, specimens are dried in the same conditions but following repeated temperature changes from 50 °C for 8 hrs to 20 °C for 16 hrs while sealed in lap film, the bond strength drops with the increase of the drying periods. Thus, drying has greater influence on the bond strength than repeated temperature change of 30 degree. Therefore, it appears that drying lowers the bond strength between aggregate and paste, then surface scaling occurs on account of the freeze-thaw cycle in winter.

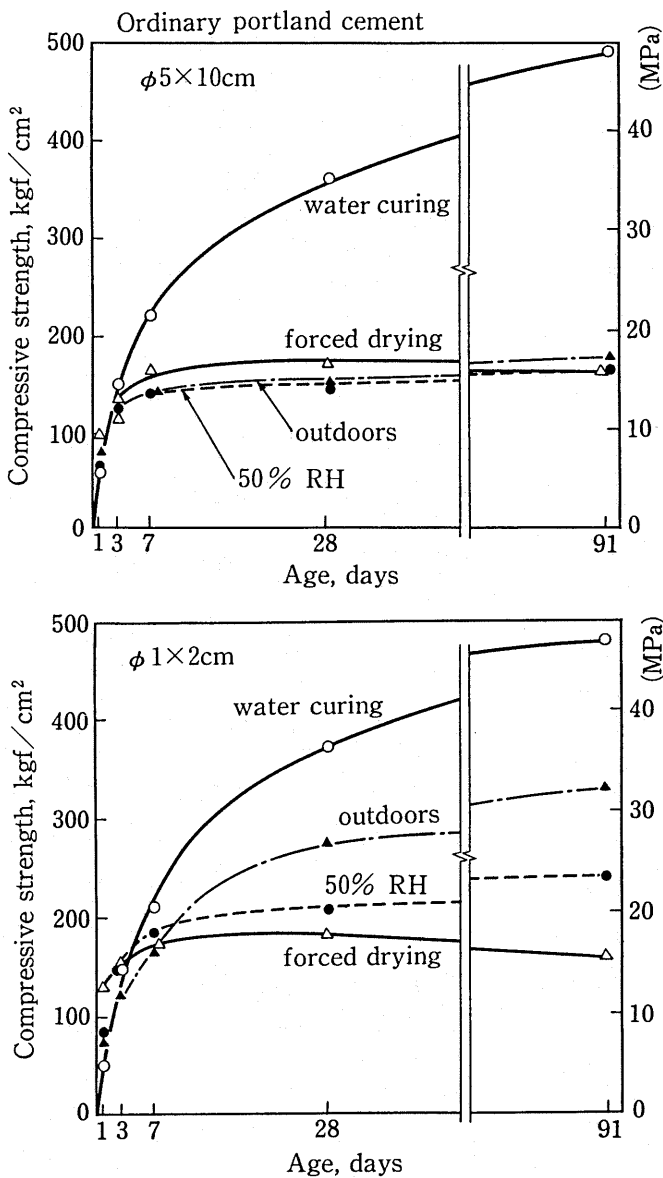
Fig. 12 Development of compressive strength

the distribution of combined water of specimens dried on one side previously mentioned. Moreover, as the compressive strengths of  $\phi 1-5$  cm mortar specimens indicate different values owing to their difference in size, strength values were corrected in accordance with the compensation curve for seven strength levels based on the size of the specimens. Thus, the compressive strength of the small specimen is shown in Fig. 11, and the relationship between age and strength on the  $\phi 5$  cm,  $\phi 1$  cm is shown in Fig. 12. Fig. 12 demonstrates that any strength in the case of the outdoor exposure (mean air temperature 15 °C, 82 % RH, wind velocity 1.5 m/s, covered by a roof), 50 % RH 20 °C and forced drying at 25 % RH 30 °C is fairly lower than in the case of water curing. Moreover, a small specimen has higher strength than a large specimen in the case of outdoor exposure, and 50 % RH as shown in Fig. 11. It appears that this fact is due to the effect of the above-stated carbonation. In the case of forced drying, the strength is almost the same value through each size specimen. In Fig. 12 although in water curing the strength increases with age regardless of the size of specimen, in the above-mentioned three drying conditions the strength development is retarded considerably. Furthermore, in outdoor exposure the strength of  $\phi 1$  cm specimens increase slightly with age. As mentioned above, the strength development of a portion near the exposed surface is retarded owing to drying, and in the outdoor exposure or 50 % drying, the strength of a portion very near the surface is higher, but for portions a little deeper, the strength development is retarded after 7 days. Fig. 13 shows test results on the carbonation mentioned above. In the 50 % RH air which contains carbon dioxide, the smaller the specimen the higher the strength, but in the 50 % RH air which contains little carbon dioxide, the smaller the specimen the lower the strength. In the combined water test too, the same results as mentioned above have been obtained. Therefore, the phenomena that the combined water of the portion near the surface is more than the inner portion when dried at 50 % RH from one side of the specimen as stated before [Fig. 10], and that the strength of the small specimen is higher than that of the large specimen in the case of drying at 50 % RH or outdoors, are due not to the progress of hydration, but to carbonation.
