DIAGNOSING IN SITU CONCRETE BY NON-DESTRUCTIVE TEST METHODS

(Translation from Concrete Research and Technology, Vol. 5, No. 1, Jan. 1994)

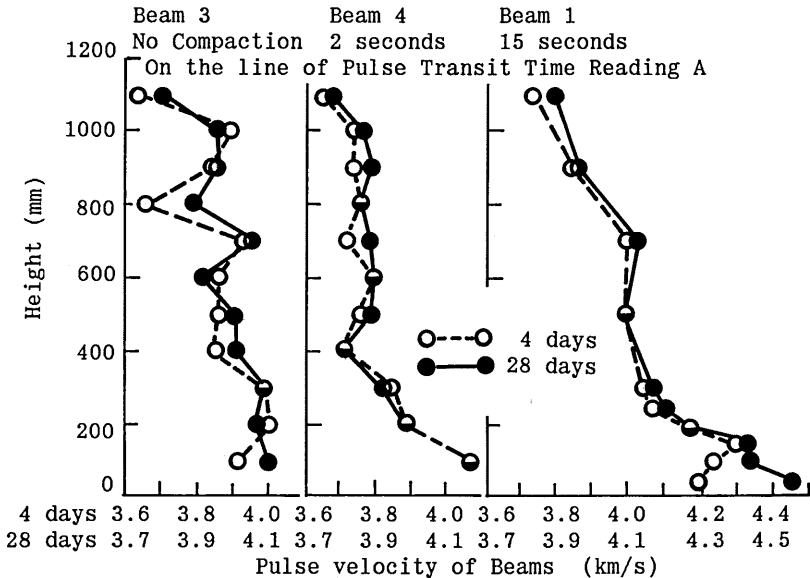
Fig.8 Changes of UPV distributions

Figure 8 shows plots of UPV observations at the ages of 4 and 28 days at each level for three specimens made by plywood panels: beam 1 with well compacted concrete; beam 3 with uncompact concrete; and beam 4 with poorly compacted concrete. For these specimens, UPV increases from the age of 4 to 28 days, but there is little change in distribution from 4 to 28 days. For neither specimen, with very different degrees of compaction, does the UPV distribution down the specimen change with time. The UPV gradients of the specimen with well compacted concrete is reasonably uniform and may agree with the strength gradients[1]. The UPV gradients of beam 2 is smaller than beam 1. On the other hand, UPVs of beam 3 with no compaction increase towards the bottom. This means that at the lower level of beams, the concrete is compacted due to its own weight effects. Thus the general tendency will be for strengths to be highest near the base of pours and lowest in the upper regions. The UPVs in the bottom 200 mm of beam 1 and 4 are too large, because the UPVs in this regions may be affected by main reinforcement[4].

Although beam 1 was cast with well compacted concrete, there are some zones in the middle of the beam with lower UPVs than the upper or lower zones, as shown in figure 8. It is obvious that the strength of these low UPV zones is less than that of the high UPV zones, and they may consist of insufficiently compacted concrete[5].

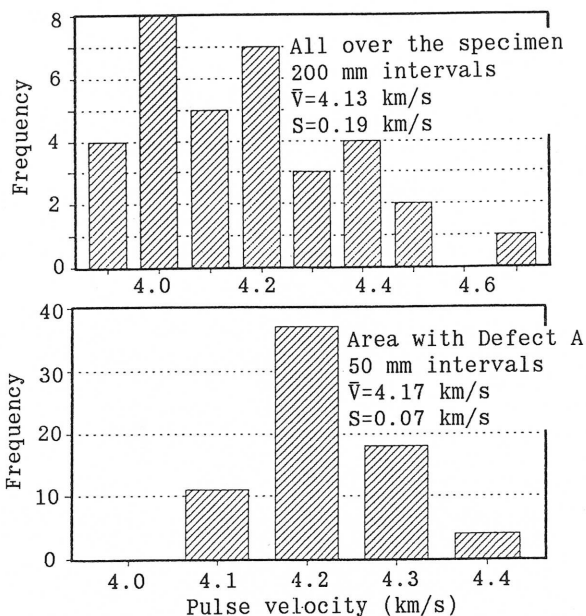
Fig.10 Frequency distribution of Beam 1

The UPVs of beam 1, measured at the grid of 200 mm at the age of 28 days, is not a normal distribution, and the mean value ($\bar{V}=4.13$ km/s) is less than the mean UPV (4.17 km/s) of the zone with the defect A that was measured at the grid of 50 mm, as shown in Figure 10. On the other hand, the UPVs of the zone with defect A show a normal distribution, and is within $\bar{V}+S$, where S is the standard deviation. And also, UPVs of the zone with defects B and C shows a similar tendency. This is because these defects were made from coarse aggregate with a UPV larger than the mortar[7]. Furthermore, UPVs more than $\bar{V}+S$ are in the zones with insufficiently compacted concrete or in the areas where the UPV may be affected by the reinforcing bar. Therefore, it may be difficult to detect honeycombing by only UPV or $\bar{V}+2S$, as proposed by Chung[8] and reported by Tomsett [9].

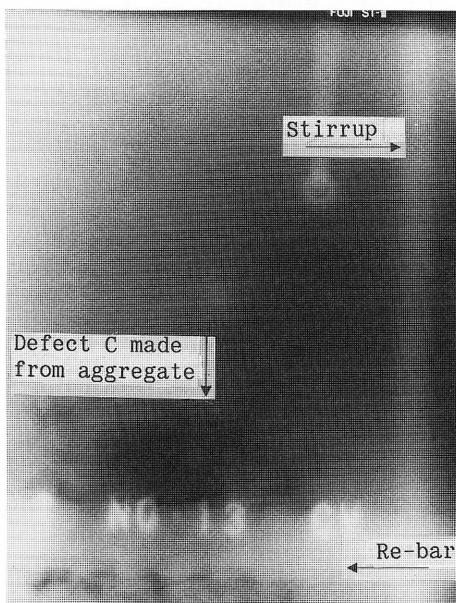
Photo.2 Radiograph of zone with defect C after increasing the light intensity

Photograph 1 is an unenhanced gamma radiograph of the zone with defect E of beam 1. It is easy to recognize the stirrup and defect E with the thickness of 30 mm. However, it was difficult to recognize defect C made from the coarse aggregate by the original radiograph, and then, the light intensity of this original radiograph was increased by computer enhancement. As a result, defect C can be recognized to be a pattern as honeycombing at the position of the reinforcing bar, although the shadow of the stirrup becomes

unclear, as shown in photograph 2.
