AN EXPERIMENTAL STUDY ON EFFECTS OF CORNER-ANCHORED EXTERNAL LATERAL REINFORCEMENT FOR SEISMIC RETROFITTING

(Translation from Proceedings of JSCE, No.676/V-51, May 2001)

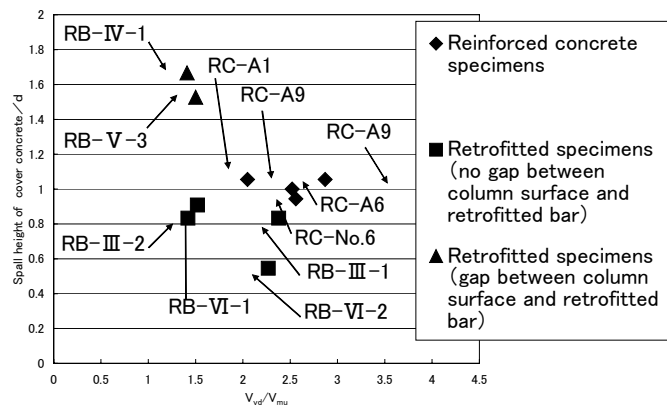
Figure 6 Relationship between height of cover concrete spalling on loaded side and shear-to-flexural capacity ratio

In order to compare the damage condition of retrofitted specimens with that of ordinary RC specimens, we studied the area over which the cover concrete fell away on the loaded side. **Figure 6** shows the relationship between the height up to which the cover

concrete was lost on the loaded side and shear-to-flexural capacity ratio. Here, we discuss specimens that failed in flexure and with an axial reinforcement ratio of over 3%. The height up to which the cover concrete was lost is divided by effective depth d in order to obtain non-dimensional index. When there is no gap between the lateral external reinforcement and the column surface, there was little difference in terms of loss of cover concrete between retrofitted specimens and RC specimens. However, when a gap is present, the cover concrete fell away up to a greater height than with RC specimens. This is because the external lateral reinforcement does not restrain buckling of the axial reinforcement and cracking of the cover concrete. But as shown in **Picture 1**, even in the case of RB-IV-1 which has some gap between lateral reinforcement and the column surface, severe damage on the shear resisting side was limited to about d , the effective depth. This is about the same as for specimens with no gap between the external reinforcement and the column surface as well as for normal RC specimens.

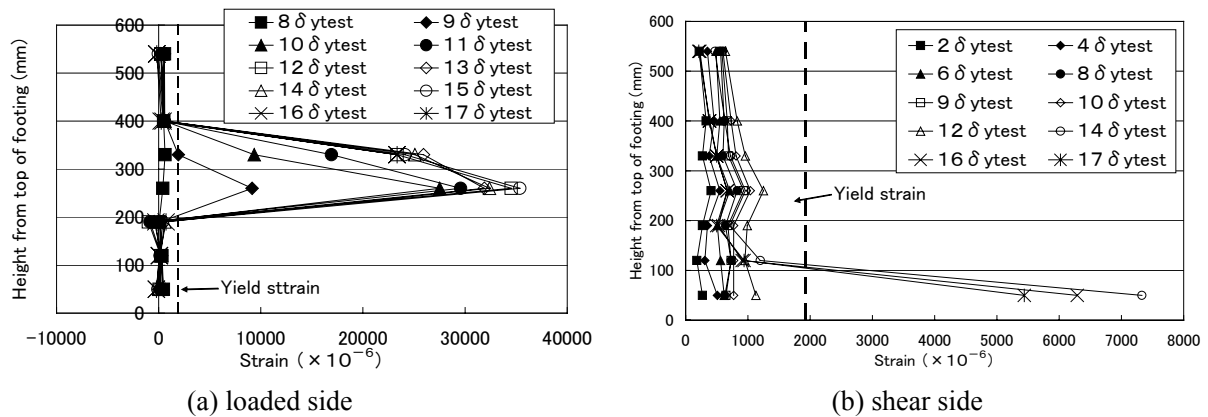
Figure 7 Measured values of retrofitted bar strain for RB-III-1

Figures 7, 8, and 9 show measured strain values for the retrofitted bars in RB-III-1, -2, and -3. The figures show strain for the retrofitted bars at the front and the side of the specimen. The strain gages were fitted at the center of the retrofitted bars. The values used in these figures are the maximum values obtained during the loading cycle. In the case of RB-III-1, which has the highest ratio of retrofitted bars, the retrofitted bars on the front yielded at cycle 9 δy_{test} , and at the final stage, retrofitted bars in the range $0.5 d$ to $1 d$ (d : effective depth) yielded. On the other hand, on the side, no retrofitted bars yielded until the ultimate state, and only the lowest bar had yielded by the end of the test. In RB-III-2 (**Figure 8**), retrofitted bars 200 mm above the footing yielded at the same time on both the front and the side. The lowest bar also yielded on the

As shown in **Figure 7**, the hoop reinforcement strain at a point 330 mm above the top of the footing on the compressive side in RB-III-1 reached the yield at 9 δ test loading. After that, the strain increased due to push-out of the hoop reinforcement caused by buckling of the axial reinforcement. But, as shown in **Figure 19**, the influence of axial reinforcement buckling on the side seem small, and as the horizontal force decreases, the retrofitted bar strain also decreases. The maximum f_w/f_{wy} at a height of 330 mm was about 50%. In the case of RC-No.6, the hoop reinforcement yielded at 12 δ test loading on the compressive side in **Figure 17**. In **Figure 20**, the measured values at the end of hoop reinforcement are larger after the horizontal loading falls and yielding ultimately occurs there. This may be because the hoop reinforcement is pushed out of the compressive side by buckling of the axial reinforcement.

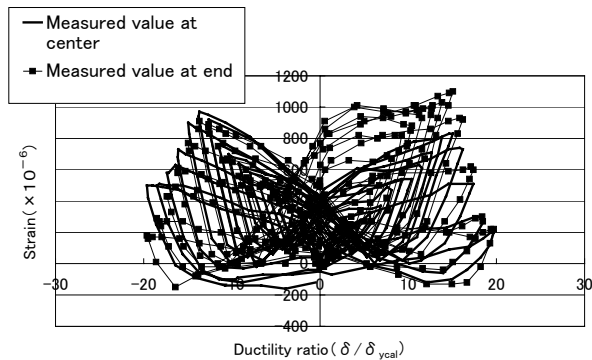
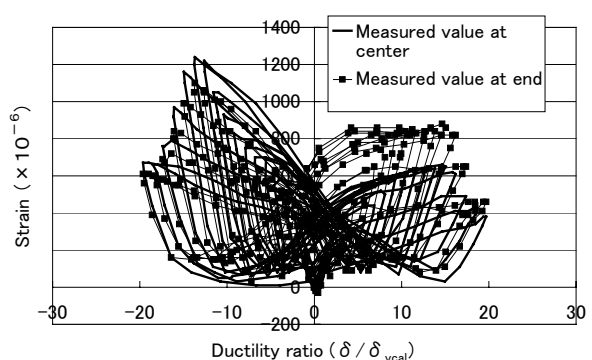
Figure 10 Measured value of strain of strain of retrofitting bar of RB-III-1

Figure 10 shows measured values of retrofitted bar strain at heights 180 mm and 245 mm from the footing on the side. In this figure, measured values for both end and center of the same retrofitted bar are shown.

These values are almost same, so it can be said that strain is almost uniform from end to center when the retrofitted bars are in contact with the surface of the column.

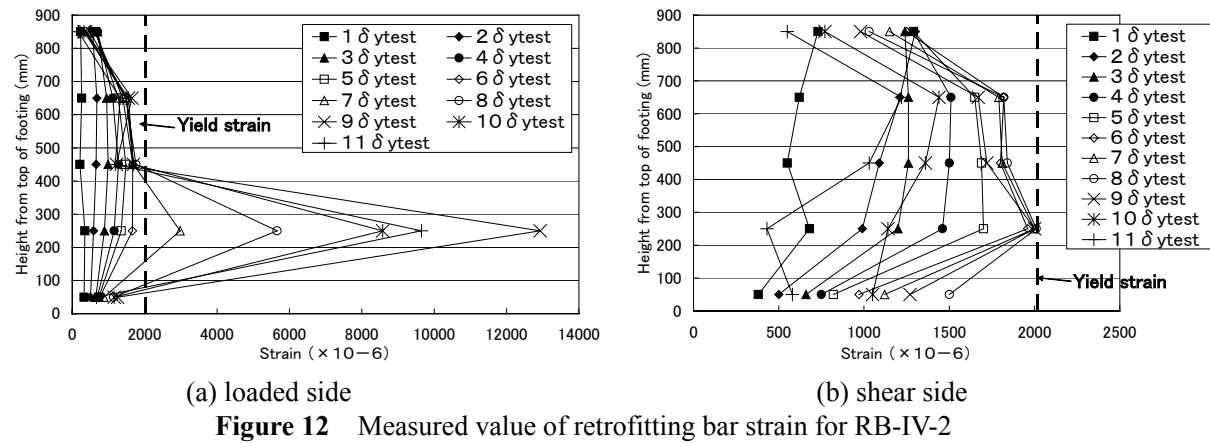
Figures 11 and 12 show the measured values for RB-IV-1 and -2, in which the retrofitted bars do not touch the surface of the column. In the case of RB-IV-1 (**Figure 11**), bars on the front yielded at a height of 200 mm above the footing. This situation is the same as for RB-III-2, where the parameters are the same except for the gap between the retrofitted bars and the column surface. On the side, the maximum strain occurred in the range from 0.5 d to 1.0 d. Its value was about 75% of the yield strain, and the bars did not yield. With RB-IV-2 as shown in Figure 12, which failed in shear after flexural yielding, retrofitted bars on the front yielded in the range up to 250 mm (0.5 d) above the footing. This yielded range is less than that of RB-III-3, which has almost the same parameters as RB-IV-2 except for the gap between the retrofitted bars and the column surface. At a height of 250 mm on the side, the retrofitted bar strain was close to the yield strain. However, these retrofitted bars on the lateral part did not yield.

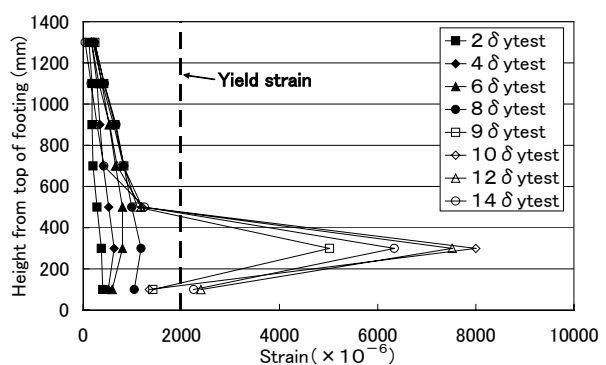
Figure 14 Measured value of retrofitting bar strain for RB-VI-1

Figure 14 and 15 show the experimental results for RB-VI-1 and RB-VI-2, which have a large section. In the case of RB-VI-1, retrofitting bars up to 300 mm (0.55 d) above the footing yielded on both the front and the side, as shown in **Figure 14**. This yield range was almost equal to that of RB-III-2, which has almost the

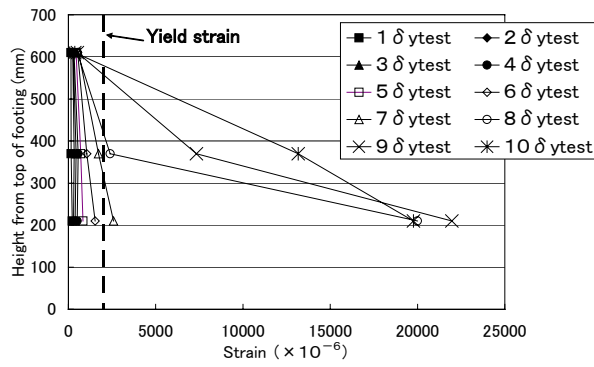
Figure 16 Measured value of hoop reinforcement strain for RC-A1

Figures 16, 17, and 18 show experimental strain values of hoop reinforcement in ordinary RC columns. In RC-A1, the hoop reinforcement yielded at the same time on the front and side as shown in **Figure 16**. The range over which yielding occurred was about 0.5 to 1.0 d from the top of the footing, and this was almost the same on both the front and the side. **Figure 17** shows the experimental results for RC-No.6. In this case, the hoop reinforcement yielded first on the side. The range of yielding was about 0.5 to 1.5 d from the footing on the front, and 0.5 to 1.0 d on the side. **Figure 18** shows the experimental results for RC-A9. Hoop

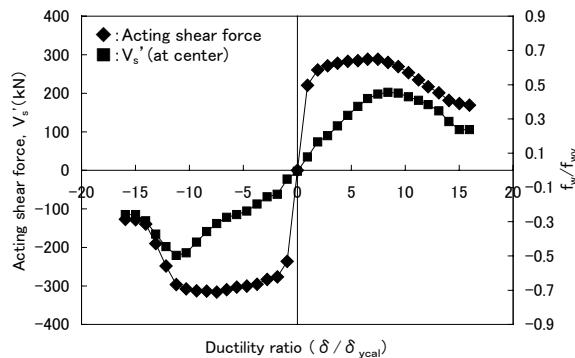
Figure 19 Acting shear force and V_s' for RB-III-1

Figures 19 and 20 show the shear force and V_s' in the case of RB-III-1 and RC-No.6, both of which have a shear-to-flexural capacity ratio of about 2.5. Here, V_s' is the calculated shear force as based on truss theory using measured values of retrofitted bar strain and hoop reinforcement strain. In **Figures 19 and 20**, the horizontal axis is the ductility ratio (δ/δ_{ycal} ; δ : horizontal deformation; δ_{ycal} : calculated value of yield deformation), the left vertical axis is load (kN), and the right axis is f_w/f_{wy} (f_w : calculated stress using measured strain values of retrofitted bars and hoop reinforcement; f_{wy} : yield strength of retrofitted bars and hoop reinforcement). f_w/f_{wy} was fixed at 1.0 after yielding. The values used for calculation were measured 350 mm above the top of the footing, because the main shear crack intersected retrofitted bars and hoop reinforcement at this height. As deformation becomes more severe, V_s' gradually increases. This is because V_c (V_c : ultimate shear strength without shear reinforcement) gradually falls during cyclic loading. The V_s' values shown in **Figures 19 and 20** are calculated values based on truss theory using the raw measured strain values of retrofitted bars and hoop reinforcement. Consequently, these values certainly include the influence of deformation toward the outside caused by buckling of the axial reinforcement on the loaded side, and do not indicate the real shear force supported by the steel bars. However, when the ductility ratio (δ/δ_{ycal}) is less than 5, the influence of buckling is thought to be very small. In this range, the rate of increase of V_s' is grater in the case of RC columns than in the case of retrofitted columns. This indicates that the fall in V_c of an RC column during cyclic loading is larger than that of a retrofitted column. As can be seen in **Figure 20**, V_s' exceeds the actual shear force in the case of RC-No.6. This may be because V_s' includes the influence of axial reinforcement buckling as mentioned above.

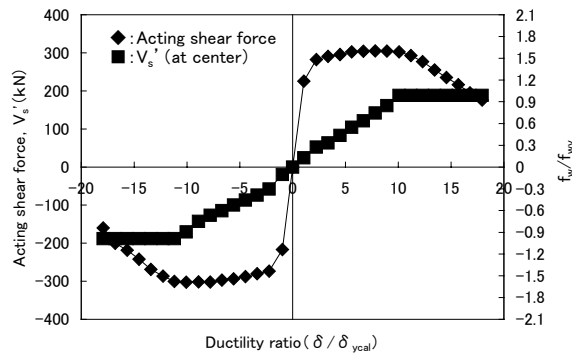
Figure 21 Acting shear force and V_s' for RB-III-2

Figures 21 and 22 show the acting shear force and V_s' for RB-III-2 and RB-IV-1, which have a shear-to-flexural capacity ratio of about 1.4. In the case of RB-III-2, retrofitted bars on the side yielded, while they did not yield in the case of RB-IV-1. The strain values were measured at height of 200 mm above the top of the footing, the height at which the maximum value was obtained. Compared with RC-No.6 in **Figure 20**, the rate of increase of f_w/f_{wy} is smaller in the case of retrofitted columns. When retrofitted bars yielded, as in case RB-III-2, the loss of V_c becomes small.
