**Field Investigation of the Flood Disaster in South-West Area of Sri Lanka
Occurred in May 2003**

SYNOPSIS

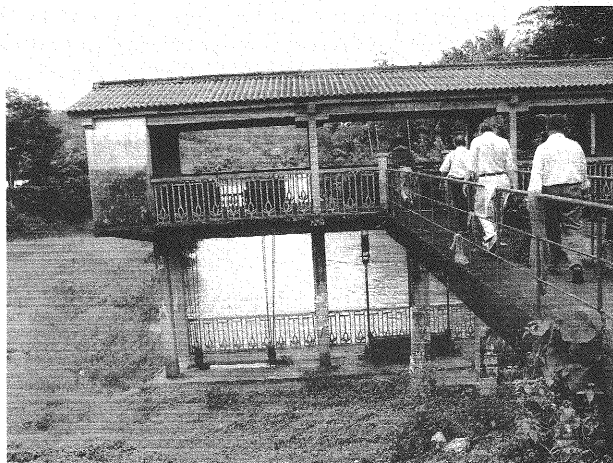
Photo 3 Pumping station coping with inundation by heavy rainfall

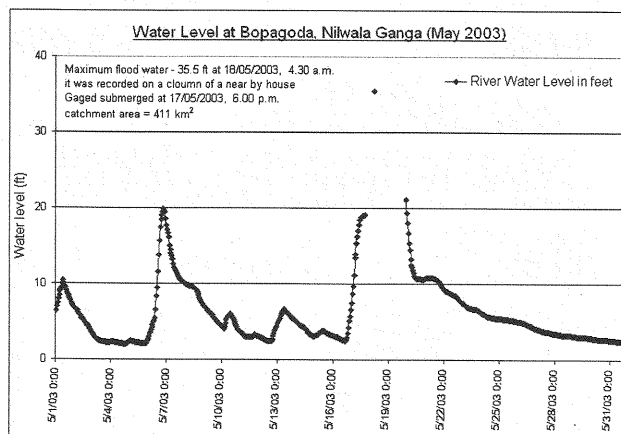
The water level in Bopagoda in the upstream Nilwara River is shown in **Figure 6**. The water level rapidly rose from May 17th to 18th, reaching over 35 ft, (10.7m) at the maximum level. Because the water level surpassed the upper limit of the automated water level gauge, the figure shows the maximum water level based on a flood mark around there. It is estimated that the maximum water depth was reached around 4:30am on May 18th. In Pitabeddara which is located in the upstream region, the maximum flow discharge is estimated from water level to be 2,900m³ on May 18th.

Figure 6 Water level at Bopagoda

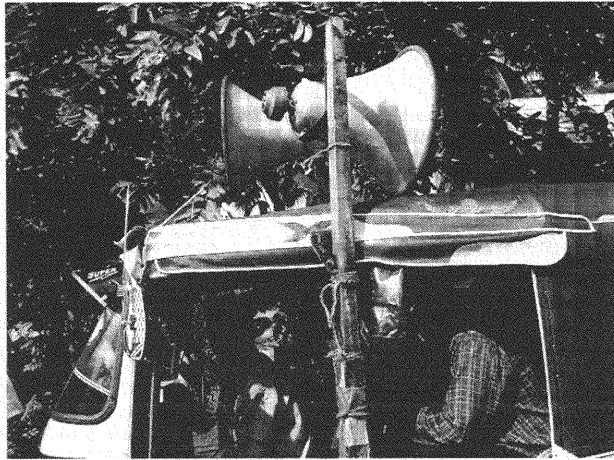
Photo 4 Announcement of disaster information through loud speakers

It seems the evacuation was carried out smoothly in spite of the large scale of the present flooding. However, it should be noted that the means of communication of disaster information on sites other than the mass media such as TVs and radios was mostly through word of mouth including the use of loud speakers. Promptly conveying accurate information to residents in scattered communities and evacuating them quickly and safely is an important issue. Therefore, it is necessary to build an information communication network from provincial and local authorities to each community, and to prepare and improve a prompt information communication and evacuation framework within each community. Also, it is recommended that actual flooding results be recorded immediately following the disaster and organized for future records as well as for effective utilization as educational materials for disaster prevention.
