AN OUTLINE OF HEAVY RAINFALL DISASTERS IN HIDAKA REGION, HOKKAIDO
CAUSED BY TYPHOON NO. 10 IN 2003

Typhoon No. 10 Hokkaido Heavy Rain Disaster Investigation Team 2003, Japan

SYNOPSIS

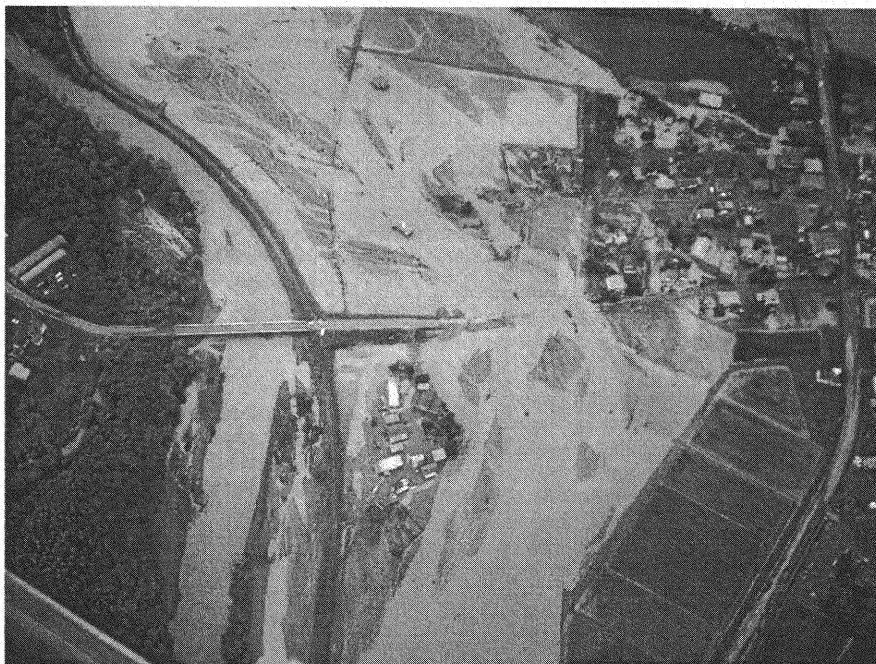
Fig. 2 Flood in the upstream side of the Saru Rive (Kotan Bridge cross its tributary, the Nukibetsu River)

Ten people died, 3 people were injured and one person was reported missing after Typhoon No. 10 had passed over Hokkaido. Fig. 2 shows the flood in the upstream side of the Saru River. According to data collected by the Hokkaido Prefecture Government Office, 18 houses (18 households) were completely destroyed, 13 houses (13 households) were partially destroyed and 20 houses (20 households) were damaged, and flooding occurred above floor level in 129 houses (133 households) and below floor level in 438 houses (482 households). The total number of evacuees was 8,315. Most of the people who died had been traveling in cars when the typhoon passed over Hokkaido. A car fell into the Rubeshibe River in Kamishihoro Town because the road collapsed due to the progression of bank erosion to the backfill material of the abutment, and another car that had stopped near the Akamu Bridge across the Appetsu River was carried away by the flood. Residents of the area (7,304 persons, 3,058 households) were urged to evacuate,

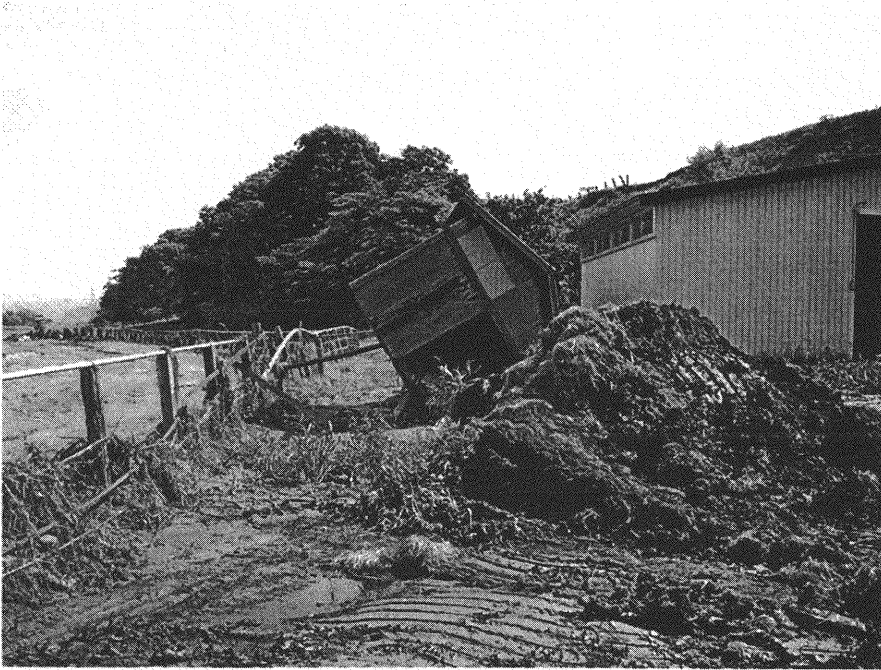
Fig. 3 Collapsed barn on the lower stream of the Appetsu River due to the flood

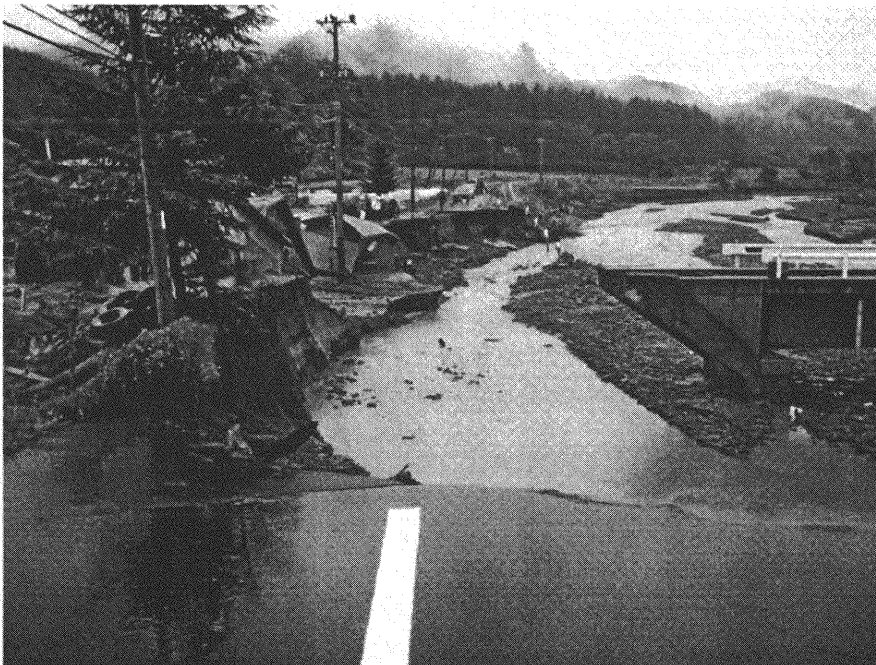
Fig. 4 Collapsed road due to progression of bank erosion to the backfill material of the abutment (Photograph offer: Hokkaido Prefecture Government Office)

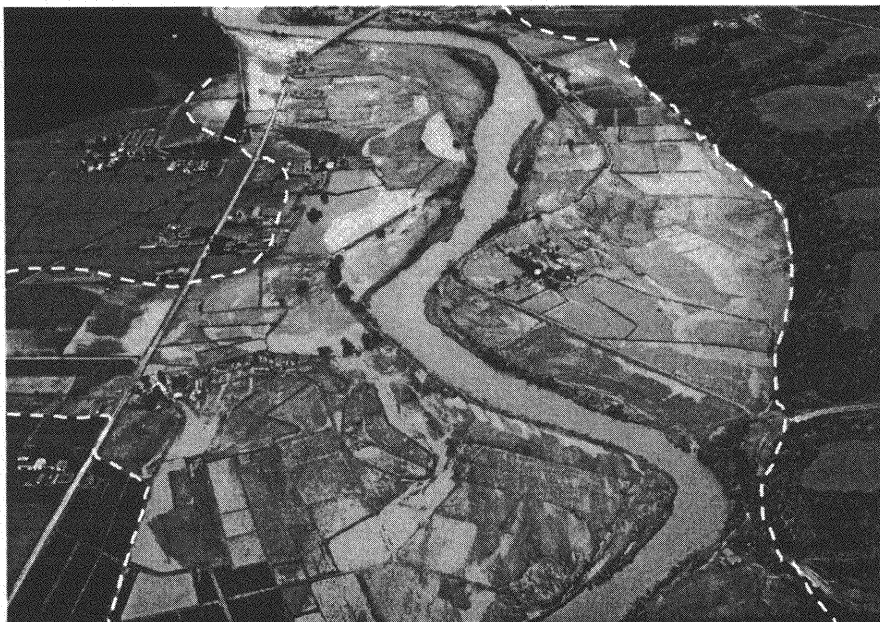
Fig. 6 Flood in the lower stream of the Akamu Bridge cross the Appetsu River
(Photograph offer: Hokkaido Prefecture Government Office)

The Appetsu River flooded from the river mouth to the confluence with the Ribira River because the estimated flood discharge at the Akamu Bridge site was over 2000 m^3/s -much higher than the river flowability at Akamu Bridge (about 1000 m^3/s). In the downstream area where river improvements had already been carried out, the overtopping and the flooded water from the levee crevasses flowed on the protected lowland in the form of a river channel (Figs. 6, 7). In the upstream and midstream areas where river improvements had not yet been carried out, the entire area of even land in the valley became a flood plain when the river broke its banks. The confluence of the main stream of the Appetsu River and its tributary, the Biu River, flooded widely because a complicated flow occurred at the bend near the confluence of two rivers. The result of a numerical analysis based on a two-dimensional shallow water flow model showed that the flood plain played the role of an enormous double-row sand bar during the flood.

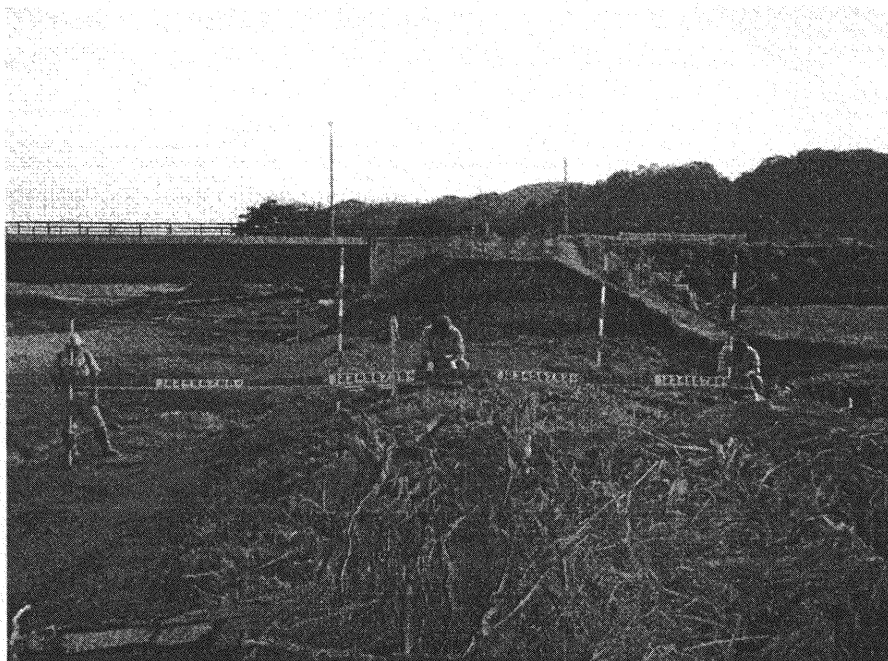
Fig. 7 Flood levee failure in the upstream side of the Higashikawaoohashi Bridge
(Photograph offer: Hokkaido Prefecture Government Office)

In the Appetsu River basin, a large amount of sediment - about 1.8 million m^3 (including the void volume) - was produced due to landslide and a debris flow. The channel morphology changed largely; however, the respective rises in bed levels in the midstream and downstream basins of the tributary and the bed level in the main stream were several dozen centimeters on average. When a flood occurred in this area due to this rainfall event, the whole flood plain, whose shape was like lengthwise connected gourds, was covered with significantly deep flood water. The maximum water depth at the site was over 2m. The flood flow here had essentially the same properties as the flow on an enormous double-row sand bar. As a result, large-scale changes of the river channel such as the formation of new river channels along both sides of the valley, which corresponded to front sand bar-lines, occurred. Sediment including cohesive soil, silt and sand was deposited comparatively deeply on the central area of the flood plain. This corresponded to an antinode of a double-row sand bar. Damage, such as erosion of the low water channel and the levee, and flood levee failure, was concentrated at the node of a double-row river channel, where two flows met to start branching again (on the front edge of an enormous sand bar, at the point of divergence and convergence of an 8-shaped flow) (see Fig. 8). At the upstream side of the node, the flood flow over the flood plain corresponding to a double-row bar and two newly formed main streams, which occurred in the upper stream of this site, converged. As a result, levees and banks burst due to flow from the protected lowland side. On the other hand, at the downstream side of the site, failures of levees and banks occurred from the riverside land because the flood flow diverged and ran again over the flood plain. Such failures were widespread at this site, where the levee line intersected the axis of the valley at a large angle.

- 4) Damage to the Appetsu River, such as erosion of the low water channel and the levee, and flood levee failure, was concentrated at the node of a double-row river channel, where two flows met to start branching again. Such failures were widespread at this

site, where the levee line intersected the axis of the valley at a large angle. Channel design has to be carried out taking special care of the relationship between the levee line and the axis of the valley.

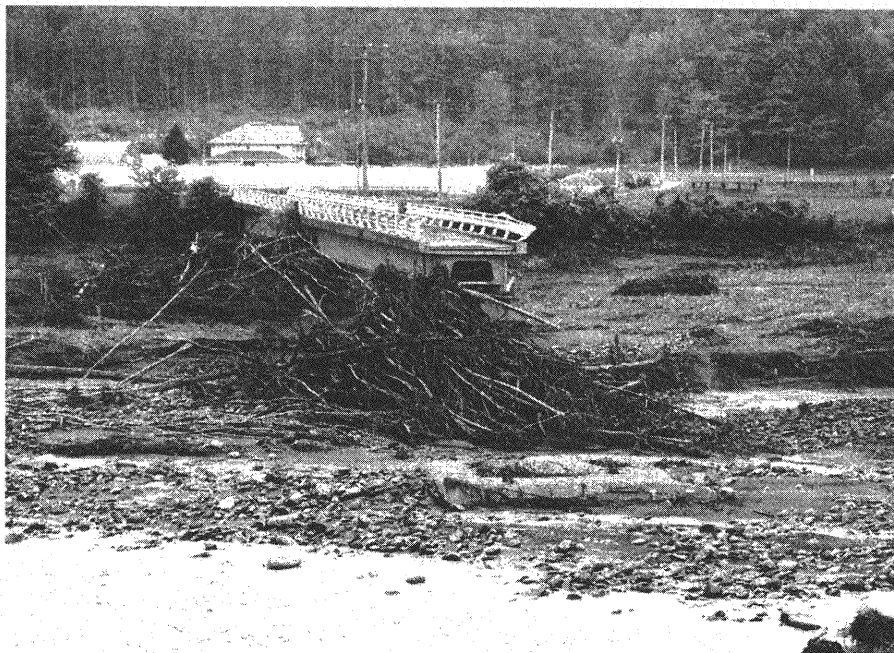
The driftwood caused heavy damage, mainly to bridges. After investigating the Nukibetsu Bridge (Fig. 9) and the Abushitoenai Bridge (Fig. 10), the following became apparent. Because most of the driftwood was caught in the bridge pier and bridge girders, the pedestrian bridge over the upstream side of the Nukibetsu Bridge had become tilted on the downstream side and two bridge girders of the Abushitoenai Bridge, a 4-span continuous bridge, were washed away. Judging by the fact that mud had been deposited on both bridges, it was thought that flood water had flowed over the bridges. The high-water marks on the upstream and downstream sides of the Abushitoenai Bridge were significantly different in height. This finding indicated that the driftwood caught at the bridge pier and bridge girders had dammed up the river. Erosion damage caused

Fig. 10 Abushitoenai Bridge of 4-span continuous bridge washed away due to driftwood caught in the bridge pier and bridge girder

5) Because the driftwood caught in the bridge pier and bridge girders dammed up the river, flood water flowed on the bridge and eroded the embankment and the backfill material of the abutment. As a result, many bridge girders were washed away. Some of the driftwood was carried away from the area in the riparian forest due to the flood. Moreover, some of it was caught in the riparian forest. From the point of view of preventing a river-related disaster, it is necessary to examine whether the riparian forest should be left as it is not cut down.

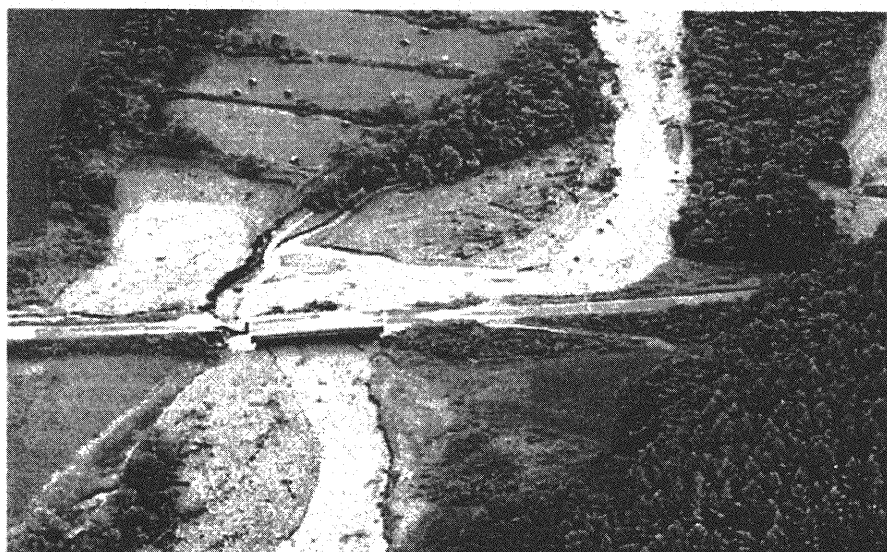
Fig. 11 Damage to the Eishin Bridge due to the flood (Photograph offer: Shin Engineering Consultants Company, Limited Company)

by the flood flow was inflicted at many sites. The road near the Eishin Bridge (Fig. 11) collapsed due to progression of bank erosion as far as the backfill material of the abutment. Similar damage, such as erosion of the embankment, frequently occurred even in the river basins, excluding the Saru River and Appetsu River basins.
