LONG-TERM CHANGES IN LAKESHORE VEGETATION ZONE IN
HASUGAWARA REGION OF LAKE KASUMIGAURA

SYNOPSIS

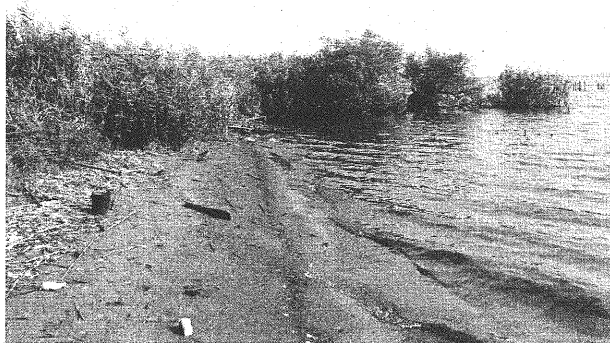
Fig. 5 Condition of pocket beach a in Hasugawara region

In Fig. 4(f), small pocket beaches labeled *a*, *b* and *c* can be seen. For example, Fig. 5 shows a photograph depicting the condition of pocket beach *a*, which was taken looking northwards. A vegetation zone of *Phragmites australis* exists at the north end of the pocket beach, forming a solid boundary preventing northward longshore sand transport. Thus, pocket beach *a* is a statically stable beach. Similarly, pocket beaches *b* and *c* are also statically stable because both of their ends are separated by lakeshore vegetation. Taking the conditions of the pocket beaches into account, the direction normal to the shoreline at the center of the pocket beaches is drawn, which gives a wave direction of approximately N98°S, as shown in Fig. 4(f). This wave direction is considered to be approximately equivalent to the predominant wave direction in the Hasugawara region, and the oblique wave incidence to the mean shoreline is the cause of the northward longshore sand transport in the Hasugawara region.

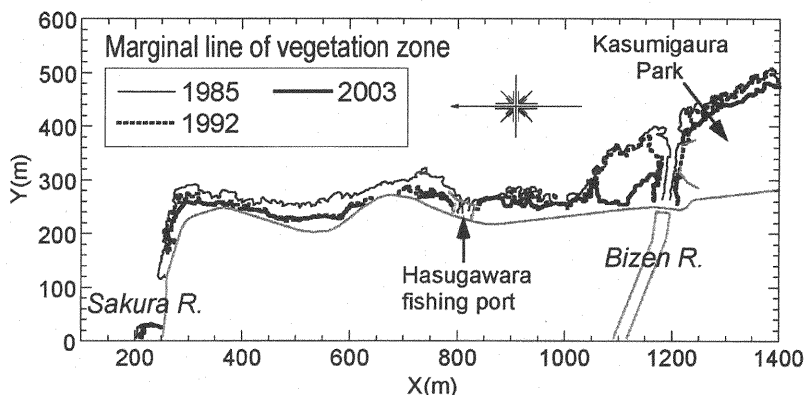
Figure 6 shows the change in the marginal line of the lakeshore vegetation zone between 1985 and 2003. The vegetation zone retreated by as much as 100 m on the left bank of the Bizen River and 60 m in the Hasugawara region. The recession on the left bank of the Bizen River was triggered by dredging. Significant recession of the vegetation zone occurred in the zone between Hasugawara fishing port and the Sakura River mouth, although no shoreline changes could be seen south of Hasugawara fishing port.

Fig. 6 Changes in lakeshore vegetation zone in Hasugawara region

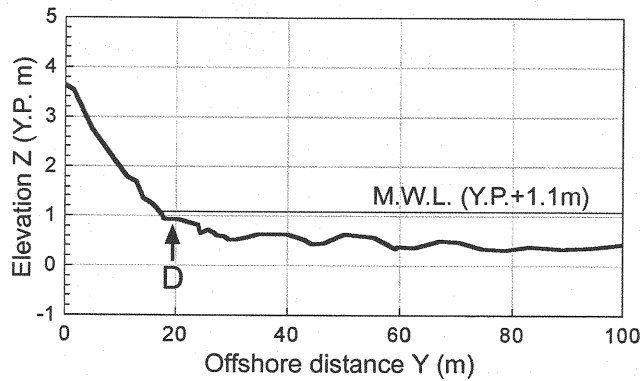
Figure 10 illustrates the longitudinal profile along transect No. 5. The foreshore slope is 1/13, the bed elevation of the beach is as shallow as Y.P. 0.5 m at a point 20 m offshore of the shoreline and a flat bed extends offshore. The depth distribution of the median diameter d_{50} along transect No. 5 is shown in Fig. 11; d_{50} is as coarse as 0.7 mm near the

Fig. 10 Longitudinal profile along transect No. 5

shoreline, corresponding to the steep foreshore slope, whereas it is as fine as 0.3 mm in the zone deeper than Y.P. 0.8 m. Point D, where the grain size markedly changes, is shown in the longitudinal profile in Fig. 10; it is also located where the slope changes between the foreshore slope and the flat offshore bed. The critical depth where the grain size decreases from the coarse grain size near the shoreline to the fine grain size with increasing depth, where the grain size approaches approximately 0.2 mm in the offshore zone, is approximately equal to the depth of closure h_c (Uda (10)). Therefore, h_c is Y.P. 0.5 m (mean water depth=0.6 m) as shown in Fig. 11. This depth is approximately equal to the critical depth of Y.P. 0.4 m obtained from the depth of the offshore marginal line of the receded vegetation zone.

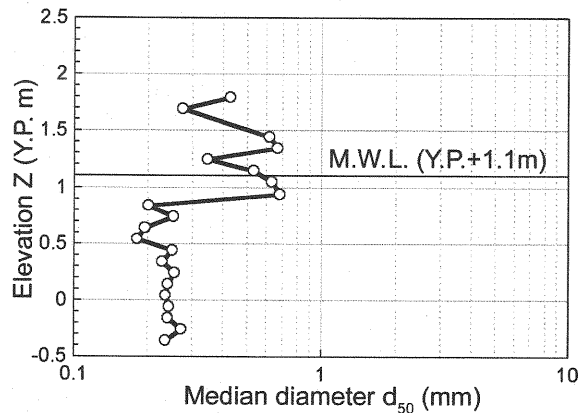
Fig. 11 Depth distribution of median diameter d_{50} along transect No. 5

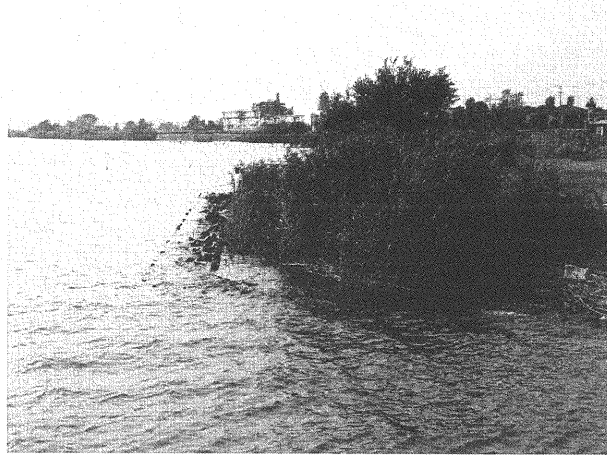
Urgent measures for protecting the lakeshore vegetation of Lake Kasumigaura have been taken since 2000. In this project an artificial reef was used as a breakwater to reduce the impact of wind waves (Uda et al. (7)). This method was also applied in the Hasugawara region; an artificial reef was built by using stones to protect the offshore marginal line of the lakeshore vegetation at transect No. 17, located at the north end of the area studied area shown in Fig. 9. Although the artificial reef, with a crown height very close to the mean water level, was built immediately offshore of the shoreline, as shown in Figs. 12 and 13, a channel with a depth of 0.3 m below the mean water level of the lake (Y.P. 0.8 m) immediately formed shoreward of the artificial reef. Since the shoreward flow is generated by wave overtopping over the artificial reef,

Fig. 12 Stone-made artificial reef for protecting lakeshore vegetation in Hasugawara region

the channel along the reef is thought to have formed by the actions of both local scouring by wave overtopping and the flow returning through the channel to outside the reef to satisfy the mass continuity. This means that when an artificial reef is used as a wave-dissipating facility to protect the lakeshore, a channel with several meters width should be built. This structure is effective in protecting the lakeshore vegetation without damaging lakeshore views because it is mostly submerged.
