# IMPACT OF HANSHIN/AWAJI EARTHQUAKE ON SEISMIC DESIGN AND SEISMIC STRENGTHENING OF HIGHWAY BRIDGES

The Hanshin/Awaji Earthquake (Hyogo-ken Nanbu Earthquake) of January 17, 1995 caused destructive damage to highway bridges. Obviously this was the first experience to suffer such destructive damage since the 1923 Great Kanto Earthquake. Various tentative measures were taken for seismic design of repair and reconstruction of highway bridges which suffered damage due to the earthquake. This paper summarizes the damage feature of highway bridges and a series of actions taken for seismic design and seismic strengthening of highway bridges in about half year since the earthquake.

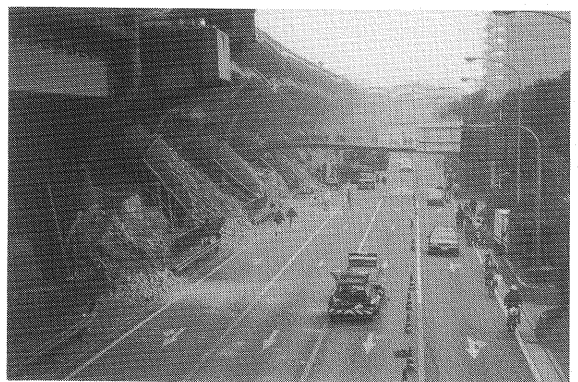
The bridges collapsed in the most critical way as shown in Photos 1 and 2. There were 18 spans that totally collapsed. The bridges completed in 1969. They were designed by the 1964 Design Specifications of Steel Bridges, and 0.2 horizontal and  $\pm 0.1$  vertical seismic coefficients were used

Photo 1 Collapse of 18-span Bridges from Kobe Side, Fukae, Route 3, Kobe Line, Hanshin Expressway

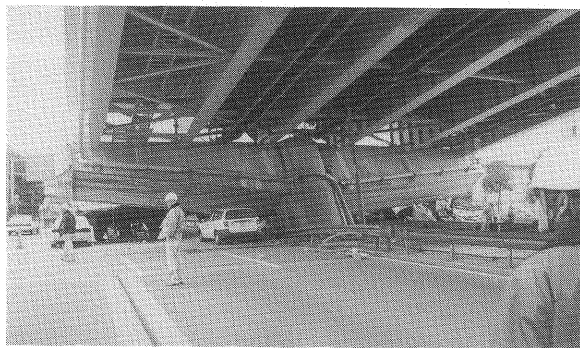
Photo 3 Failure of Reinforced Concrete Pier, Takashio

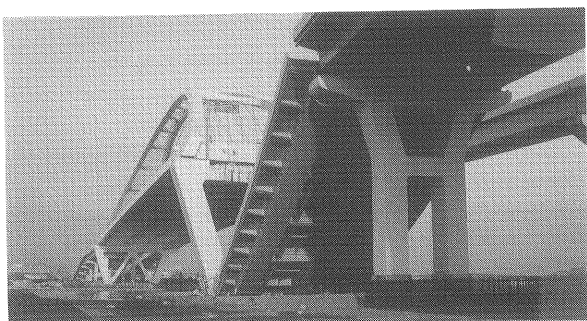
An approaching girder to the Nishinomiya Bridge fell down from one of the supports as shown in Photo 5. The girder was 52 m long, and was supported by two steel frame piers with 24.7 m and 23.5 m in height as shown in Fig. 11. The bridge completed in 1993. The foundations were designed by the 1980 Design Specifications of Highway Bridges, and the superstructure and the steel piers were designed by the latest 1990 Design Specifications. The horizontal seismic coefficient of 0.3 was considered based on the allowable

Photo 5 Collapse of an Approaching Bridge to Nishinomiya Bridge, Route 5, Bay Shore Line, Hanshin Expressway
