# An Experimental Study on Seismic Performance Using GRP Wrapping around the Lap-Spliced Bridge Piers

T.G. Kwon \*, K.S. Youm \*\*, Y.H. Lee \*\*, Y.K. Hwang \*\*

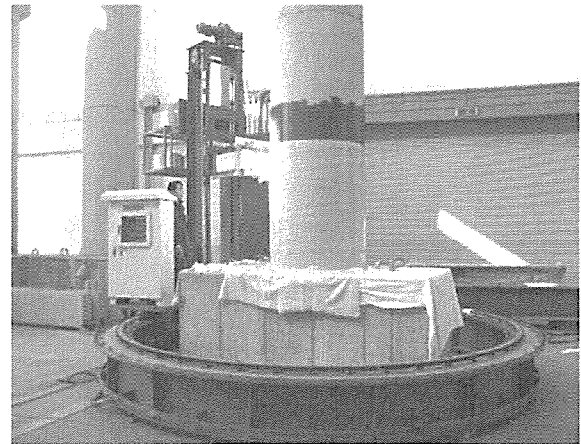
Figure 2. GFRP wrapping equipment

As shown in Fig. 2, 1.2m width FRP wrapping in the lap-spliced region was conducted using automated FRP wrapping equipment in KICT (Korea Institute of Construction Technology) structures laboratory. This equipment was designed to control fiber orientation angle, width, and thickness of FRP wrapping. Since this equipment wraps wetted fiber bundles continuously, better confinement effect can be achieved than that of jacketing or sheet bonding. In the FRP wrapping fiber orientation angle is limited to 5° to provide better confinement effect and uniform continuous wrapping. The details of specimens are shown in Table 1. The mechanical properties of FRP were determined according to ISO 527-5 [5] and ISO 14129 [6]. The mechanical properties of GFRP from the coupon test are summarized at Table 2. The wrapping length of GFRP was chosen to be 1200 mm, which was 1.4 times of the lap-splice length.

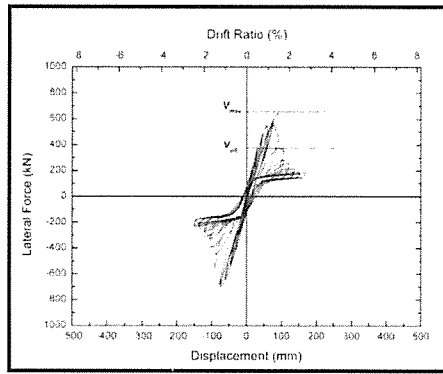
(b) Specimen 2 – Continuous bar column  
Figure 5. Hysteretic response of column

As shown in Figure 5(a), the as-built column developed an unstable response due to lap-spliced bond failure between the longitudinal main and starter bars. The first flexural crack was observed at a drift ratio of 0.5 % or at a lateral displacement of 30.5 mm. The first vertical crack was occurred at a drift ratio of 1.25 % (76.25 mm). As the drift ratio increased to 1.5 % (91.5 mm), cracks were spread within the lap-spliced region and the load-carrying capacity rapidly dropped due to the bond failure, as shown in Figure 6(a). The test was terminated at a drift ratio of 1.65 % or a displacement of 101.0 mm. The maximum lateral force of the as-built column was recorded as 643 kN corresponding a displacement of 91.5 mm. After the lap-spliced bond failure, its load-carrying capacity settled at 200 kN.

As observed in Figure 5(b), the performance of the continuous bar column, which did not have lap-spliced starter bars in the plastic hinge region, was better than that of lap-spliced column. The failure of the continuous bar column occurred at a drift ratio of 3.05 % or a lateral displacement of 185.8 mm, when the compression buckling of longitudinal bar was observed, as shown in Figure 6(b).

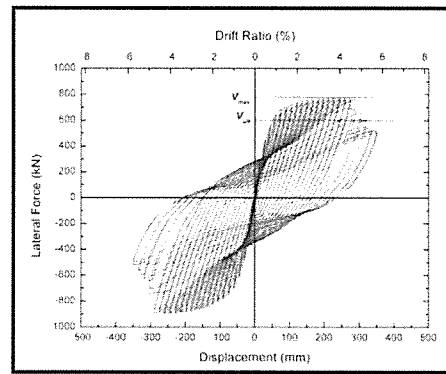
Figure 8. Hysteretic response of retrofitted columns

Figure 7(a) depicts the retrofitted columns with GFRP. A gap of 30 mm was provided to avoid additional strength enhancement and damage of footing. The FRP thickness of retrofitted columns was 6 mm, 8 mm and 10 mm, respectively. Compared to the lap-spliced column, the retrofitted columns developed very stable hysteretic loops and exhibited significantly improved seismic performance, as observed in Figure 8(a), (b), and (c). Flexural cracks were observed at the column base, as shown in Figure 7(b). The retrofitted columns reached 3.1 to 3.2 times the ultimate displacements of the as-built column. Throughout the testing, no rupture of GFRP was observed. As the drift ratio increased, the degradation of the load-carrying capacity and deterioration of the bonding within the retrofitted region were observed. Figure 9 compares the lateral load-displacement envelope curves for all the tested columns. The maximum lateral force of the retrofitted columns was noted as 763 to 776 kN, corresponding to a displacement of 315 to 318 mm.

The estimated displacement ductility of the as-built column is calculated as 2.6, whereas that of the continuous bar column is 4.8. The estimated displacement ductility of the retrofitted columns was evaluated as 8.2 to 8.3. This showed that the retrofitted columns developed higher ductility capacity compared to the lap-spliced column and even the column with continuous bars. Test results of all the columns are summarized in Table 3.

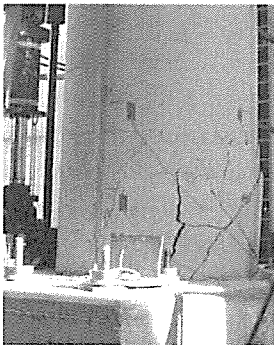
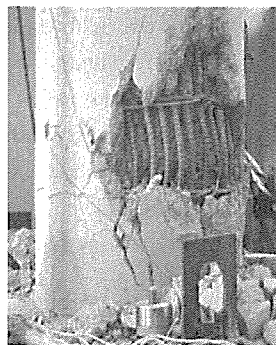
Figure 6. Column failure modes

(a) Bond failure

(b) Flexural failure

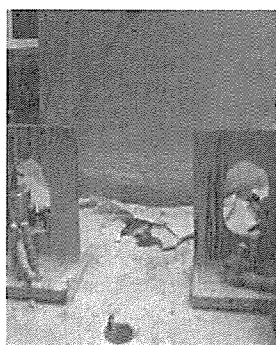
Figure 7. GFRP retrofitted column

(a) Retrofitted section

(b) Crack pattern

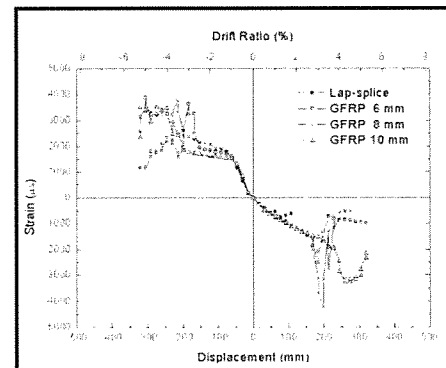
**Figure 10. Strain distribution of longitudinal bar**

Strain gauges were attached to the surface of GFRP at the bottom of the column in the push and pull faces and mounted on the main and starter bar in the lap-spliced region. The strain distributions of the longitudinal bar of the tested columns were shown in Figure 10. In case of the column with continuous bar, the strain gauge readings confirmed the yielding of the longitudinal bars, as shown in Figure 10(a) and (b). However, the strain gauge readings of the lap-spliced column confirmed the lap-spliced bond failure between the main and starter bars.

Although the main and starter bar strain slightly exceeded the yield strain value of  $1500 \mu\epsilon$ , the unyielding of the lap-spliced longitudinal bar was confirmed by the recorded strains of the gauges, regardless of the GFRP thickness. If GFRP perfectly confined concrete to ensure plastic hinge rotation and effectively prevented the lap-spliced bond failure, the lap-spliced longitudinal bars had to be yielded. It is estimated that the behavior of the retrofitted columns at large displacements would be gradually delayed bond-slip of the lap-spliced longitudinal bars. The strain distribution of the main bar at 1.2 m height from the bottom, as shown in Figure 10(c), verified the yielding of the main bar. It is suggested that the plastic hinge was located at the end of the GFRP wrapping region.

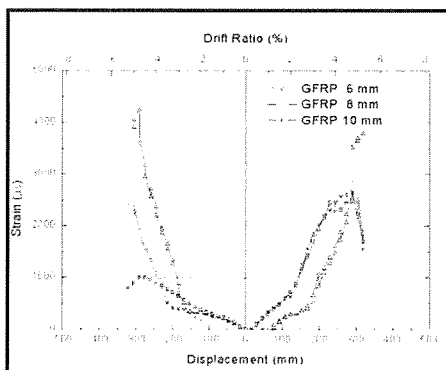
Figure 11. Strain distribution of GFRP

The dilation strain distribution of GFRP recorded for all the retrofitted columns was from 900 to 2000  $\mu\epsilon$  at 0.5 m height and from 2000 to 4000  $\mu\epsilon$  at 1.2 m height, as shown in Figure 11(a) and (b). Especially, the strain dispersion of 8 mm thick retrofitted column with increasing the height was the smallest of all retrofitted columns and maintained approximately 2000  $\mu\epsilon$ . The maximum recorded GFRP strain value was about 4300  $\mu\epsilon$ , which was about 33 % of the ultimate GFRP strain used in the test. This means that the GFRP of the retrofitted columns didn't damaged at all. According to the thickness of GFRP wrapping, the dilation strain of GFRP varied. Therefore, To retrofit the lap-spliced column with GFRP, the retrofit design equation is suggested that the dilation strain of GFRP should be estimated according to the thickness of GFRP.

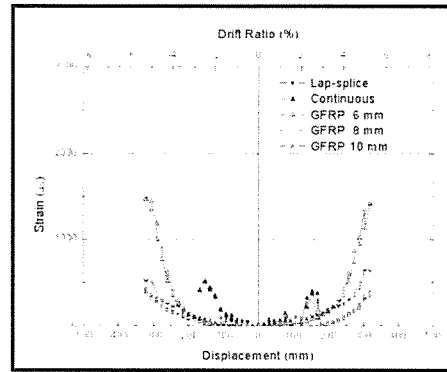
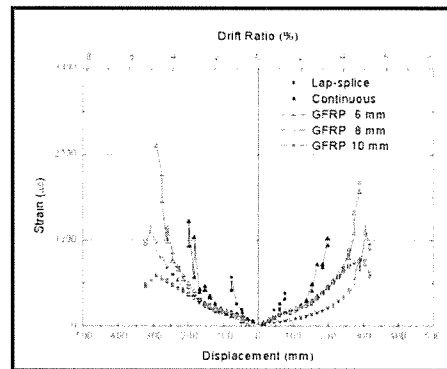
Figure 12. Comparison of hoop bar strain

In case of bridge columns constructed before 1991 in South Korea, it was common to contain insufficient transverse reinforcement. In case of all the tested columns, the hoop bars were closed by lap splices placed at 300 mm centers. The measured strain of the hoop bar verified the insufficient amount of confining pressure provided by the hoop bars and confirmed the unyielding of hoop bars, as shown in Figure 12(a) and (b). Even though the columns were retrofitted with GFRP, the strain of hoop bar didn't varied. Therefore, it is conservative that the confining effect of hoop bar should be ignored.
