STUDIES ON FATIGUE DAMAGES BASED ON STRAIN
MEASUREMENTS OF A HIGHWAY BRIDGE

By Shugo KATO*, Osamu YOSHIKAWA**, Hiromasa TERADA*** and
Yoshio MATSUMOTO***

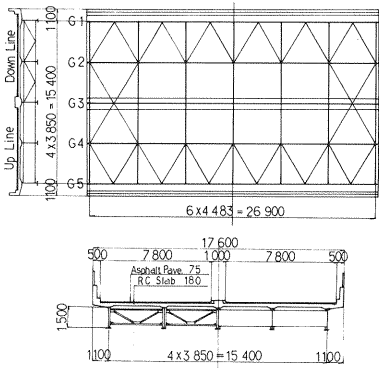
Fig. 1   Test bridge.

To identify the behavior of the structure, strain measurements were taken in the simple composite plate girder bridge shown in Fig. 1, which was brought into use in 1960.

This bridge with span 26.9 m consists of five main girders, one cross beam at span center and four sway bracings arrranged at 4.5 m spacing. These sway bracings are not considered to support the live load. Therefore, this bridge is a grid-type structure of five main girders and one cross beam, and its grid bending rigidity is $Z=7$.

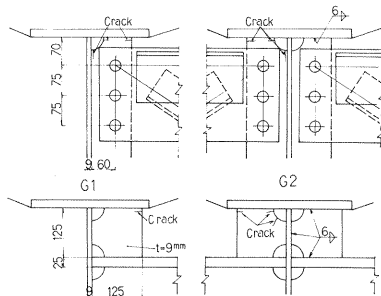
Fig. 2   Details and crack pattern.

Ten years after construction, cracks developed on the floor slab of 18 cm thick and they have been continuously reinforced by bonding steel plate on its lower surface, where the steel plate thickness was 4.5 mm. Fig. 2 shows the structural details and cracks that have developed at the ends of stiffeners at sway bracing and of cross beam connection plates. These cracks have developed at the toe of fillet welds and/or at the center of scallops, and propagated along the weld beads.

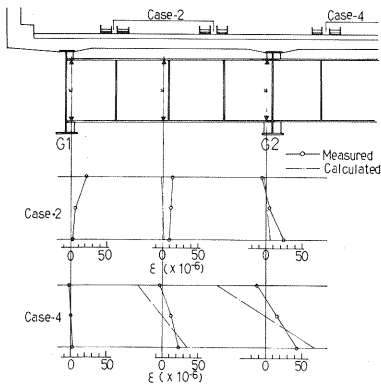
Fig. 5　Measured strain of cross beam.

Measured strain distributions are shown in **Fig. 5**, where the center of rear axles of the loading truck is set on the cross beam. The calculated ones are obtained on the basis of the influence line of the grid-structure system. Usually, the bending moment of cross beam at the exterior girder Gl is assumed to be zero in the calculation, because the torsional rigidity of a plate girder is very small. It is however obvious from **Fig. 5** that the bending moment actually occurs at that point in spite of the assumption in the calculation. Moreover, it seems that the normal force exists together with bending moment.

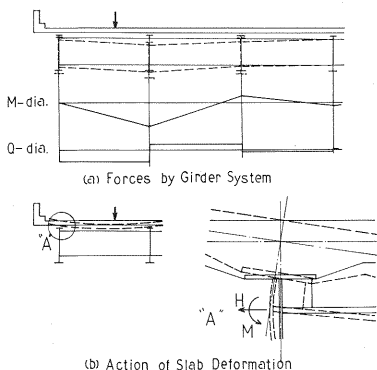
Fig. 6　Improved assumption of behavior of cross beam.

As the structure is loaded, main girders deform differently at the position where the cross beam is attached as shown in **Fig. 6** (a), resulting in bending moment and shearing force in a cross beam.

At the same time, the distortion of a slab rotates the upper flange of main girders as in **Fig. 6** (b). Then the cross beam resists to these behavior, and normal force, bending moment and shearing force emerge at the end of the cross beam.

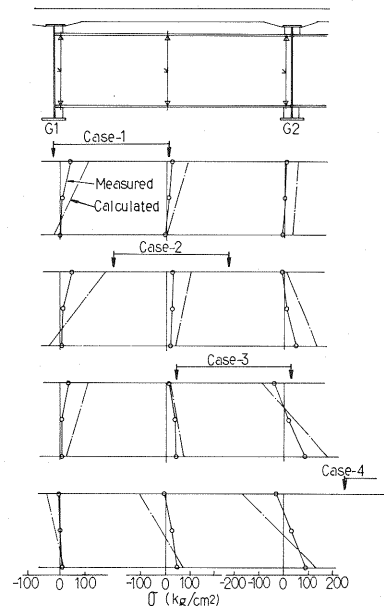
Fig. 7　Improved stresses of cross beam.

Then under the assumption of the behavior of main girders, the calculated stress distibutions become as shown in **Fig. 7**. Although there are some discrepancy between calculated and measured stress distributions, they show the same tendency. The influence of slab deformation therefore cannot be negligible contrary to the assumption in the previous calculation.

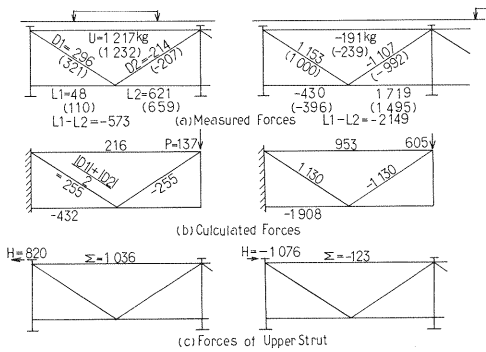
Fig. 8   Member forces of sway bracing.

Fig. 8 (a) shows the measured member forces of the sway bracing near the center of the span.

The values in the parenthesis of **Fig. 8** (a) are

those of the sway bracing adjacent to the support.

Both are under direct loading on each sway bracing. These results clearly imply that the member forces are quite similar in two sway bracings and that the amount of the diflection of main girders does not have any influence on the member forces. Moreover, the actual member force of the upper strut is larger than the calculated one, and do not balance with those of other members as a truss.

Here, assuming a sway bracing to be a cantilever truss, following analysis is done. At first, the measured forces in the diagonal members are presumed to show the behavior as a truss because they agree with each other. Then the load to act at the end of a cantilever truss is calculated using the force in the diagonal member, so the forces to act in the upper and lower struts are obtained as shown in Fig. 8 (b). The horizontal forces H in Fig. 8 (c) are the effect of horizontal deformation due to the distortion of a slab shown in Fig. 6 (b). The sum of the force in the upper strut is similar to the measured force, so the assumption may be correct.

These results imply that the force acting on the upper strut is composed of the forces due to not only the differential amount of girder displacement but also the horizontal deformation of the upper flange resulted from the deflection of the slab. As to the forces of lower struts, the difference between L1 and L 2 in measured forces nearly equal the calculated one as shown in Fig. 8 (a), (b). This may be because the compressive force, which should act on the lower strut L 1, is imposed on the strut L 2 due to the lower out-of-plane rigidity of the exterior girder G 1.

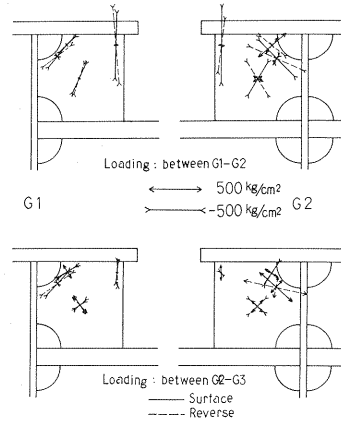
Fig. 9   Principal stresses in rib plate.

Fig. 9 shows the measured principal stresses of rib plates. The broken lines in Fig. 9 are of the back of plates.

The compressive stresses are dominant on both sides of rib plates at the exterior girder G 1, and the tensile stresses which might cause fatigue cracks are not observed. Generally higher stresses occur at the tip and center of scallops, that correspond to the crack positions.

The stresses of the rib plate in the main girder G 2 are sensitive to the loading positions, that is, the compressive stresses emerged in the case of loading between G 1-G 2 are altered to the tensile stresses when the load is applied between G 2-G 3. The rib plate at the main girder G 2 is therefore always under the alternate stress condition.

Moreover, since the relative deflections induced by these two different loadings seemed to be equal, a main factor of the alternate stresses is slab deflection. Since the measuring point at the tip was at the distance of 7 mm from the weld toe and edge of scallops, it is easily expected that the higher alternate stresses might act at the positions where cracks are initiated.

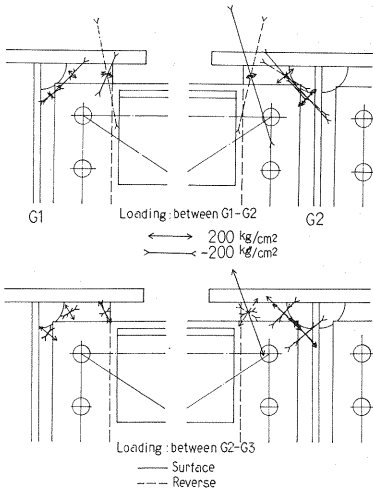
Fig. 10   Principal stresses in stiffeners.

Fig. 10 shows the principal stresses at stiffeners on static loading test. The tendency of measured stresses are similar to those at rib plates, except that the stresses in the stiffener at the girder G 1 is alternating with loading cases, and that the magnitude and direction of the principal stresses change from the front side to the back side.

This would result from the out-of-plane bending by the structural eccentricity of stiffeners and guesset plates connecting sway bracing members. The stresses in the stiffener at the main girder G 2 show higher levels than those in the stiffener at G 1. This fact agree with the frequency of crack occurence.

(4) Since the large out-of-plane bending was noticed on stiffeners, the influence of the structural eccentricity between a stiffener and a gusset plate of sway bracing might be supposed. Considering the crack appearance such that the cracks on stiffeners initiate at the reverse side of gusset plates, it is to be desired to get rid of the structural eccentricity in the connection details.

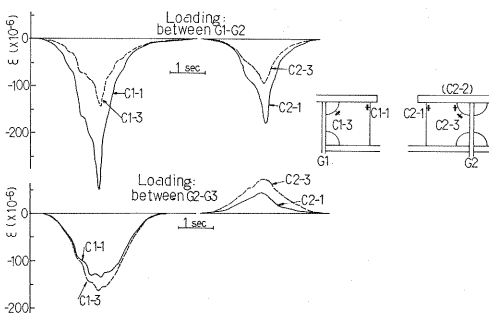
Fig. 11   Strain behaviors of rib plates.

Typical strain responses are shown in Fig. 11 and 12, where the running speed of the truck was 40 km/h.

The strain responses at the rib plate show only one mode, which indicates the cross beam to act as a part of main structure system.

As compared with the case of loading between G 2–G 3, the strain response in the case of loading between G 1–G 2 shows the complex shape and the effect of direct loading can be readily observed.

The strains of the rib plate at G 1 is compression on both loading cases but that at G 2 is alternated by each loading case.

Furthermore, the magnitude of strains at the tip and center of a scallop is alternative in accordance with the case of loading. The strain responses in stiffeners differ a little with those in rib plates shown in Fig. 12. The responses at the loading between G 1–G 2 are sensitive to the individual axle loads. The stiffener in G 1 is always suffered the large out-of-plane bending, which consists with the result of static test.

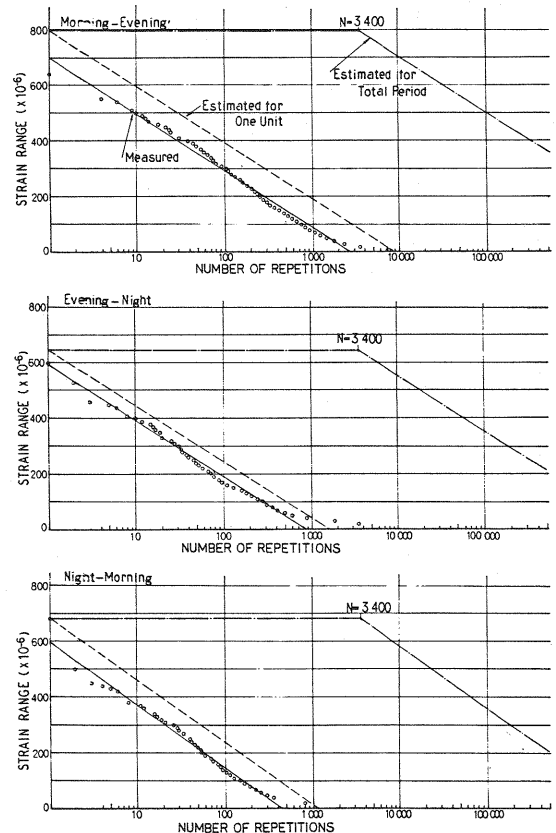
Fig. 16　Estimation of strain-frequency.

The example of calculated strain range-cycle relationship based on the procedure are shown in **Fig. 16** on the weld toe of a stiffener. Also the maximum strain ranges calculated are listed in **Table 2**.

The strains in static loading in **Table 2** show the calculated ones by loading the maximum load onto the influence lines obtained from the static test. It is apparent from **Table 2** that the maximum strains on the strain range-cycle relationship agree with the calculated static strains, and the assumption of this procedure may be nearly appropriate.

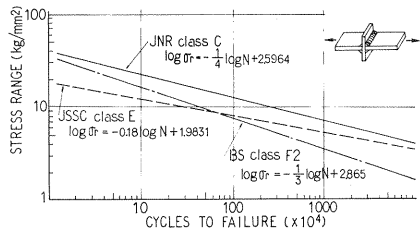
Fig. 17 Basic fatigue strength for fillet weld.

In order to determine the fatigue damage for each structural datail, design $\sigma_\gamma-N$ curves of Japan Steel Railway Bridge Standard (JNR for short)[3], Fatigue Design Specifications by Society of Steel Construction of Japan (JSSC)[4] and British Standard BS 5 400, part 10 (BS)[5] are applied. The category is assumed as a non-load-carrying fillet weld to the weld toe and as a holed plate to the scallop. Design $\sigma_\gamma-N$ curves of each specification are shown in Fig. 17, 18.

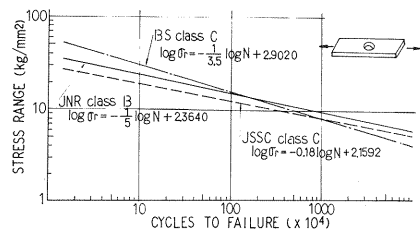
Fig. 18 Basic fatigue strength for plate with a hole.

Here, the basic fatigue strength on the holed plate differs from JNR and JSSC to BS, that is, the basic fatigue strength is provided as the nominal stress σ_0 in JNR and JSSC as against the edge stress $\sigma_c=K\sigma_0$ in BS, where the stress concentration factor at the edge of a hole is $K=2.4$. Measured stresses are compensated therefore for following alternations, respectively, and then compared to each design $\sigma_\gamma-N$ curve.
