REPAIR OF FATIGUE DAMAGE IN CROSS BRACING CONNECTIONS IN STEEL GIRDER BRIDGES

By Chitoshi MIKI*, Hiroyuki TAKENOUCHI**, Takeshi MORI***
and Seiji OHKAWA****

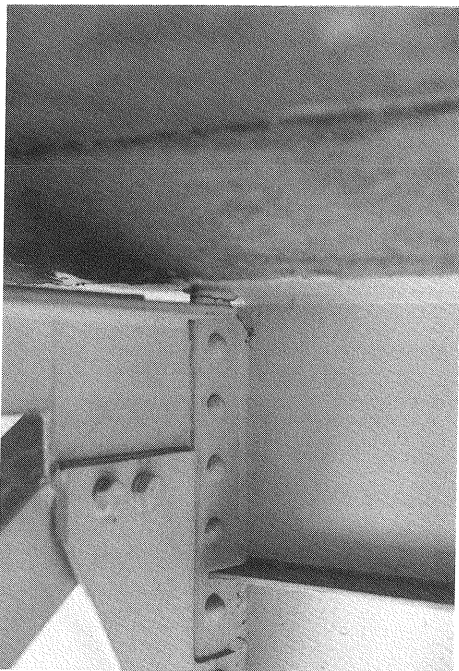
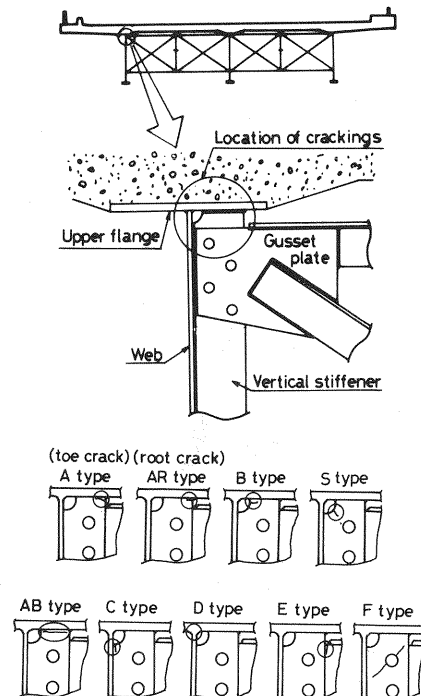
Fig. 1   Types and locations of crackings.

In recent years, fatigue cracks have been found at welds between vertical stiffener and the top flange of main girders, where cross bracing or transverse girders are attached in highway plate girder bridges as shown in **Fig. 1**[1]. The occurrence of fatigue cracks at such locations is most typical of fatigue damage to highway bridges in Japan. Such fatigue damage is featured by occurrence of many cracks around the same time at the same kind of detais of bridge, in spite of some amount of differences in details and qualities of fabrication.

The causes of occurrence of this fatigue damage are considered to be secondary stress induced due to relative vertical deflections between adjacent main girders, and to deflections of concrete slabs[2]. In effect, forces of out of plane direction of girder web apply on vertical stiffeners with cross bracing, and it may be said transmission of these forces occurs through fillet welds between stiffeners and top flanges or webs.

AB type+D type Crack

Based on the above results of study described so far, it is proposed that the method as applied to TIG-B specimens be the basis for the repair method for actual bridges. According to the results of investigations of actual bridges, most of the fatigue cracks are Type A, as shown in **Fig. 1**, and their surface length is less than 10 mm at the edge of box welds. For cracks of this kind, gouging is not especially necessary and should be repaired by fillet welding performed on top and toe finishing by TIG dressing. This repair method can be applied similarly to cracks of B and C types also. The crack sizes to which this repair method can be applied would be of a degree that the surface length will not exceed plate thickness of the vertical stiffener.

In case a crack of Type A or B grows further, that part is to be completely removed by gouging and filled by welding, and moreover, additional welding performed overall. In this case also, the toe is to be finished by TIG dressing. When the crack becomes large, gouging is to be done over the entire length of the weld, and full penetration welding is to be performed. However, there is a possibility of adverse effects of large heat input by full penetration welding to the surrounding members and concrete deck plate. Therefore, extending full penetration welding to unnecessary portion must be avoided. There is considerable possibility of a crack initiated from the root having grown substantially at the root even though the length at the surface may be short. Therefore, gouging is to be performed until the crack can be completely

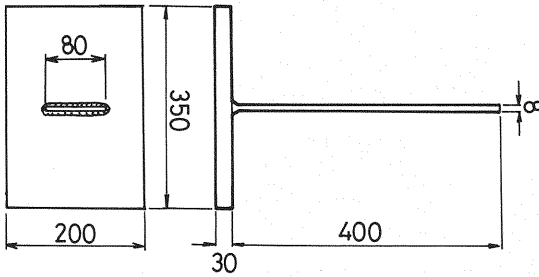
In cross bracing connections of plate girder bridges, the locations where the most damage occurs are fillet welds between vertical stiffeners or cross-bracing connection plates and top flanges. When this

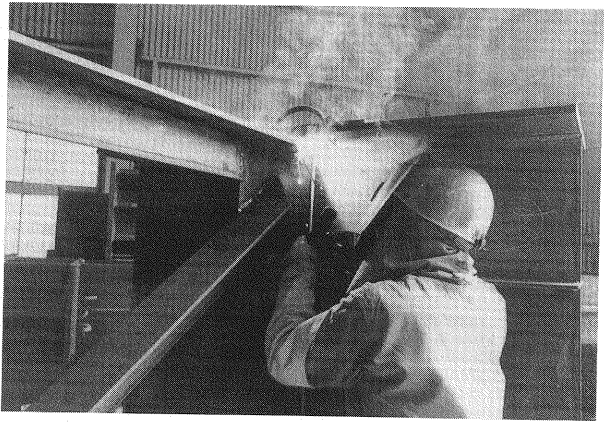
Photo 1　Bridge model used for making test specimens.

The TIG-D specimens have details identical to TIG-B, but TIG dressing was done in very adverse conditions assumable to occur in the actual field practice such as raising electric current and shaking the torch. Fabrication of TIG-A, B, C, and D specimens was performed in the model bridge shown in Photo 1 with the aim of reproducing repair work efficiencies at damaged portions of the actual bridge.

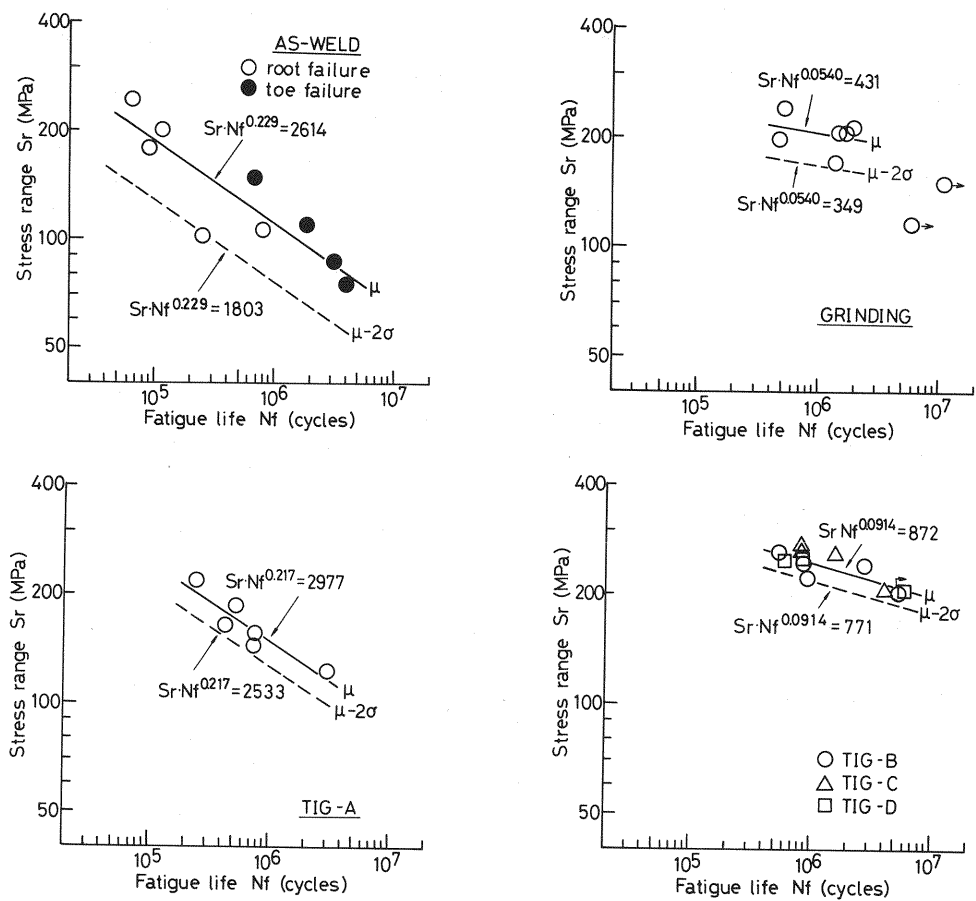
Fig. 4　Results of fatigue tests.

Fatigue test results are shown in Fig. 4 with mean line (μ line), and ($\mu-2\sigma$) line (σ : standard deviation) which are obtained from regression analyses. All of the test results and the design allowable S-N curves in the Design Standards for Steel Railway Bridges[8] are shown in Fig. 5. Approximately half of the AS-WELD specimens failed due to fatigue cracks occurring from toes, while the remainder failed due to fatigue cracks initiated from roots. This indicates that the throat depths of these specimens were close to the limits of root cracks and toe cracks[6]. Test results of cracks occurring from toes were distributed in the long life range, and the fatigue strengths were slightly higher when compared with specimens failed due to root cracks. Such a trend was similar to the results of past studies[6]. According to the Design Standards for Steel Railway Bridges, joints of this type are classified into Class C under the condition that "adequate size of fillet weld will be possessed", that is, failure would occur at the toe. However, the test results in this case indicate that it would be not conservative to apply allowable stress of Class C to this connection. When throat depth of the weld is small and cracks occur from the root, it may be classified into D or poorer is indicated.

If it is assumed that AS–WELD specimen is failed by the passage of 30 million large vehicles, the corresponding stress range, from the regression line of the S–N line in **Fig. 4**, will be

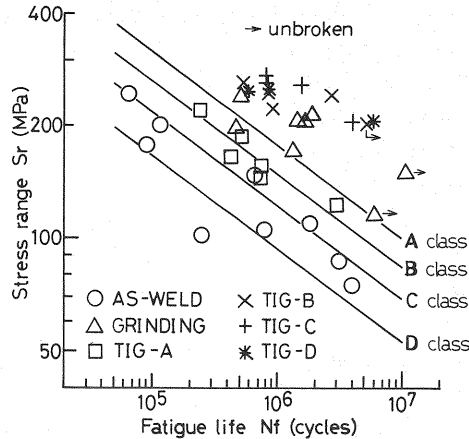
Fig. 5 Test results and standard design curves.

With **Fig. 5** as a reference, and assuming the joint in the present condition to be Class D according to the Design Standards for Steel Railway Bridges[8], and this is to be improved to Class A by repairs, the remaining fatigue life will be

Aa shown in **Fig. 5** the fatigue strength given by the Class B design line, can be adequately secured by grinding, one pass of reinforcement welding, and TIG dressing.

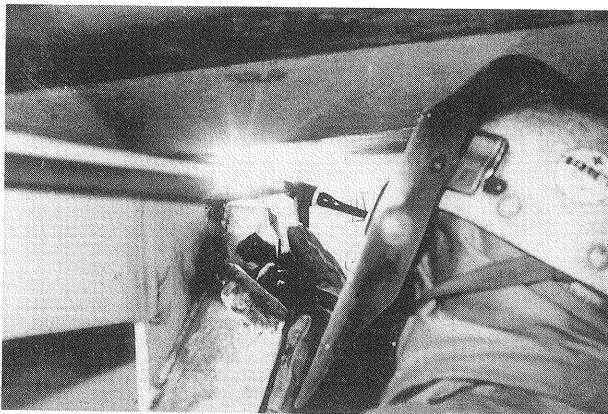
Photo 2   Repairing of actual bridge.

Photo 2 is a view of trial execution on an actual bridge. The upper supporting member of the cross bracing and a part of the diagonal member flange have been cut away because they hinder repairing of welded portions.
