## Timber Bridge Inspection Project in Sweden

### スウェーデンにおける木橋の点検調査プロジェクト

POUSETTE Anna\*, FJELLSTRÖM Per-Anders\*, GUSTAFSSON Anders\* and MATSUDA Seiko\*  
アンナ・プセツト\* パールアンダーシュ・フィエルストルム\*  
アンダーシュ・ギュスタフソン\* ○松田青子\*

\*SP Träteknik : Technical Research Institute of Sweden, Building Technology and Mechanics,  
Wood Technology (Skeria 2, SE-931 77, Skellefteå, Sweden)

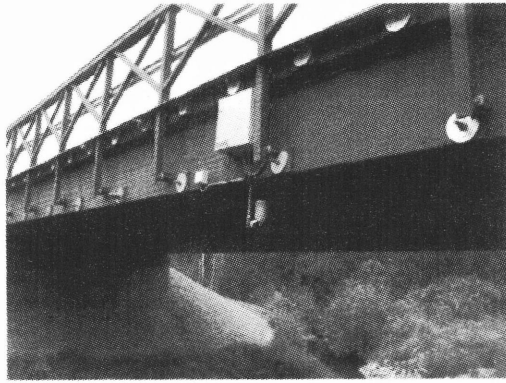
Figure 9. Measuring set-up of stress-laminated box-beam bridge

Two bridges were prepared in some points for manual moisture content measurements, both wood pieces for the oven-dry method (T) and pins for the resistive method (R). In one bridge wood pieces in seven places and pins for the meter in four places have been put in the deck plate since the bridge has been built in 1994 and were used to give the moisture content through the bridge deck, see figure 10. The deck plates had the lowest moisture contents at the top, and at the bottom the moisture content was about 16 %. The average moisture content had increased about 1.4 % during the last 8 years. Another bridge which has been also prepared in four places for moisture content measurements gave almost same results.
