Analysis of a RC Rigid-Frame Arch Bridge affected by Sichuan Earthquake, 2008

Zhongqi Shi¹, Kenji Kosa², Jiandong Zhang³ and Hideki Shimizu⁴

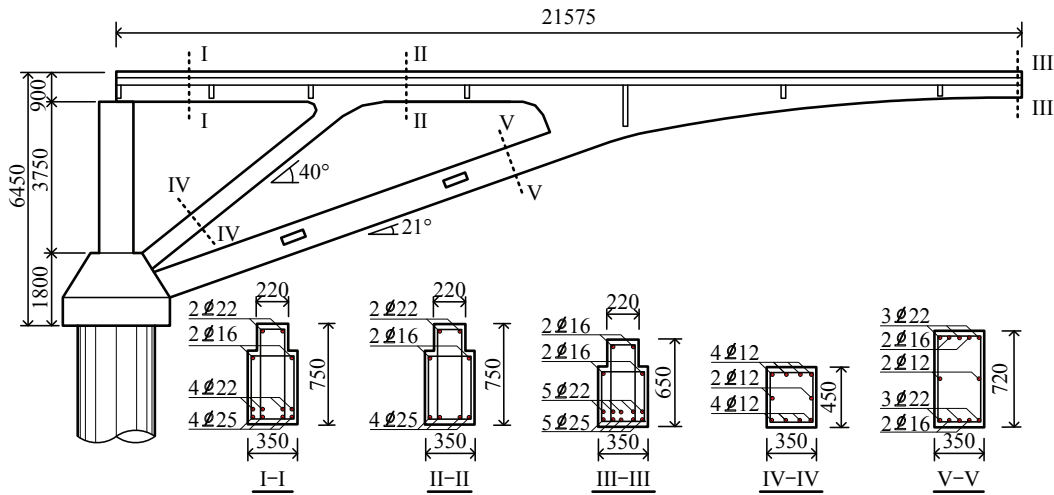
Fig.4 Dimensions of Left Half Span of Span 2 Based on the Survey (unit: mm)

The detailed dimensions for half of Span 2 are illustrated in Fig.4 for instance. We can see that, the arch leg (Point A in Fig.4) and the inclined leg (Point B) has about 21° and 40° slope respectively. The arch frame is formed by one arch leg from left pile cap, the corresponding one from the right cap, and the girder in the middle span. This arch frame composes one single rigid-frame, together with two inclined legs, and the girders (Point C) at the ends of deck. One span consists of five rigid-frames connected by several crossing beams (Point D in Fig.4), micro-bending slabs (Point A in Fig.5), and extending slabs (Point B in Fig.5). Spans were connected by piers and abutments to form the entire bridge.
