AN INVESTIGATION ON FATIGUE STRENGTH FOR TRANSVERSE CHORD OF STIFFENING TRUSS

By Kenji SAKAMOTO*, Masahiko YASUDA*,
Makoto FUKAZAWA** and Chitoshi MIKI***

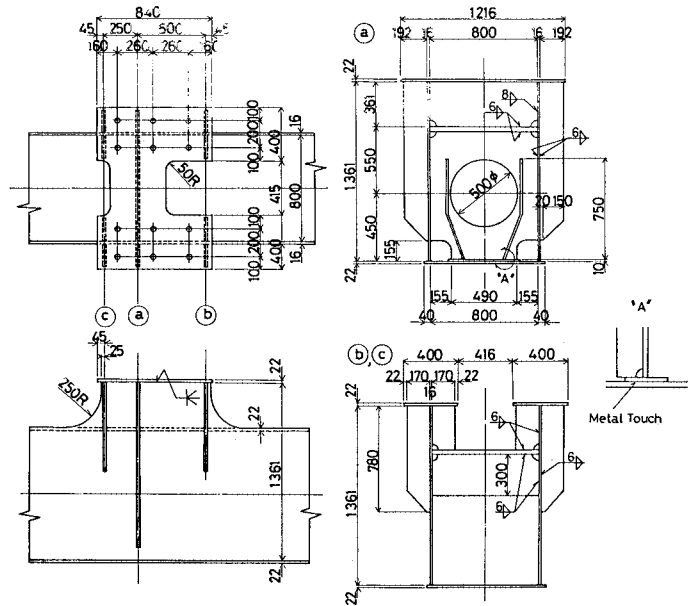
Fig. 3 Details of section supporting stringer.

Details of the section supporting the stringer are characteristic as shown in Fig. 3. In the fatigue design code for Honshu-Shikoku Bridge²⁾, details are grouped in 4 categories from A to D according to the fatigue strengths of details, where Category A is the highest. In the original design of this transverse chord, various welding details of top flange [compression-side] were all Category C and these of bottom flange [tension-side] were Category A. The diaphragm jointed to top flange and both side webs by fillet welding. But the joint between diaphragm and bottom flange was bearing connection. Moreover, because bending moment and torsional moment are applied to the transverse chord, the fillet weld is done from the inside of member together with the partially penetrated groove weld from outside for the corner joints. The size of the scallop of the diaphragm is larger than usual to allow for continuous MIG welding with a self-driven welding machine.

With these details it is expected that the torsion, due to the support reaction at the stringer, induces out-of-plane distortion of the web plate at the scallop of the diaphragm. This out-of-plane distortion may cause cracks at

- (a) The diaphragm was welded to the bottom flange
- (b) The bottom flange plate was thickened from 22mm to 28mm, or a cover plate 16mm thick and 450mm wide was added, almost over the full length of the flange.
- (c) Size of fillet weld to the bedplate for the sidewalk was increased from 7mm to 12mm.

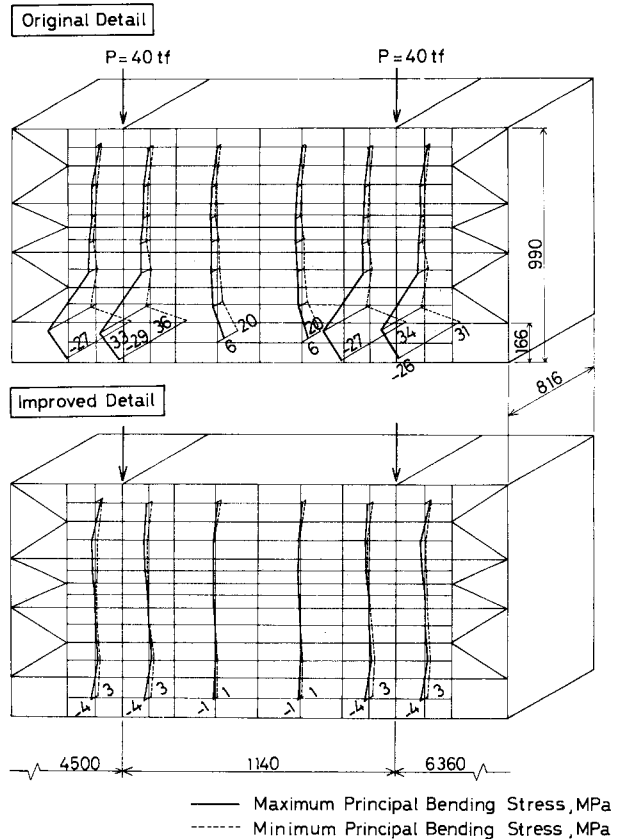
Fig. 8 Result of finite element analysis.

In order to examine the test results, a finite element analysis using shell elements was carried out. Fig. 8 shows the distribution of the principal bending stresses of the loading side web plate. Bending stress at the scallop in the improved detail is about one-seventh of that in the original detail. This shows the same result as given in the test result.

Accordingly, to reduce the applied maximum bending stress, the bottom flange plate was thickened from 22mm to 28mm, or a cover plate 16mm thick and 450mm wide was added almost the full length of the lower stress region.

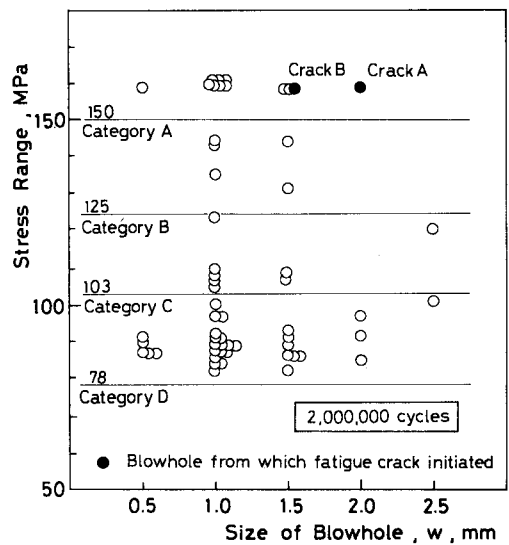
Fig. 11 Relation among initiation of crack, size of blowhole and applied stress range.

The relation among the initiation of crack, size of blowhole and applied stress range is shown in Fig. 11. Only two cracks are not enough to derive apparent relation. Fatigue cracking however, tends to originate from relatively large blowholes at a higher applied stress range region.

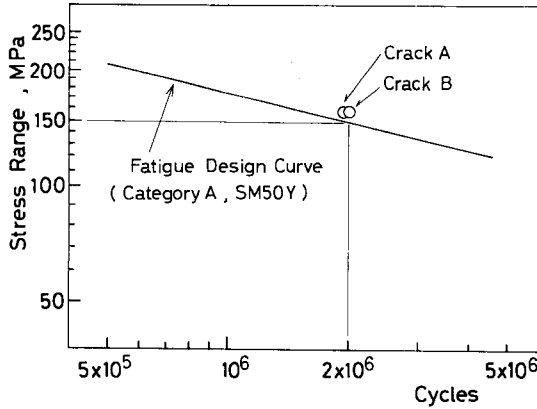
Fig. 12 Fatigue design curve and test result.

A margin of error at less than 25% remains for the estimate fatigue life from 1 500 000 cycles to 2 000 000 cycles of Crack B. This may prove the method appropriate. Estimated fatigue lives N_f are as follows.

Crack A $N_f=1\ 950\ 000$ cycles

Crack B $N_f=2\ 020\ 000$ cycles

No difference in the fatigue lives was found between Crack A and Crack B. The estimated fatigue lives are plotted beyond the fatigue design curve toward the longer life side.

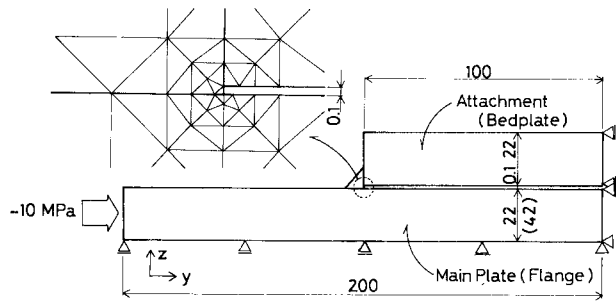
Fig. 16 Model calculated by finite element method.

Stress characteristics at the root of the transverse fillet weld under compression are examined by the finite element method. The finite element model in this analysis is shown in Fig. 16. Displacements in z-direction of the main plate were restricted according to the constraint of the web plate and the transverse stiffener. Three cases were conducted in order to calculate the effect of the fillet weld size, and to examine the difference between the flange plate thickness of the specimen (42 mm thick), and the actual member (22 mm thick). Case-1 dealt with the 42mm thick flange, case-2 with the 22 mm thick flange, and case-3 with the larger size fillet weld.
