WELD REPAIR OF CRACKED BEAMS AND RESIDUAL FATIGUE LIFE

By Kentaro YAMADA*, Yoshinaga SAKAI**, Akimasa KONDO***
 and Yoichi KIKUCHI****

Fatigue cracks often initiate at as-welded toe of various attachments where stress concentration is high. Bending fatigue tests were carried out on two beams with welded cover plates and gussets. About forty fatigue cracks were observed, when the cracked parts were successively repaired with stopholes and splice plates. The fatigue test results were compared with previous test data. The cracked beams were further repaired with groove welds and fatigue tests were continued. Fatigue cracks initiated and propagated from weld defects near the end of the attachments. Fatigue life of repaired parts was somewhat longer than that of as-welded one due to grinding the weld toes after weld repair.

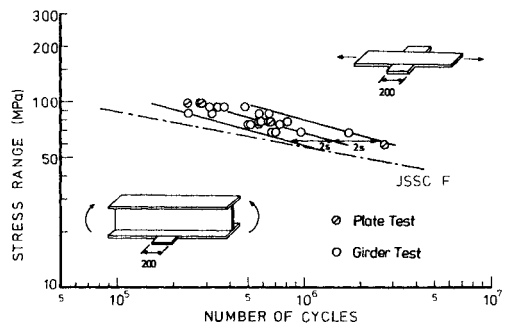
Fig. 3 Fatigue test results of beams with groove welded gussets of 200 mm long (G).

G-type Gussets : Fatigue test results of 200 mm long gussets welded to tension flanges are plotted in Fig. 3. Also plotted are the fatigue test data of tensile plates of 200 mm wide with the as-welded gussets of 200 mm long⁹⁾. The mean $S-N$ diagram and the standard deviation, s , were computed from total of 26 data, as follows.

The mean $S-N$ diagram and the confidence limits plotted two standard deviations away from the mean are shown by solid lines in Fig. 3.

test data seems to satisfy the allowable stress range, as shown in Fig. 3.

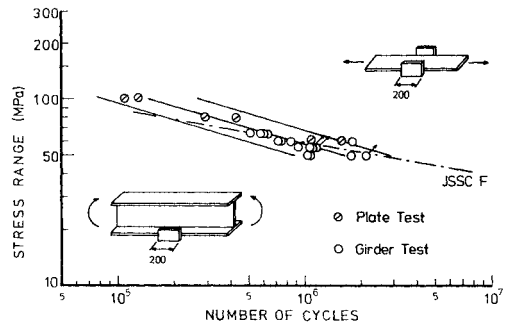
Fig. 4 Fatigue test results of beams with fillet welded gussets of 200 mm long (T).

T-type Gussets : Fatigue test results of 200 mm gussets welded transversely to tension flange are plotted in Fig. 4. Also plotted the test data previously obtained for the same type of gussets welded to tensile plates³⁾. The mean *S-N* diagram and the confidence limits are also plotted in Fig. 4. They are determined from total of 19 data, as follows.

The stress concentration factor at the end of the T-type gusset is higher than that of the G-type gussets, when the length of the gussets is the same³⁾. Therefore, fatigue strength of T-type gusset is lower than that of G-type gusset. The detail is not specified in the JSSC recommendation for fatigue design. If one applies the detail class F for this detail, some data fails to satisfy the allowable stress range, as shown in Fig. 4. It implies that the allowable stress range of this detail ought to be lowered to, for example, detail class G.

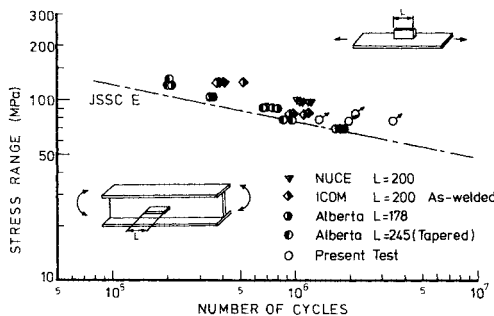
Fig. 5 Fatigue test results of a beam with gussets welded to web (GW).

GW-type Gussets : No fatigue cracking was observed at the end of the gussets welded to the web, even after the additional fatigue tests which were carried out after weld repair. The runout data is plotted with an arrow in Fig. 5, along with the previous test data of the same type of details⁵⁾. The present test data seems to show longer fatigue life compared with the previous test data. This may be due to the good weld toe shape which is favorable to fatigue resistance. The data satisfy the allowable stress range of detail class E of the JSSC recommendation for fatigue design.

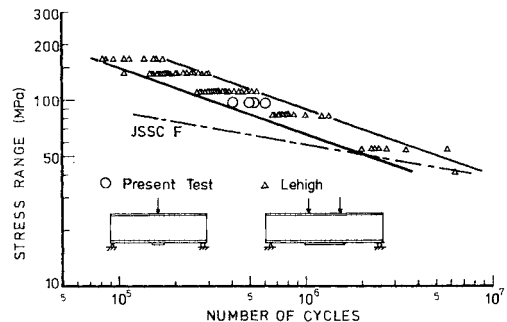
Fig. 6 Fatigue test results of beams with a welded cover plate of 400 mm long.

Cover Plate : The as-welded cover plate showed four independent fatigue crackings at the toes of the end fillet welds perpendicular to the applied stresses. The cracks propagated into the flange plate and then to the web. The test data is plotted in Fig. 6 with the test data generated at Lehigh University⁶⁾. The cover plate in the present test was 400 mm long and it showed an equivalent fatigue life as the Lehigh data, provided that the cover plate length of Lehigh data was over 1 000 mm. The detail is classified into detail class F according to the JSSC recommendation for fatigue design. The data satisfied the allowable stress range, as shown in Fig. 6.

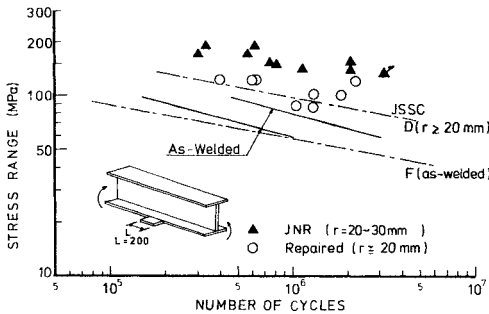
Fig. 11 Fatigue test results of beams with gussets of 200 mm long (G) after weld repair.

Fatigue test results of G-type gussets are plotted in Fig. 11. All test data was found to have longer fatigue life than the as-welded ones shown by a confidence interval. It may be because the ends of the gussets were ground to the radius of about 20 mm which eliminated high stress concentration at the weld toes. It implies that the weld defects observed in the repair welds were less harmful than the stress concentration at the weld toes of the gusset ends. Therefore, the repair welds described here are acceptable to repair fatigue crack and to prolong the fatigue life.

The JSSC recommendation for fatigue design classifies the ground ends of over 20 mm radius into detail class D⁹⁾. When repair weld is not subjected to an appropriate non-destructive testing, the fatigue life may not satisfy this allowable stress range. In these cases, it may be safe to lower the allowable stress range of the repair weld, for example, to the detail class F for the as-welded gussets.

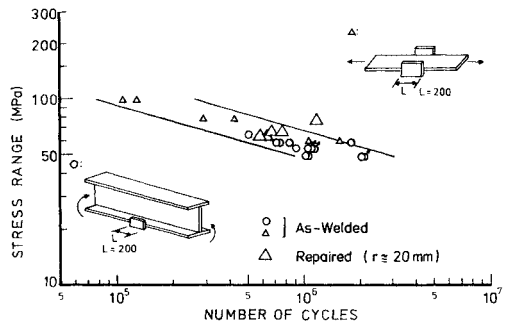
Fig. 12 Fatigue test results of beams with gussets of 200 mm long (T) after weld repair.

Fatigue test results of the T-type gussets with repair welds are plotted in Fig. 12, where the as-welded data is indicated by two solid lines corresponding to the confidence interval. The present test data of the repair welds showed approximately the same fatigue life as the as-welded gussets, even though the gusset ends were ground.

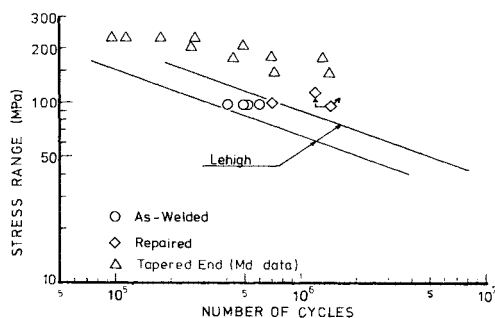
Fig. 13 Fatigue test results of cover plates after weld repair.

Fatigue test results of the cover plates after repair weld are plotted in Fig. 13. Also plotted are the confidence interval of the as-welded cover plates tested at Lehigh University⁶⁾ and the test data of the cover plated beams with tapered end welds tested at University of Maryland⁸⁾. The data of the repair weld showed an equivalent or longer fatigue life compared to the as-welded ones, owing to the ground end welds. Especially one side of the cover plate resisted 1.44 million cycles of loading, and additional 1.16 million cycles of higher loading before fatigue cracking was observed at the plug weld of the stopholes. It implies that the present weld repair procedure was satisfactory to repair cracks from the cover plate ends. The
