FATIGUE STRENGTH OF WEATHERED AND DETERIORATED RIVETED PLATE-GIRDER

By Koei TAKENA, Hiromichi KAWAKAMI*, Seiichi TANIFUJI**
and Chitoshi MIKI****

In this study, a detailed review of the fatigue test results of riveted joints which have been performed in Japan, is conducted. A fatigue test is carried out on a plate-girder bridge which has been used in a railroad about 70 years. The fatigue strength and the initiation and propagation behavior of fatigue cracks of weathered and deteriorated riveted plate girder is discussed.

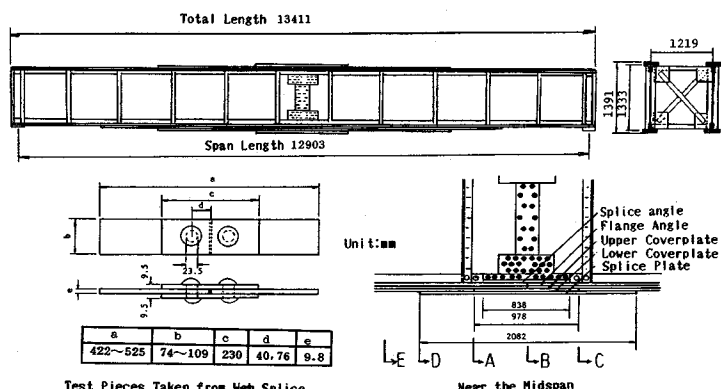
Fig. 4 Specimen.

A riveted deck plate girder (Fig. 4) of a JNR bridge spanning the river Kannagawa on the border of Saitama and Gunma prefectures was tested. Stress measurements of this bridge under train loading were performed by Abe et. al. ¹²⁾ The maximum measured stress by the passage of old steam locomotive is about 45 MPa. Therefore, the cumulative fatigue damage in service may be negligible. The steel employed was "S 39", which is approximately equivalent to SS41. This bridge with a span length of 12.9 m was constructed of two I-section girders each 1.391 m deep. The largest sections (E-E sections) of these girders had the flanges composed of two angles and two cover-plates. Rivet splices were connected at the midspan; webs, flange angles and upper cover-plates were connected at the midspan; and lower cover-plates were connected at two sections located at 0.49 m from the midspan. Rivets were not loosened. Tension flanges, except near the supporting point and partially at flange angles, were found relatively sound with little reduction of sectional area due to corrosion. On the surface of compression flange upon which there was no tie the corrosion had advanced; particularly a heavy reduction of sectional area was recognized at the boundary with splice plates.

After fatigue tests of this girder, small test pieces of riveted joints were taken, as indicated in Fig. 4, from the web splice.

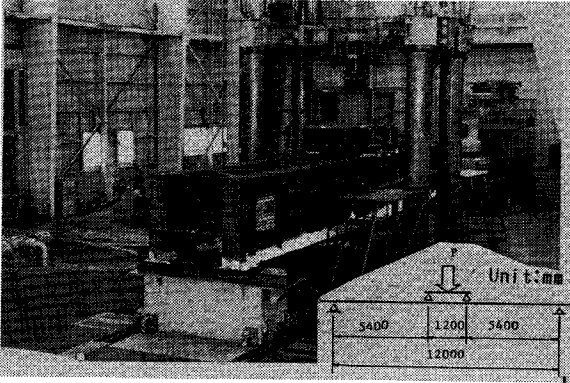
Fig. 5 Fatigue Testing Set-up.

minute with sine load waves ranging from 49 kN to 1470 kN. Fig. 5 shows the testing set-up. In this test the stress range was halved with the minimum stress stepped up for each specific number of cycles so that beach marks could be left on the failure surface. After the test, the girder was broken up with the rivets removed in order to check for potential cracks which were not found during the test. First, visual examination and magnetic inspection were done to check for cracks in rivet holes. When cracks did not observed, a penetration test followed. Most of the potential cracks were observed by these detailed inspection. The joint specimens cut out of the web were submitted to fatigue testing at stress ratio 0.

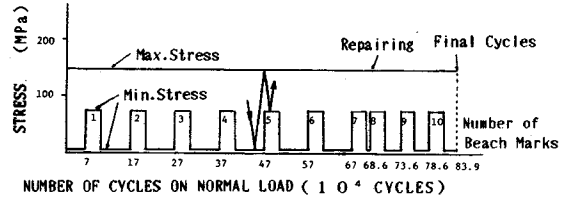
Fig. 6 Loading History.

Fig. 6 illustrates the loading history. At about 10^4 cycles a crack (L_A crack) initiated near the edge of a corroded groove of the horizontal angle leg (reduction of sectional area was about a half that of the original shape) at the end of the splice angle in the vicinity of A-A section of the left girder. Photo 1 shows the ultimate state of this crack. This crack was observed to coalesce into new ones which developed later.

At 68.6×10^4 cycles, the crack near A-A section of the right girder had grown so large that the testing was interrupted. As seen from Photo 2, the right girder then had all its flange cut through, with the crack

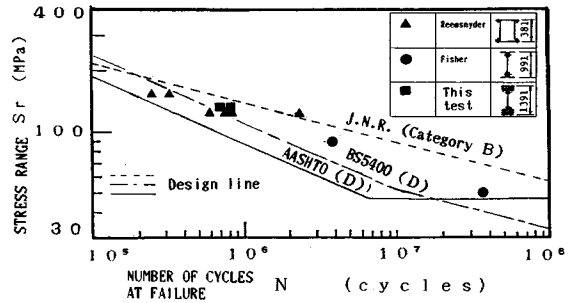
Fig. 7 Test Results of Riveted Members.

The relationships between number of cycles to failure and stress range of riveted details in this test is illustrated in Fig. 7, in which the number of cycles to halve the stress range for the purpose of leaving beach marks on the failure surface is not included. For the comparison, the design life curves for riveted joints in JNR, AASHTO and BS 5400 specifications and other fatigue test results of large size riveted member are also given. The results of this test are close to the other results of riveted members; and these results approximately match the lower bound of fatigue test results of small test specimens in Fig. 3. The results of riveted members come below JNR design life curve; and below the BS 5400 one in a high stress range region. In the tests of aged and deteriorated stringers undertaken by Fisher et al., fatigue cracks initiated from rivet holes in the equi-moment section with no rivet splice and the stress condition at rivet

splice was severer than the stress condition at riveted detail with no rivet splice. From this fact, it seems that the fatigue life of rivet splice closely follows the AASHTO design life curve for D-category joints.

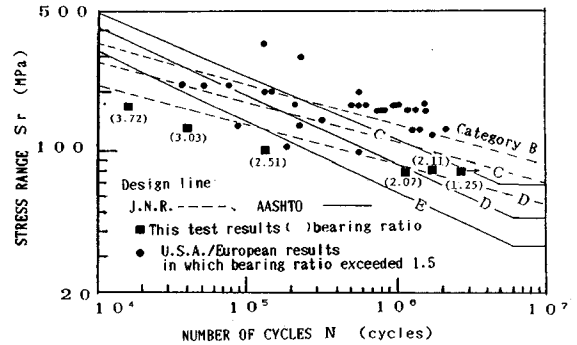
Fig. 8 Test Results with Bearing Ratio Varied.

After this fatigue test, specimens cut out of the web splice were submitted to fatigue tests. These specimens had various bearing ratios. The test results were illustrated in Fig. 8. The results of test reviewed by Fisher et al. with loosened rivets and the bearing ratio amounting to more than 1.5 and the AASHTO design life lines are also given in Fig. 8. The results of this fatigue test are lower than the AASHTO E-category design line when the bearing ratio exceeded 2.5, and barely equivalent to the D-category design line when the bearing ratio dropped to about 2. The rivets of these test specimens are not loosened. It is known from this that the fatigue strength considerably decreases as the bearing ratio increases.
