# River Bridges with Natural Banks: A Case Study of Twenty-One River Bridges in Papua New Guinea

○Hokkaido University  
Hokkaido University

Member Gibson Ali HOLEMBA  
Member Takashi MATSUMOTO

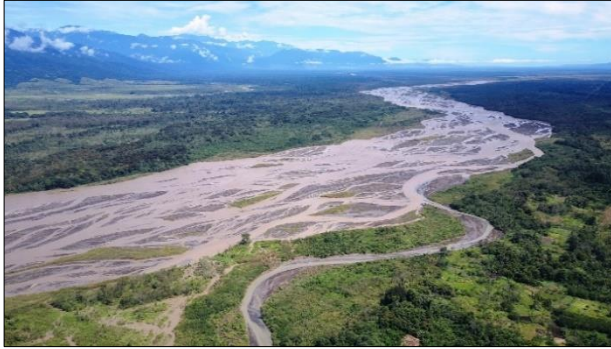
**Figure 4. Mavic Pro DJI Drone image of Kesuai Bridge, Ramu Highway, Madang Province, PNG. Photo Credit: Jeremy Mark (2017).**
