## Water supply pipeline damage related with geomorphology and geology in Kashiwazaki-city

Kobe University   Student member of JSCE   ○Jérôme Blard  
 Kobe University   Regular member of JSCE   Yasuko Kuwata  
 Kobe University   Fellow member of JSCE   Shiro Takada

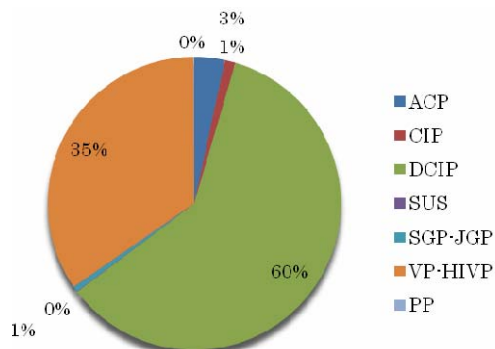
After the earthquake, 60,000 households were concerned by water outage (40,000 in Kashiwazaki). Many different kinds of materials were used for the distribution system, as it is pointed in Fig. 1. The total length of pipe is approximately 712.3 km, with also different diameters: 31% are less than 50 mm, 45% are between 75 and 100 mm, 17% are between 200 and 350 mm, and finally 7% are more than 400 mm. 98.7% of the smallest diameters are Vinyl Pipe (VP), whereas others mainly use Ductile Cast Iron Pipe (DCIP). Fig. 2 shows the damage ratio of pipeline due to material. In the case of this city, the damage of CIP and SGP are remarkable.

Fig.1: Materials used for the water supply system
