Damage to Structures in Rikuzentakata Region Due to Tsunami

1. Introduction

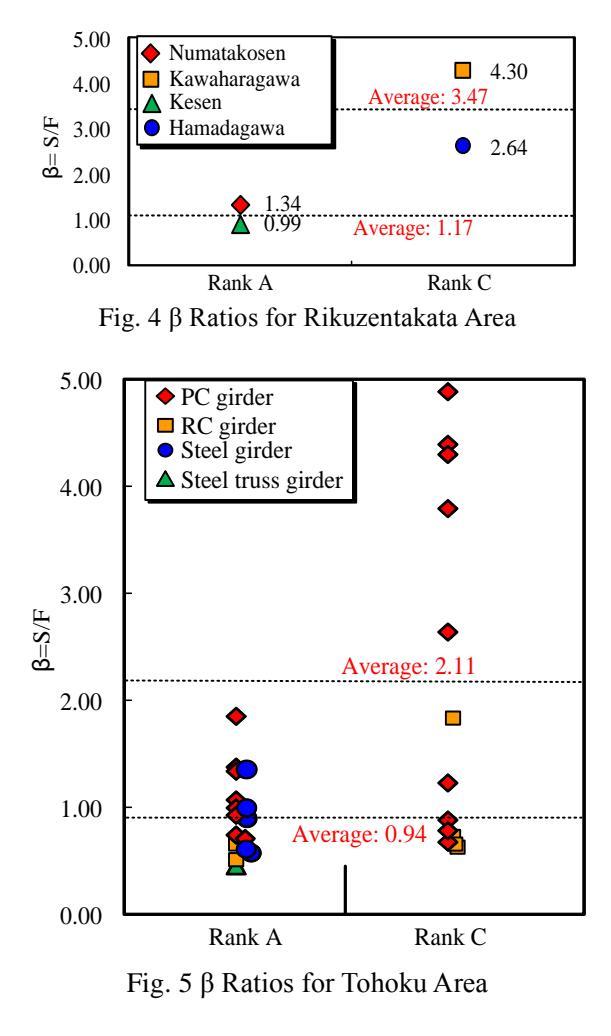
(F= μ W) is tsunami impact force. Fig. 4 illustrates β ratios for four bridges in Rikuzentakata (refer from Fig. 1). β ratios of two Rank C bridges are all greater than 1.0 with average as 3.47, inferring resistance is greater than tsunami impact force. Thus, their girders survived. β ratio of Rank A bridges is in small level (avg. 1.17). Average β ratio of Rank C bridges is 2.97 times of Rank A bridges. β ratios for 29 bridges in entire Tohoku area are presented in Fig. 5 (Rikuzentakata included). Average ß ratio of Rank A bridges with girders outflowed is 0.94. Average ß ratio of Rank C bridges with girders survived is 2.11 (2.24 times of Rank A). Further, PC girders have relatively greater β ratios and 53% have survived (9 in 17, Rank C); all steel girders have relatively small β ratios and flowed out, inferring small resistance to tsunami impact.

From Fig.4 and Fig. 5, difference of β ratios between Rank C and Rank A bridges are obvious. Thus, β ratio is considered as an effective indicator to judge outflow of girder. As velocities in all areas probably not uniform to be 6.0m/s as authors used. Some β ratios of Rank A bridges are greater than 1.0 (like Numatakosen Bridge, Fig. 4) while some of Rank C bridges are smaller than 1.0.

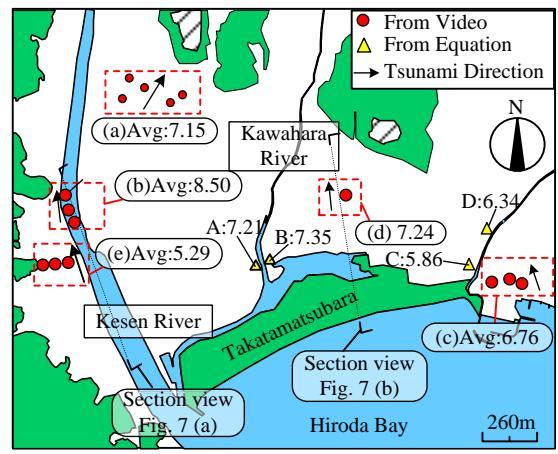
Fig. 6 Distribution of Tsunami Velocities

Two methods will be used for estimation of velocity. From recorded videos, velocity can be calculated by checking the floating distance of debris and the time. Also, based on study of Mr. Matsutomi, equation $v=0.58(gh_f)^{1/2}$ is derived. (h_f: tsunami depth front of building, values obtained from 2011 Tohoku Earthquake Tsunami Joint Survey Group). Estimated velocities are plotted in Fig.6. Focusing on velocities from videos, average value is around 7.0m/s. This is greater than 6.0m/s of entire Tohoku area (Chap.3). Velocities from equation can roughly coincide with those from video. Tsunami velocity in river area ((b), 8.50m/s) is 29% greater than land area (avg. of (a), (c), (d) and (e), 6.61m/s). From former study, tsunami energy can be partly weakened by friction of land and plants. Further, from video screens and height differences between tsunami and structures (Fig. 7), wave shapes can be drawn (positions in Fig. 6). Except for wavefront part (A, B of Fig. 7), entire tsunami is in shape with relatively small slope. Tsunami heights also do not have great difference between river and land area. However, based on wavefront (A, Fig. 7 (a)), wave of river is considered as Breaker Bore with greater velocity. For land area, slope angle (around 9°, B, Fig. 7 (b)) is relatively small, probably inducing the smaller velocity.
