Investigation on the Vibration of Diagonal Members in Ikitsuki Bridge

Nagasaki University Student Member ○WANG Qu Nagasaki University Member NAKAMURA Shozo
Nagasaki University Member OKUMATSU Toshihiro Nagasaki University Member NISHIKAWA Takafumi

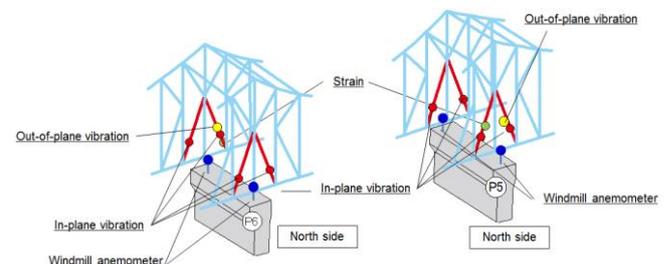
Fig.4 The location for observing vibration and wind condition

In order to confirm the cause of crack, a long term remote monitoring of wind condition and vibration of some diagonal members with similar structural characteristics to the cracked member had been carried out since December 2011. Some accelerometer, windmill anemometer and strain gauge were used to find the relationship between vibration behavior and wind condition. The number of them is shown in Table1 and the location for observing is shown in Fig.4.

Wind direction and wind velocity had been measured by windmill anemometer at four points of each north and south side on two intermediate supports (P5 and P6). In order to reduce the influence of the following flow in the downstream side to measure the wind condition, the height of anemometer is about 5m. Vibration for eight members had been measured by accelerometer at eight points of in-plane and two points of out-planes on two intermediate supports (P5 and P6). 10 strain gauges were set on two members among them.
