## Slope movement monitoring using LPWA network and slope stability analysis through its observation

Ehime University

○A. Hafidz, A. Putra, H. Yasuhara, N. Kinoshita

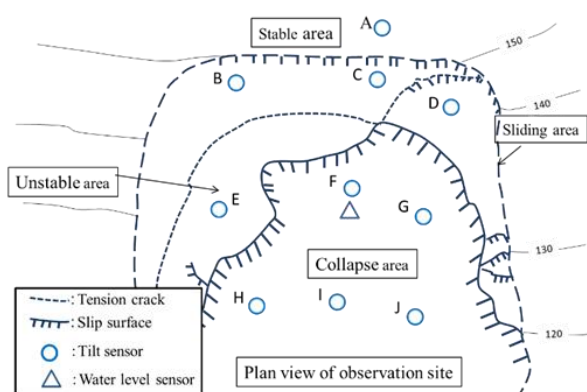
**Figure 1:** Tateyama site

Since March 2018, ten tilt sensors have been installed at the Tateyama site (**Figure 1**). At the Tateyama site, slope movement data was obtained using the tilt sensors. This tilt sensor can detect slope movement in one direction only. The temperature sensor was also installed in the entire box.
