Damage Analysis of Xiaoyudong Bridge Affected by Wenchuan Earthquake, China

Zhongqi SHI¹, Kenji KOSA², Jiandong ZHANG³, Hideki SHIMIZU⁴ and Yuji SAKAMOTO⁵

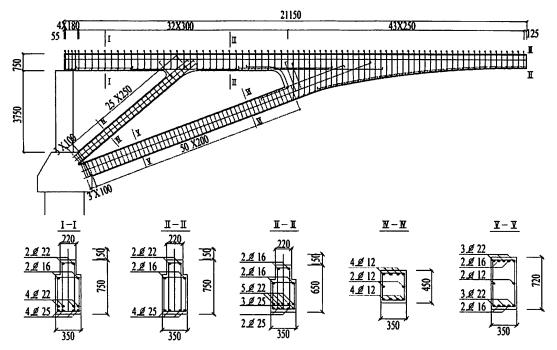
Fig.6 Reinforcements of Half Span (unit: mm)

found that most of the dimensions of this bridge are same with Xiaoyudong Bridge according to the field survey. Therefore, the author assumed the reinforcements of Xiaoyudong Bridge based on that, and modified it according to the results of field survey. As following, the condition of half-span reinforcements is shown in Fig.6, and the overall reinforcement ratios for some important cross sections are shown in Table.1. It became obvious to us that the inclined has the lowest reinforcement ratio of about 0.72%, while the mid-span has the highest one of about 2.56%. The reinforcement ratios of the other cross sections are all between 1.0% and 2.0%.

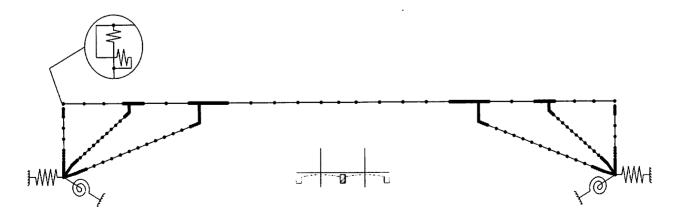
Fig.9 Model for Single Span and Support Condition for the Analysis

The model has been made for the 2nd Span considering no serious supports movement happened here. As shown in Fig.9, on the right angle direction of the axis of the bridge, considering the five arch frames which have been arranged together to form one span of Xiaoyudong Bridge, here select one single arch frame, included the micro-bending slab, to establish the model. For resisting the positive moment, use the section that included girder and slab, while use only the girder for the negative moment. Because there are only two columns for every pier, the properties of the column have been multiplied by 2/5 to fit the single frame. Besides, for the beam at the top of the pier and the footing, here directly use 1/5 value of the characteristics. Due to the insufficiency of the piles' information, as illustrated in Table.3, a horizontal spring and a rotational spring with high rigidities have been set at the bottom of each footing, ignoring the vertical displacement. On the other hand, for the springs between the girder and pier, one shear resisting spring which is assumed to be comparatively weak, and one vertical spring which is only be able to support the compression are in use.

Furthermore, at the positions of footing, the beam on the top of the piers and the joints between legs and girder, noticing the relatively greater cross section area and greater amount of reinforcement, rigid bodies have been modeled.

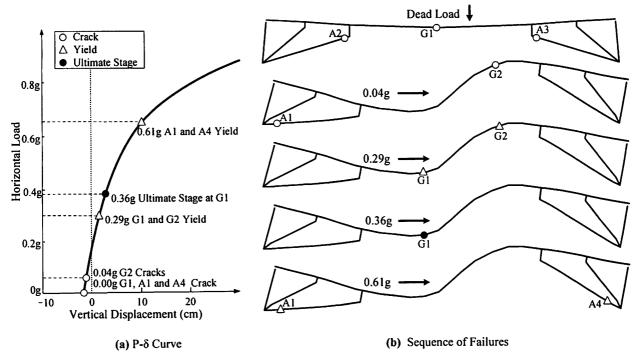
Fig.13 Analysis Result of Case 1

For the Case 1, illustrated in Fig.13 on the next page, which is using the M-Φ relationships under no axial force, cracks will happen at the middle span and the top points of both arch legs only under dead load. Crack may occur due to the negative moment to the right of middle span at 0.04g horizontal load, as well as the bottom of left arch leg. Then as the horizontal load

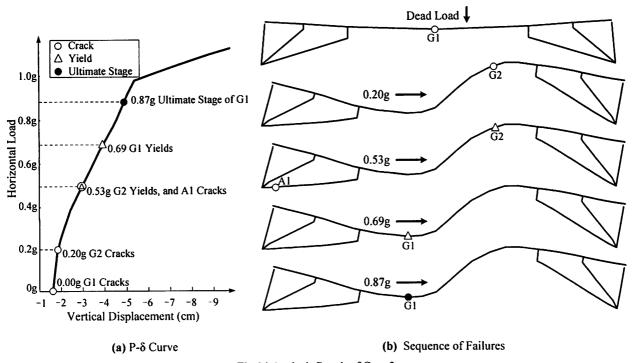
Fig.14 Analysis Result of Case 3

Compared with Case 2, the failures of middle span and the corresponding horizontal load of Case 3 are almost the same, (as illustrated in Fig.14) that it cracks under only dead load, yields at about 0.69g and reaches the ultimate stage at 0.87g. Because the M- Φ relationships have been modified based on latest axial forces condition in the legs, the sequence of failures for the legs is distinguished from the other cases. The bottom of left arch leg cracks at first among all the arch legs and no leg will yield till the end of calculation at 1.2g.
