Damage Analysis of Utatsu Bridge Affected by Tsunami due to Great Eastern Japan Earthquake

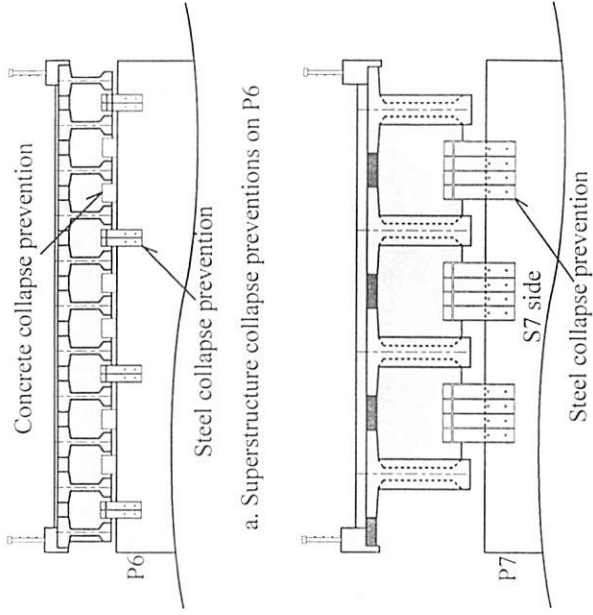
Fig.7 Details of Collapse Prevention on P6 and P7

experienced a displacement of 28m together thus it is proper to regard them as a whole. When the bridge was retrofitted, 2 cables, which were used to prevent the relative movement in axis direction of superstructures, were installed between S6 and S7. The details of the cables are plotted in Fig.5. These cables played an important role to keep S6 and S7 flowing out together. Besides that, the damage of handrail between S6 and S7

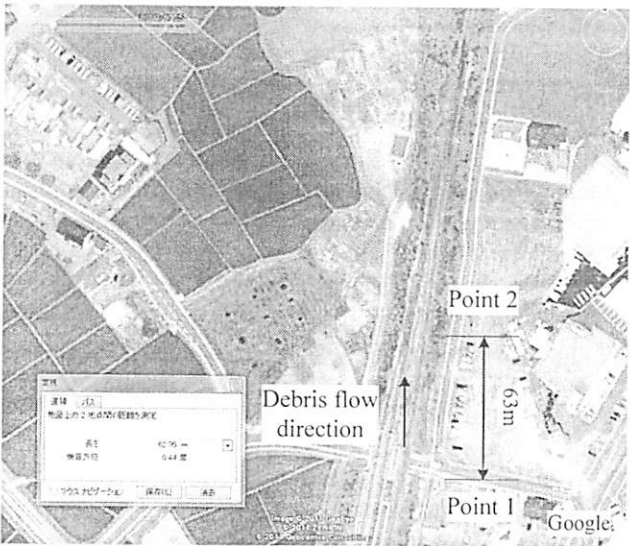
Fig.12 Displacement of the Debris Recorded at Location 1 (by Google Earth)

In this paper, the velocity calculation of location 1, which is about 7.5km south west from Utatsu Bridge, is shown as an example. As shown in Fig.12, the flow of the floating debris was recorded. The distance from point 1 to point 2, which the debris passed through, was measured as 63m. When the debris passed point 1, the timing was starting and while it passed point 2 the timing was over. Based on the video's timekeeper, $t=10s$ was obtained, as shown in Fig.13. In the end, by using the Equation (1), the wave flow velocity at location 1 was calculated as 6.3m/s. By the same method, 12 groups of velocity data are available, illustrated in Fig.14.

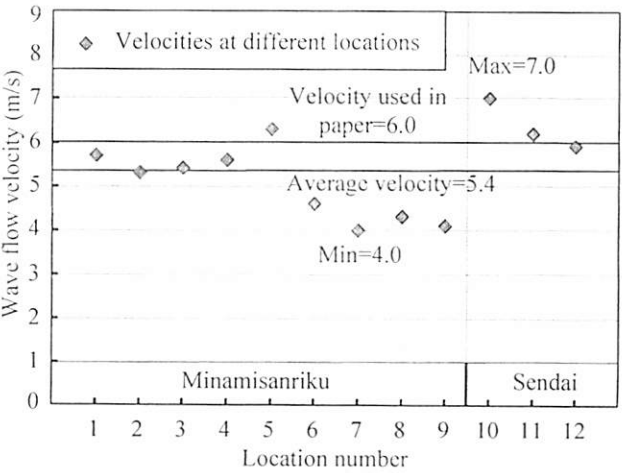
Fig.14 Calculating Result of Wave Velocity

Owing to the lack of the video data at the Utatsu Bridge, the authors assumed the wave velocity at Utatsu Bridge by using the 12 groups of data in other places. From Fig.14, it is observed that the maximum, average, and minimum velocities are respectively 7.0m/s, 5.4 m/s, and 4.0m/s. Combining the huge losses of the Utatsu Bridge, it is proper to assume the velocity at Utatsu Bridge as 6.0m/s, which is slightly larger than the average velocity.

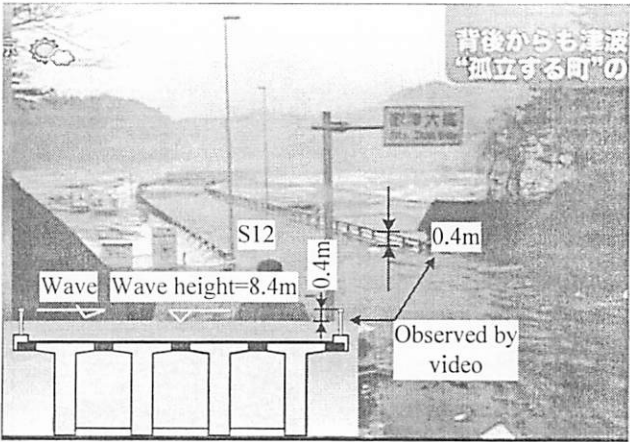
Fig.15 Calculation of the Wave Height at S1 (by the video on Youtube)

The wave height was able to be determined as well by using video records. An evaluating example at S12 of the Utatsu Bridge was stated. Depending on the video record, the height from the wave top surface to the top of handrail (h) was able to be roughly determined as 0.4 m, refer to Fig.15.

After h was obtained, combining the detailed dimensions of the bridge and the sea level before wave coming, it is available to determine the wave height as

8.4m. Utilizing the same method, the wave heights of all spans could be roughly determined.

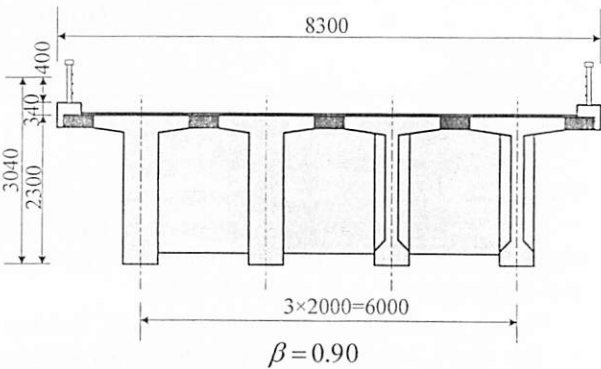
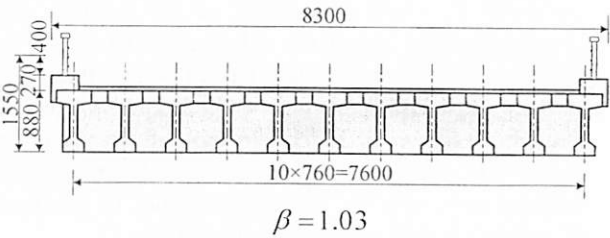
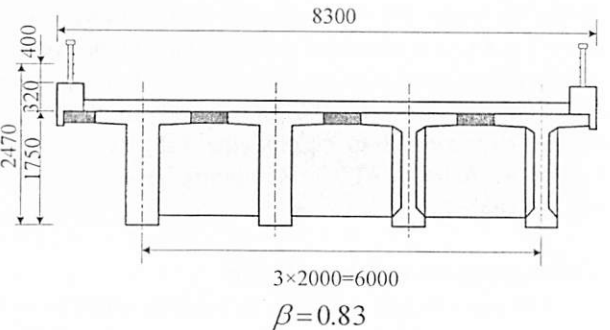
Fig.16 β Values of 3 Types of Superstructures

3 different β values have been calculated, because the Utatsu Bridge consists of 3 types of superstructures, illustrated in Fig.16. Based on the survey report⁴⁾, the average β value of the bridges, located at the Tohoku area, which suffered serious dislocations, is 0.84. The β values of the Utatsu Bridge are 1.03, 0.90 and 0.83, which are close to 0.84. Therefore, it is sufficient for the wave acting force to make S3~S10 move off.

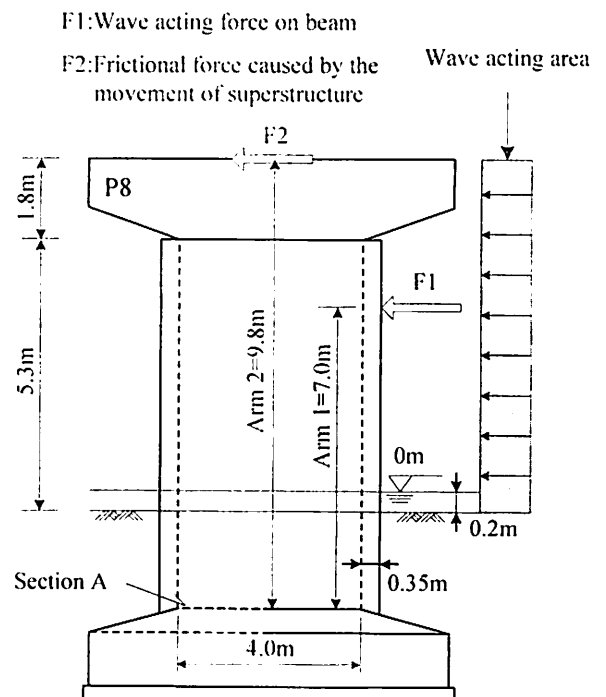
Fig.19 Acting Forces on P8

In order to calculate the acting moment at the bottom (section A) of column, all of the external forces on P8 were found. As being illustrated in Fig.18, the external forces affected on Pier 8 have been divided into 2 types. The first type (F1) is wave-induced acting force, which affected on the side area of pier, and is able to be determined by Equation (8)⁵. Before retrofit, the wave pressure area of P8 is 1.8m×7.1m.

The second type of acting force is the frictional force imposed by the movement of the superstructure upon P8. This type could be determined by using the Equation (3) which has been accomplished in Chapter 2. After these 2 external forces determined, the moment arms of them were searched according to the Japanese specification⁴⁾. In the end, both 2 acting moments caused by F1 and F2 could be determined and the result is shown in Table.1. The total acting moment on section A was calculated as 22250 kN·m. The column of P8 has been retrofitted with the reinforcement concrete surface, as shown in Fig.18 (b), so the wave pressure area became 2.5m×7.1m. And by the same method, the total acting moment was calculated as 23132 kN·m.

Aiming at checking the P8’s strength at an extreme adverse situation, the authors assume the superstructure collapse preventions hold sufficient resistance to prevent the flow of superstructures on P8. In this case, F2 would become the wave acting force on the superstructures on P8. By the same method above, the total acting moment was calculated as 29208 kN·m (before retrofit) and 30090 kN·m (after retrofit), shown in Fig.19.

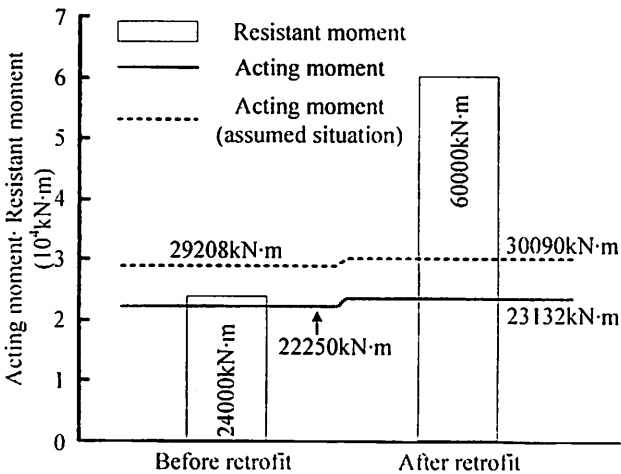
Fig.21 Comparison of Acting Moment and Resistant Moment

- (3) By the comparison of the wave acting moment and the resistant moment, after retrofit, at the bottom (section A) of Pier 8, as an example, it was summarized that the resistant moment is 2.0 times stronger than the acting moment of the extreme situation assumed, so P8 did not collapse. By the same method, it can be verified that all piers kept sufficient strength to prevent collapse.
