Effect by Failure of Foundation on Deformation Behavior of a RC Rigid-Frame Arch Bridge Damaged in Wenchuan Earthquake

Zhongqi SHI¹, Kenji KOSA², Jiandong ZHANG³, Tatsuo SASAKI⁴

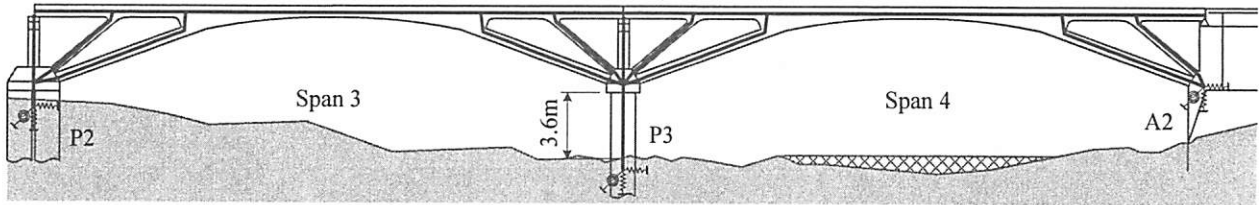
Fig. 6 Analytical Model (2-span) Considering Pile beneath P3

The model has been made for Span 3 & 4 aiming at reappearing their actual damage. As shown in Fig. 6, noticing five arch frames on the transversal direction of the axis, here select one single arch frame, including the slab, to establish the two dimensional model.

The pile beneath P3 has been exposed before the occurrence of Wenchuan Earthquake, which is a special character of Span 3 & 4 distinguished from Span 1 & 2. After the earthquake, about 7.5° residual tilt, and great damage were observed for P3 and at bottom of pile near the ground surface respectively. Therefore, aiming at taking the damage of pile beneath P3 into consideration, tri-linear M- Φ model (as shown in Fig. 5 (b)) is set for it, to simulate the exposure of it before the occurring of earthquake. Noticing relatively greater cross sectional area and greater amount of reinforcement, rigid elements have been set to the following parts: the footing, the beam on the top of the piers and the joints between legs and girder. Tri-linear M- Φ elements (here define yield stage of cross section as the tensile reinforcement reaches at standard tensile strength σ_y , and the ultimate stage of the cross section as the compressive concrete reaches at the ultimate strain of concrete $\epsilon'_{u1} = 0.0035$) calculated based on Japanese specifications are used for the other parts. Then, M- Φ relationships are calculated considering axial forces when only dead load acts on the structure.

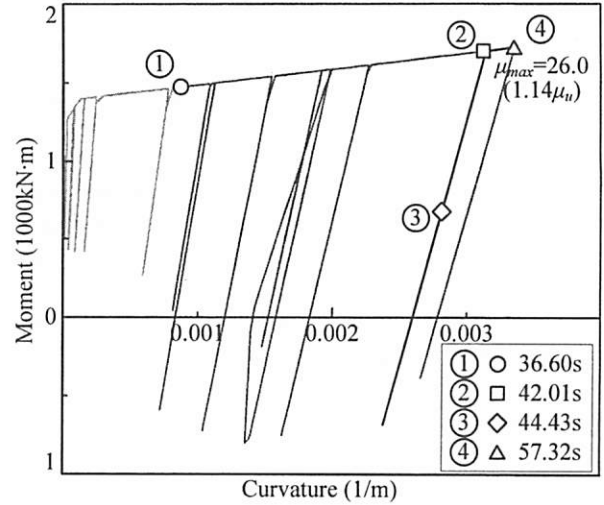
Fig. 10 M- Φ History of Point G (0.0s to 60.0s)

Besides, from the M- Φ history of Point G, as shown in Fig. 10, we can see that opposite response acts on Point P from 42.01s, after several cyclic actions, maximum plastic ratio (26.0) is got at 57.32s

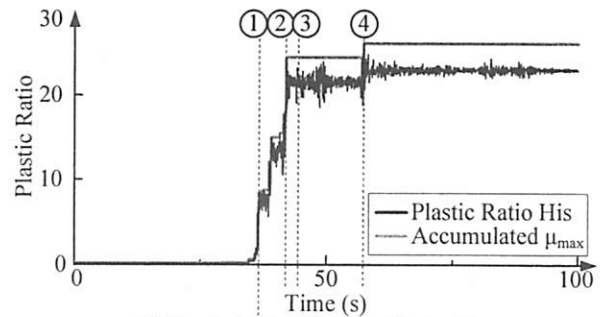
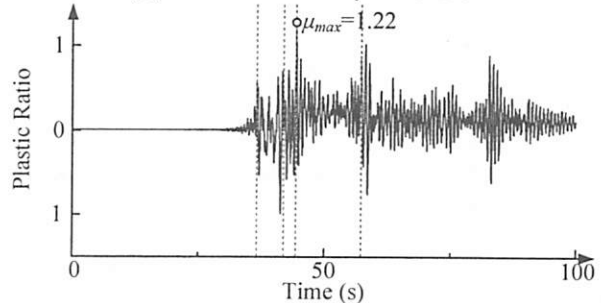
Fig. 12 Plastic Ratio Histories

To discuss the deformation behavior of this RC rigid-frame arch bridge, the plastic ratio histories for Point G and P are plotted in Fig. 12 (a) and (b) respectively, while the accumulated maximum plastic ratio history (which can be considered as the representative for the development of residual flexural response) for Point G is shown in (a) together. From Fig. 12 (a), three time points of sudden change of the accumulated maximum plastic ratio history can be discovered: ① for 36.60s, ② for 42.01s and ④ for 57.32s, respectively marked in Fig. 10 as well. Besides, time point ③ is defined as 44.32s thanks to its maximum plastic ratio ($\mu_{max} = 1.22$) of Point P as shown in Fig. 12 (b). Therefore, at all these four representative time points, relatively noticeable variation ranges of plastic ratio can be observed for both Point G and P. It indicates that notable flexural response happens to these two points.

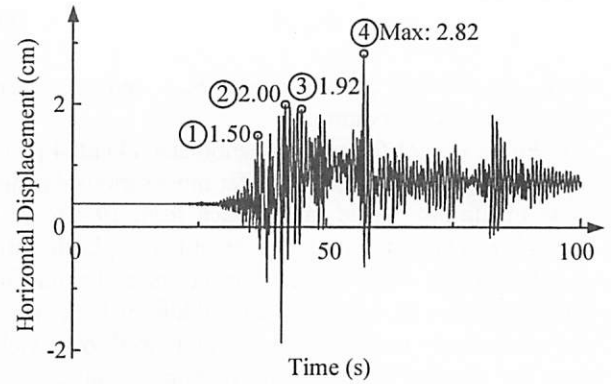
Fig. 13 Horizontal Displacement History of Point E

The displacement history of Point E (the right end of girder of Span 4) is shown in Fig. 13. Referring to four time points defined before, the horizontal displacement of Point E is got as 1.50cm, 2.00cm and 1.92cm for the first three, and maximum 2.82cm for time point ④.

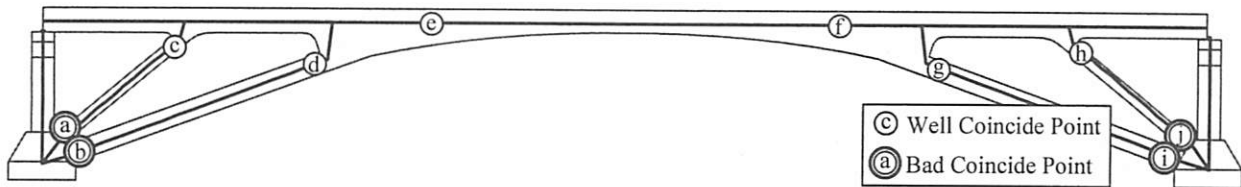
Fig. 16 Positions of Points in Table. 1 (view from upstream)

The comparison results are listed in Table. 1, with the investigate point being illustrated in Fig. 16. Point a~d

Point		(a)	(b)	(c)	(d)	(e)	(f)	(g)	(h)	(i)	(j)
Analytical Result		<1Φ _y				19.2~26.0Φ _y (0.84~1.14Φ _u)		<1Φ _y			
Actual Damage	Span 1	5δ _y	5δ _y	5δ _y	3δ _y	3δ _y		<1δ _y	<1δ _y	3δ _y	3δ _y
	Span 2	3δ _y	3δ _y	<1δ _y	<1δ _y	3δ _y		<1δ _y	<1δ _y	3δ _y	3δ _y
	Span 3	Complete failure		Failure after collapse of girder		5δ _y		Failure after collapse of girder		Complete failure	
	Span 4					5δ _y
