Damage Distribution in the 2013 Awaji Island Earthquake and Ground Motion Characteristics in Sumoto plain

Twayana Ratna Prasad¹ · Shinichiro Mori² · Yoshiya Hata³ · Masayuki Yamada⁴

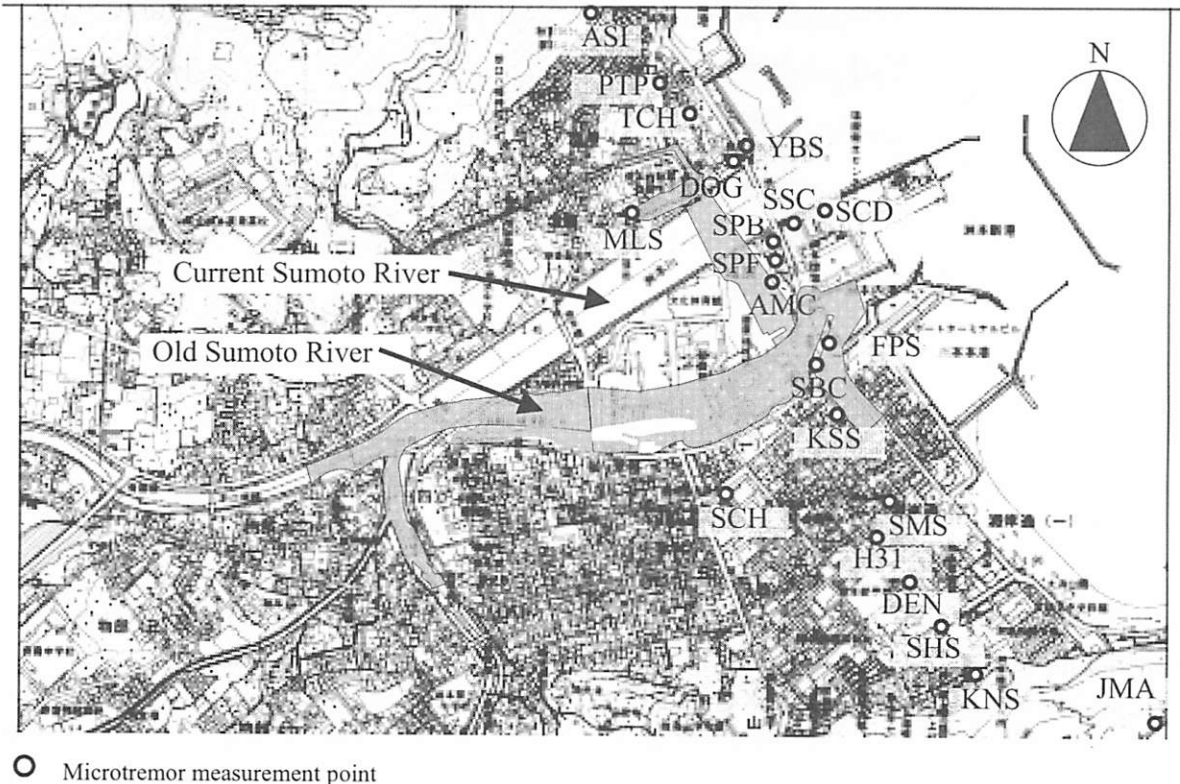
The microtremor measurements were carried out along the line joining the south edge to the north edge of Sumoto plain which is approximately 2 kilometers. The start point of this line is Sumoto JMA station (JMA),extreme point of south part of Sumoto plain, while its end point is Akiba Shrine (ASI), extreme point of north part of Sumoto plain. The microtremor measurements points at Sumoto plain is shown in Fig. 9. Each point is denoted by three alphabets representing the specific location. For example, JMA refers to Japan Meteorological Agency Sumoto, SHS refers to Sumoto Hachiman Shrine, SBC refers to Sumoto Bus Center and so on.

Fig.9 Microtremor measurement points along North-South cross section of Sumoto plain and flow direction of old and current Sumoto River.

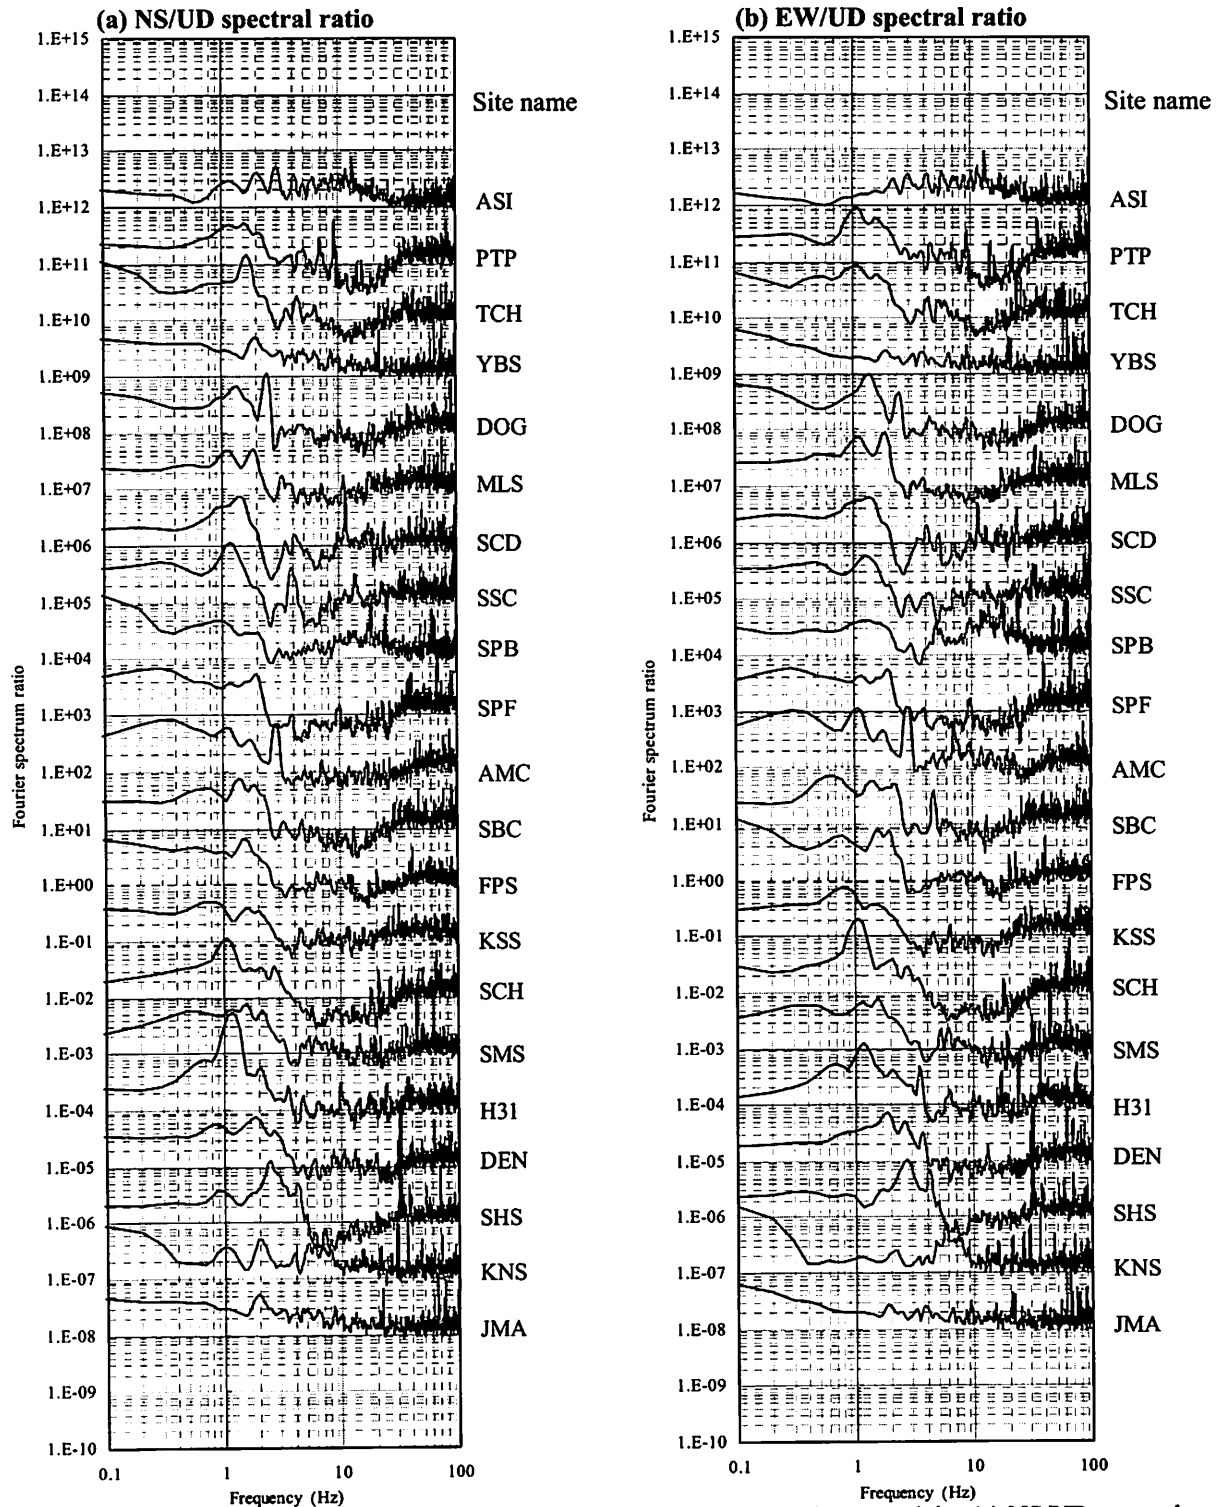
Fig.10 Fourier spectral ratio of microtremor measurement points along the Sumoto plain; (a) NS/UD spectral ratio; (b) EW/UD spectral ratio

The Fourier spectral ratio of representative 21 sites was shown in Fig.10. For an easy understanding about predominant frequency of sites, the Fourier spectral ratio were arranged in single vertical column from JMA Sumoto Station (JMA) to Akiba Shrine (ASI). As stated earlier, the JMA site is starting point, a south edge of Sumoto plain and ASI site is ending point, a north edge of Sumoto plain. Thus spectral ratios from south edge to north edge of sumoto plain were arranged from bottom to top (Fig.10). The Fourier amplitude were multiplied by the integer of 10 to avoid the overlapping of spectral ratio. Thus the amplitude shown in Fig.10 has no any physical meaning. It should be noted that multiplication factor for FPS site (grey) is 1. Two sites JMA (south edge) and ASI (north edge) sites were over hard rocks. Thus spectral ratio of these sites shows the smaller peaks at higher frequencies. In contrast to these two sites, other sites are located on the sediment deposits. Fig.11 shows the variation of predominant periods along the cross-section of Sumoto plain, where abscissa represents orthogonal distance projected on the line joining the JMA (south edge) and ASI (north edge) sites and the ordinate represents the predominant periods obtained from Fourier spectral ratio. The predominant period become longer as sites are close to Sumoto River. There is increase of

predominant periods from south edge to south bank of Sumoto river from 0.5 seconds to 1.25 seconds. The longer period on SBC and AMC sites was observed. These sites are located over old Sumoto river where thickness of soft sediment deposits may be high. The predominant period at Honmachi town was around 0.5 s-1.0 s. The predominant period around Sakaemachi was around 1.0 s-1.25 s. The old Sumoto river used to flow around Sakaemachi and it can be assumed that this town might be the flooding area of old Sumoto River. Thus thickness of soft sediment may be high causing longer period around this area. The Predominant period of ground adjacent to both abutment of Suhama bridge was around 0.8 s-0.9 s while the predominant periods at Takenokuchi town was around 0.2 s-0.3 s. Takenokuchi town represents the heavily damaged zones. The abrupt change in predominant period from 0.8 s to 0.3 s might influence on the concentrated damages in northern side of Sumoto Plain (around Takenokuchi area).

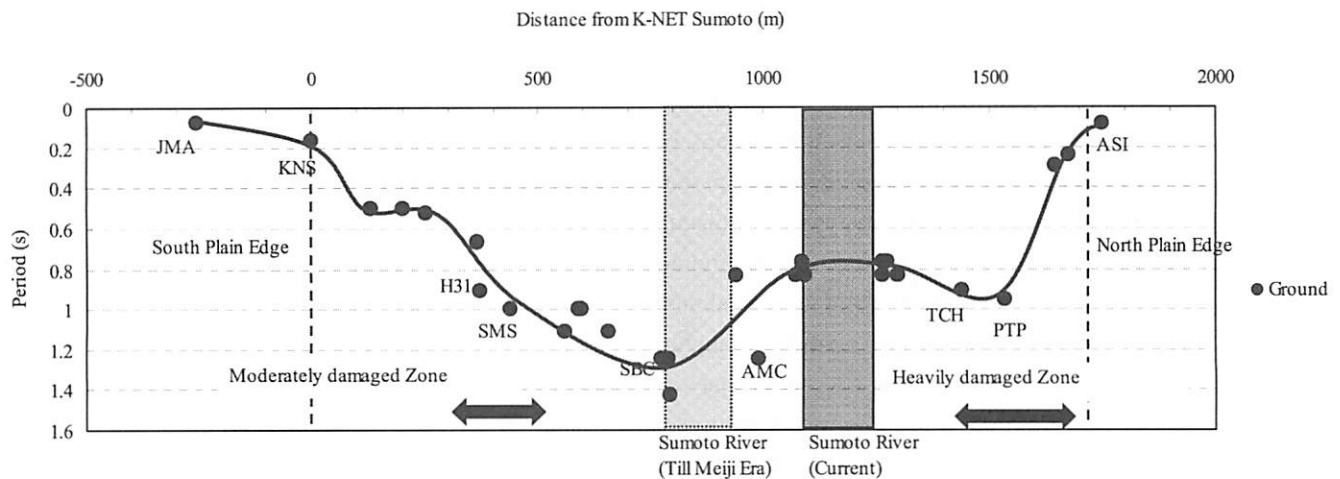
Fig.11 Distribution of predominant period at North-South profile of Sumoto plain.
