DAMAGE CHARACTERISTIC OF BRIDGES DUE TO 2013 BOHOL EARTHQUAKE

Jun-ichi Hoshikuma¹ · Toshiaki Mabuchi²

1. INTRODUCTION

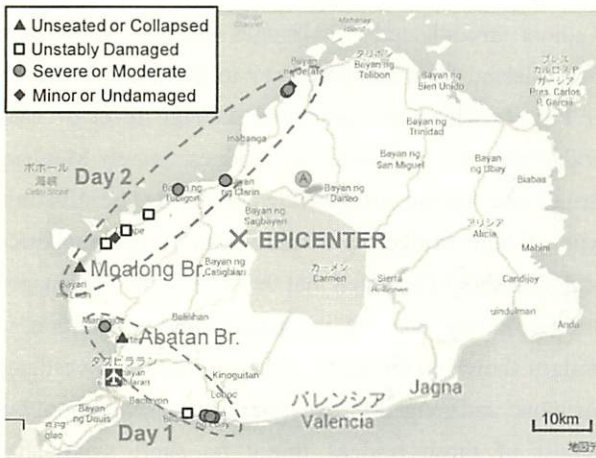
Fig.1 Location of Bridges

Authors investigated 15 bridges located in western Bohol Island from November 19 to 20, 2013, as shown in Fig. 1, where the estimated damage level of each bridge was also indicated. Two bridges, namely Moalong Bridge and Abatan Bridge were collapsed. The structural type of both bridges is a multi-span simple-supported bridge. It should be noted that there are some undamaged bridges in the area of reconnaissance in addition to bridges shown on the map. Authors could not investigate for those undamaged bridges due to time limitation, but almost of those bridges might be short single-span simple-supported bridges.

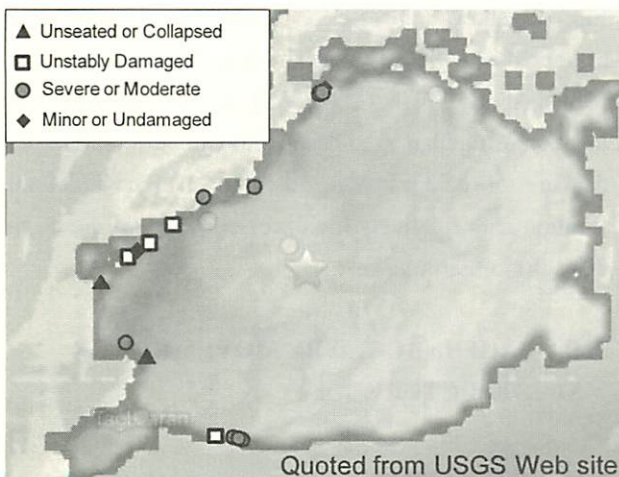
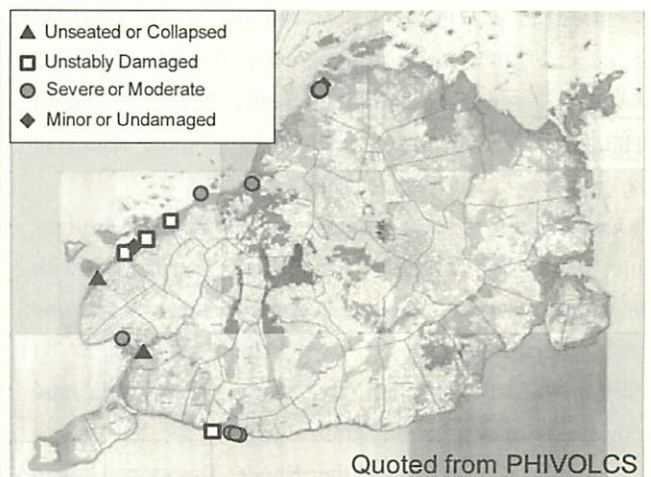
Fig.2 Effect of Ground Acceleration and Liquefaction on Damage to Bridge

Fig. 2 shows the peak ground acceleration map estimated by USGS [1] and the liquefaction hazard map published by PHIVOLCS [2] in comparison with location of the damaged bridges. It can be found that the damage of bridges was observed at the liquefiable location with relatively high acceleration area due to the 2013 Bohol Earthquake.

(a) Ground Peak Acceleration Estimated by USGS

(b) Liquefaction Hazard Published by PHIVOLCS

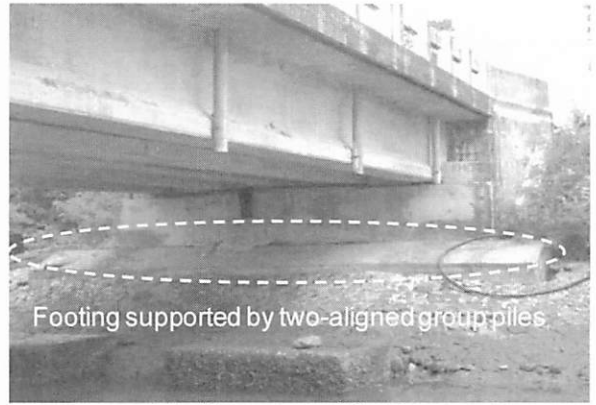
shown in **Photo 7(a)** is a single-span simple-supported bridge constructed in 2002. Taguimtim Bridge is located close to Damiao Bridge which suffered from damage as described above. It should be noted that the abutment is equipped with shear keys and the seat width of 1080mm as shown in **Photo 7(b), (c)**. Furthermore, according to hearing from DPWH engineers, the abutment body is supported by footing and two-aligned group piles. Based on these design details, the seismic effect is considered into the design of Taguimtim Bridge. Actually, no structural damage was observed in Taguimtim Bridge due to the earthquake except settlement of riprap. Residual displacement of the abutment and failure of piles observed in Tultugan Bridge as described above were not observed in Taguimtim Bridge, which may

(a) Abutment and Footing

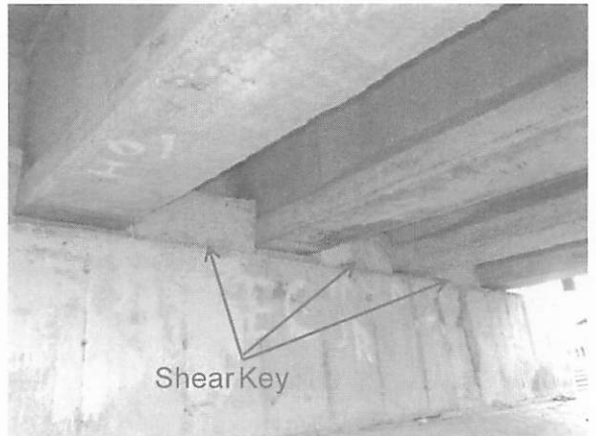
(b) Shear Keys on Seat of Abutment

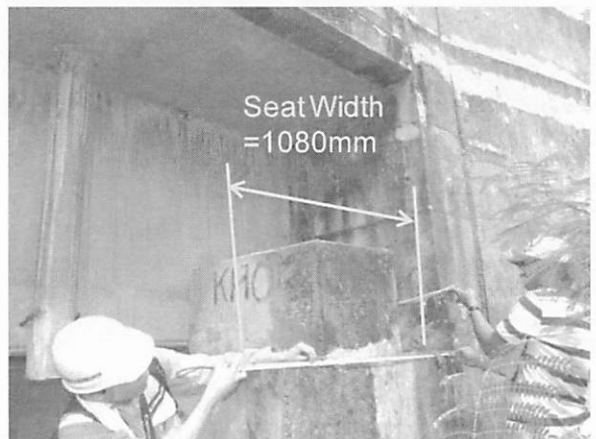
(c) Seat Width
