# DAMAGE TO TUNNELS IN THE OCTOBER 23, 2004 CHUETSU EARTHQUAKE

Key words: Chuetsu earthquake, landslides, active folding, tunnels

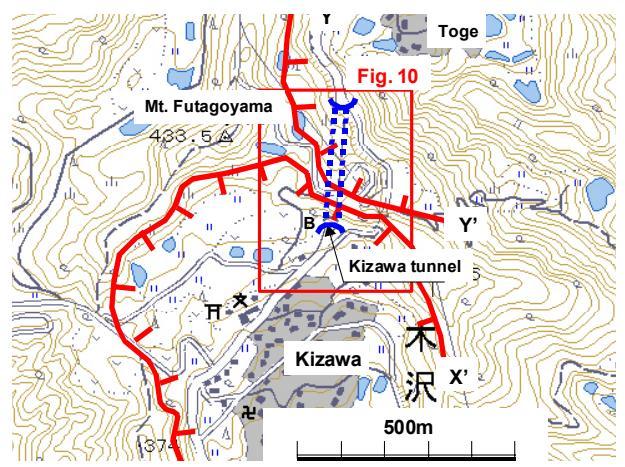
Fig. 1. Surface configuration in the vicinity of Kizawa tunnel

Kizawa tunnel skims the NW-SE trending branch of Futagoyama mountain ridge (Fig. 1). The area is covered thick with Ushigakubi formation of Pliocene age. The surface configuration shown in Figs. 1 and 2 indicates that Kizawa locality about 300 to 800m south of Mt. Futagoyama lies on an old landslide mass with its escarpment shown by line XX'. The south mouth of the tunnel is located a little below this escarpment. Α depressed configuration is also found east to northeastern side along the Futagoyama ridge suggesting the presence of another landslide escarpment (line YY'). The North tunnel mouth is closer to this configuration.

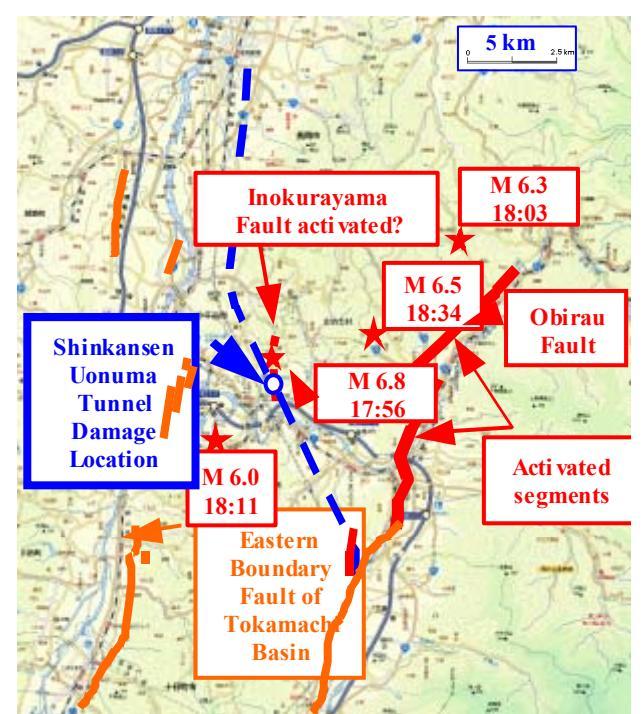
Fig. 9. Epicenters of main and after shocks and seismic faults

The shinkansen high-speed train line between Tokyo and Niigata passes through many mountain tunnels. The Uonuma tunnel is located just to the south of the main shock epicenter as shown in Fig. 9. Fig. 9 also shows the previously unknown Obirau fault and other faults.

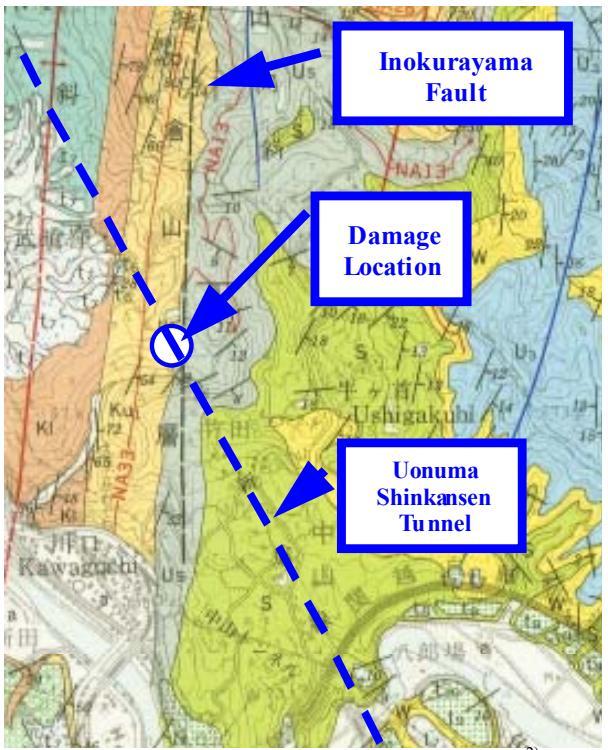
Fig. 10. Geological map with Uonuma tunnel<sup>2)</sup>

The Uonuma tunnel, a 8625m long concrete tunnel, crosses the inferred Inokurayama fault (see Figs. 9-10), which is located just above the epicenter and the damage to the Uonuma tunnel may hint a re-activation of a small segment of this inferred fault. The Inokurayama fault stretches approximately 4km in the SSE/NNW direction from its southern end, just east of Kawaguchi town, to the Konpira mountains in north with its west side as a hanging wall.
