FIELD INVESTIGATION ON THE DAMAGE OF PRAMBANAN TEMPLE, HOUSING AND INFRASTRUCTURE CAUSED BY EARTHQUAKE IN CENTRAL JAVA, INDONESIA

Tsuneo OHSUMI¹⁾ and Koji Baba²⁾

An earthquake with a magnitude of 6.3 has occurred on May 27, 2006 and caused 5,700 casualties. Investigation on damage for the Prambanan temple, housing and infrastructure was carried out in and around Yogyakarta, in central JAVA from June 5 to 8, 2006 The Prambanan complex sustained heavy damage, even this complex is located 40 km far north east of the epicenter. It is considered that the seismic wave was amplified due to the directivity effect and attacked Prambanan complex. Extensive damaged areas are distributed in the west side of the Imogiri fault. Serious damaged areas are limited in Bantul and in Klaten Regency. Damaged areas begin in Klaten Regency between Solo and Yogyakarta. In Bantul Regency, there were more than 4,000 casualties. The infrastructure suffered comparatively light damages, however, housing sustained heavy damages and totally collapsed in Bantul Regency. In this report, reasons why the infrastructure sustained light damage while housing suffered heavily and as well as why damage areas are distri

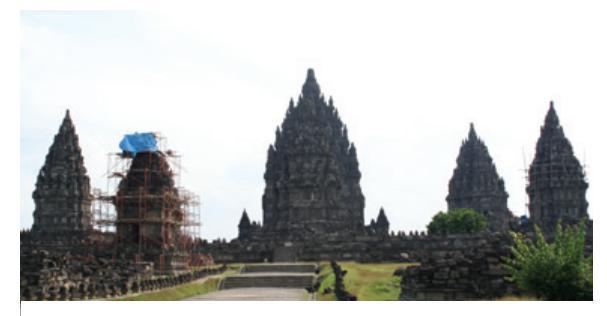
Figure 7 Full view of the Prambanan Complex.

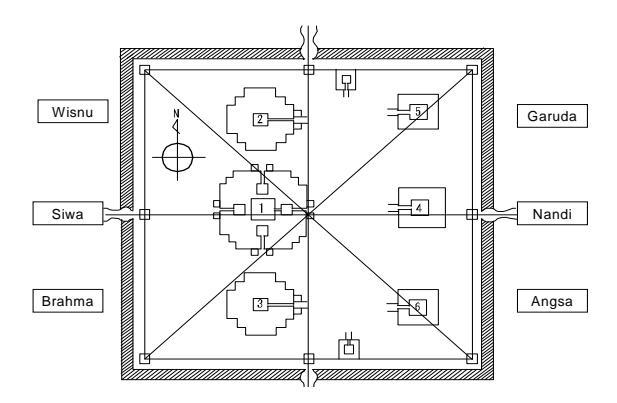
As feature of Hindu temple, Prambanan temple has three main temples (**Figure 8**) which dedicated to the Hindu Trinity, Siwa, Wisnu, and Brahma. All of three temples face a small temple of gods mount (vehicle), Wahana. The Siwa temple having 47 meters high faces the temple of Nandi enshrining the bull used by Siwa as the destroying god. The Wisnu temple with 27meters high faces the temple of Garuda enshrining the eagle used by Wisnu as the guardian god. And the Brahma temple having 37 meters high faces the temple of Angsa enshrining goose/swan used by Brahma as the creating god. The stones used for temples are local Andesites and Basalts. Both stones are described in the book written by Gonggong & Untoro Drajat (2004).

Figure 8 Location of the individual temples in the central part of the Prambanan Complex⁵⁾.

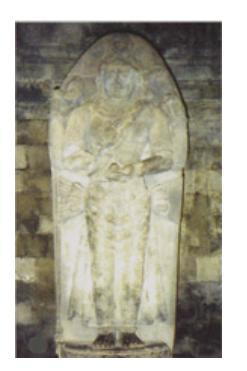
The statue of Siwa niched inside the Siwa temple was not damaged by earthquake. It is clear by comparison of before (left side of **Figure 9**) and after (right side of **Figure 9**) the earthquake. The Ramayana epic engraved on the inner wall of the Siwa temple is very well known (**Figure 10**). Regrettably, this sculpture was damaged by the earthquake (**Figure 11**). The falling stones damaged some parts of the gallery of the Siwa temple (**Figure 11,13**). Some cracks are observed in all corners of this temple. The structure of this temple is a cantilever structure supported by the base stage, then, shaking by earthquake caused a large moment at the support, consequently cracks happened. The width-wise of the cracks is deemed not so serious, and depth of crack is not clear. It is difficult to judge whether temple suffered serious damage or not. Thus, detailed diagnosis of these temples is recommended to be done.

Figure 9 Statue of Siwa There was no damage to the statue of Siwa.

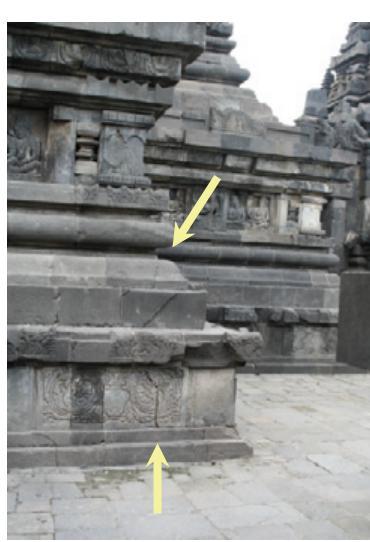
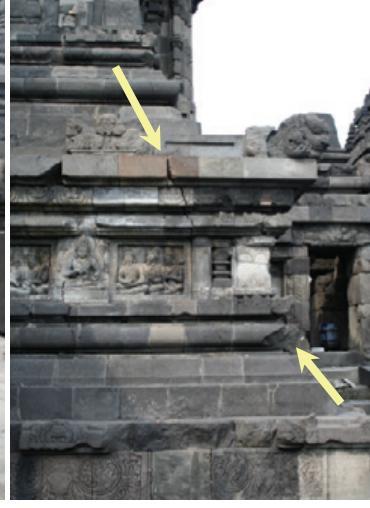
Figure11 The gallery of the Siwa temple were damaged. Some cracks appeared in the corner

section of this temple. All corner sections of the Siwa temple had cracks.

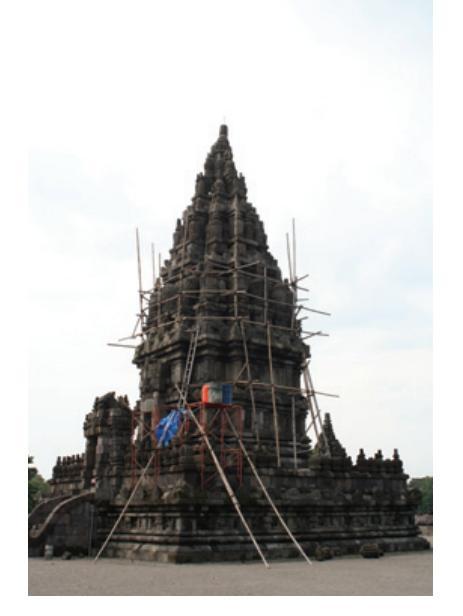
The Wisnu temple is damaged relatively light by the earthquake. Many parts of Ratna which fell from the top caused damage to the corridor (**Figure 14,15**).

Figure 15 Many Ratna parts which fell from the top of the Wisnu temple caused damaged to the corridor.

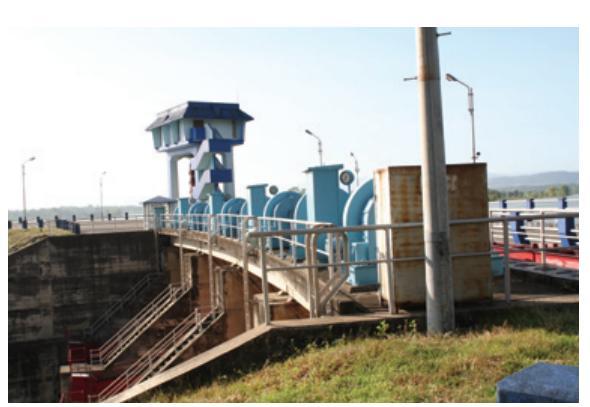
The Sermo dam (**Figure.21**) is located in 30 km west from the epicenter. Final movement is observed at 12 mm. There is no crake in this crest. A seismograph was installed on the embankment, but this instrument was out of order. The Wonogiri dam is far from the epicenter with 60 km, and there is no damage (**Figure.22**). As for neighboring people, the false rumor that a crack went into the dam and became with panic immediately after the earthquake.

Figure 22 Wonogiri dam: no damage

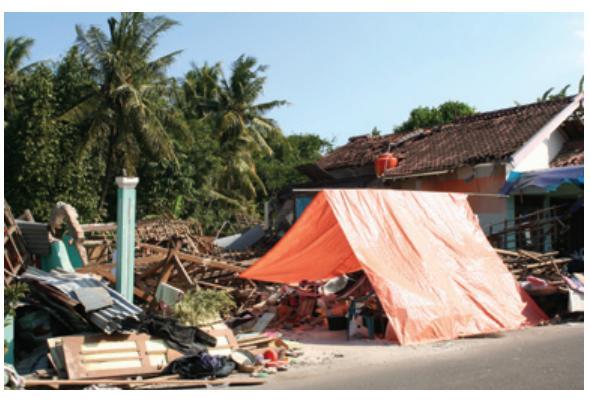
In Bantul Regency, especially at around Imogori County, housing is totally collapsed (**Figure 23**). Refugees live in the tentative tent fear the aftershock (**Figure 24**). Structure of almost all collapsed houses is made of burned brick masonry and wall infilling with cement mortar or reinforced concrete frame rarely. A roof structure is a tile-roofed on wooden mesh, which is top-heavy structure, (**Figure 25**). These structures are typical and traditional houses in Java. This is main reason of

Figure 23 Totally collapsed housing in Bantul Regency.

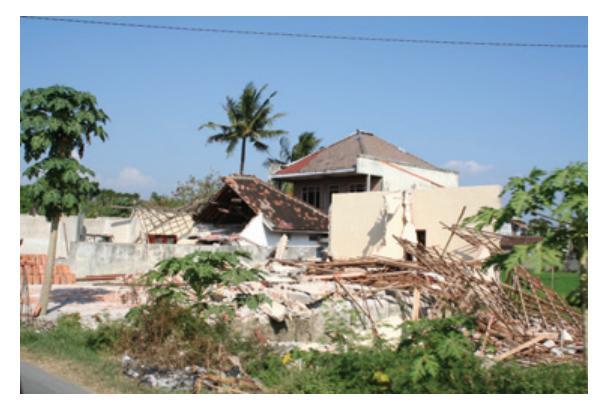
Figure 25 A roof structure is a tile-roofed on wooden mesh. Figure 26 Imogiri county: 260 casualties

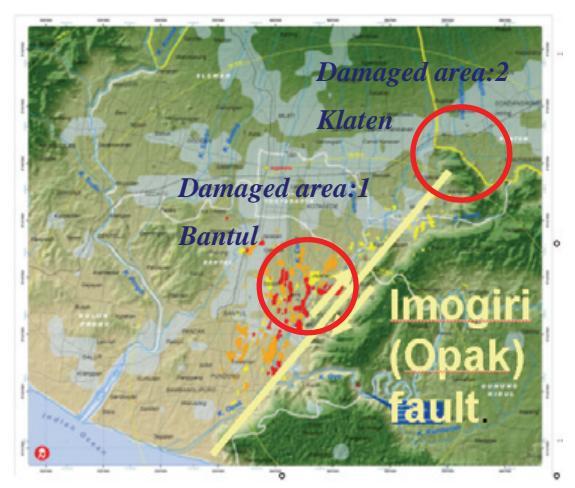
The extensively damaged areas are located in the east part of Bantul Regency or on the west side of the Imogiri (Opak) fault. Comparing the west and east sides of the fault, the west side is downthrown and the east side is up thrown. Volcanic sediments and lava exist on the west side of the fault, in which volcanic sediments and lava are not consolidated. Amplitude and deformation of the foundation by vibration of the earthquake in these areas are deemed to be large because of the site-specific character due to the geology mentioned above. As a result, these areas were damaged seriously. Contrary, the geology on the east side of the Imogiri fault is composed of limestone and sand

Figure 30 Locations of extensive damaged area.

Klaten is considered as follows; The rupture mainly extended toward the northeast and due to the directivity effect, the seismic wave was amplified in the extending direction. Therefore, the Klaten area was damaged heavily.
